# **CITY OF PUNTA GORDA ADA TRANSITION PLAN FINAL REPORT Harborwalk Core**

October 4, 2017

**Prepared For:**  
City of Punta Gorda  
326 West Marion Avenue  
Punta Gorda, Florida, 33950

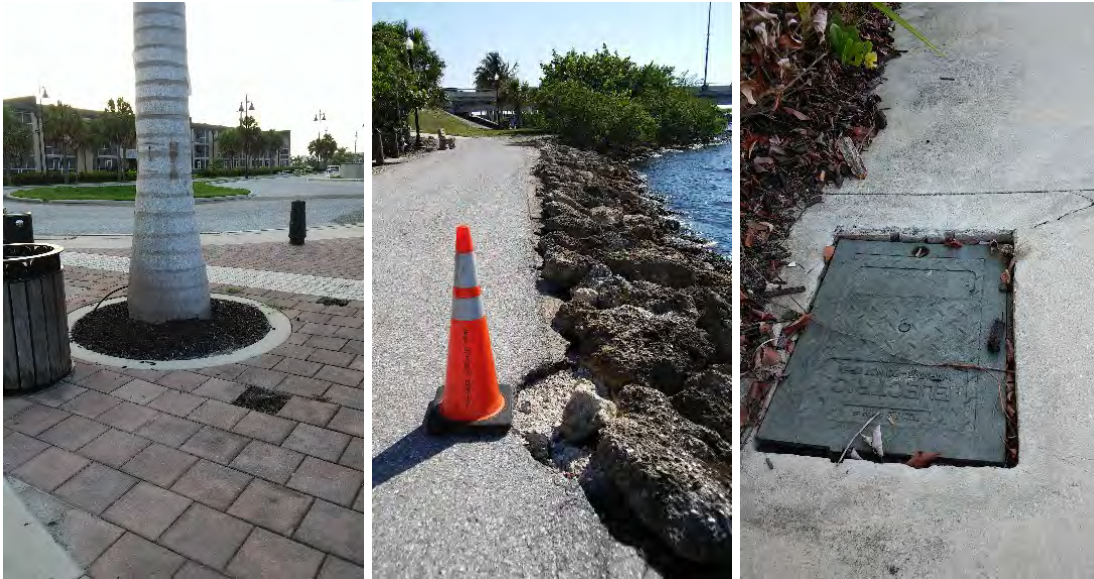
Figure 4-3 – Boardwalk ramps along the pathway

Changes in level are defined as vertical height transitions between adjacent surfaces or along the surface of a path. Figure 4-3 displays three examples where the walking surface is uneven and can be a tripping hazard as well as a barrier to accessibility to a person in a wheelchair. A map of these locations is provided in Appendix A.

Fill in/repave areas with missing bricks or pavement to minimize the potential tripping hazards.

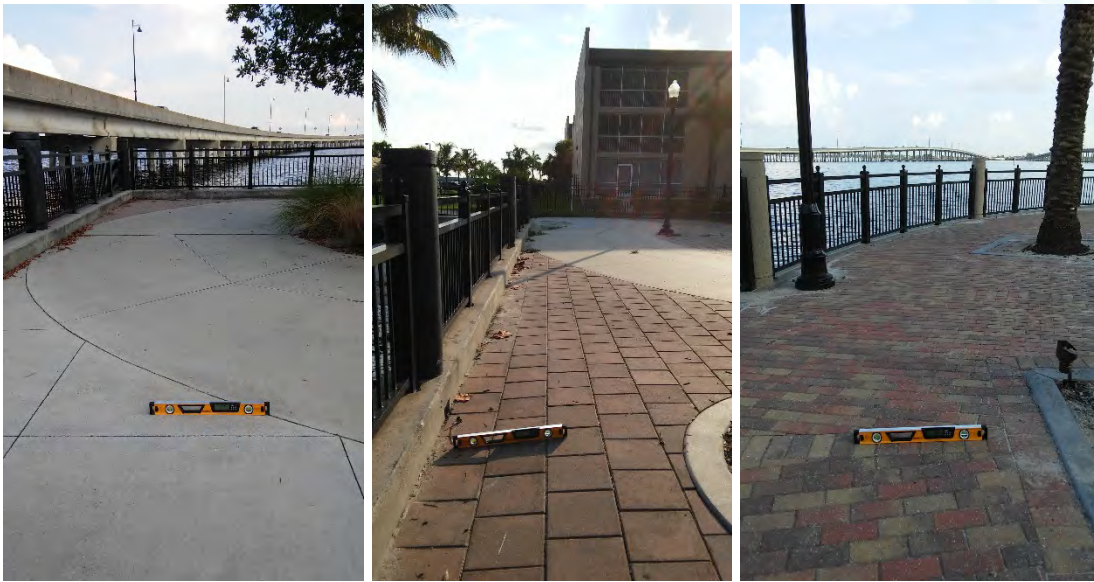
Figure 4-4 – Select locations with non-compliant cross slopes.

Per **ADAAG 403.3**, the cross (perpendicular) slope of a walking surface shall not be steeper than 2%. As such, multiple points of the Harborwalk Core multiuse trail were found to have slopes in excess of this requirement, as shown in the photos below and detailed in Appendix A.

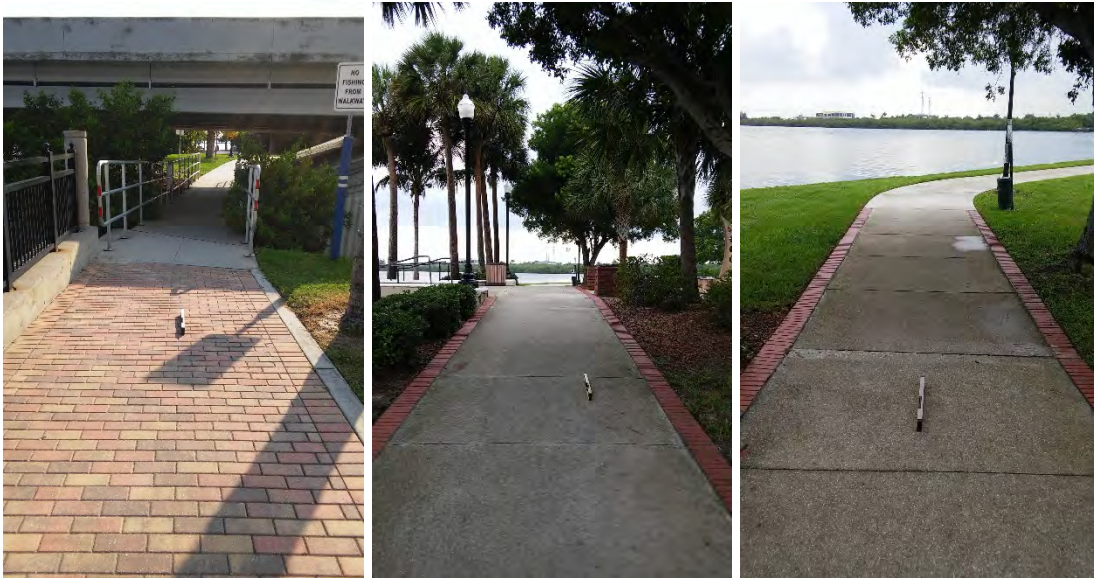
Figure 4-5 – Select locations with non-compliant cross slopes.

As such, multiple segments of the Harborwalk Core multiuse trail were found to have slopes in excess of this requirement, as shown in the photos below and detailed in Appendix A.

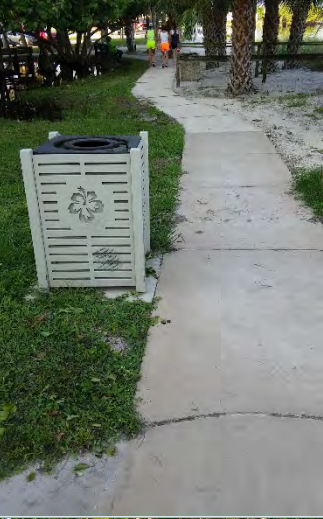
<b>A2</b>	<p>The bench is not accessible due to it being located away from the pavement.</p> <p>Move the bench forward to be adjacent to pavement.</p>

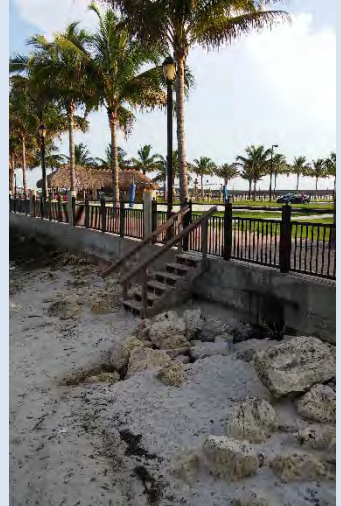
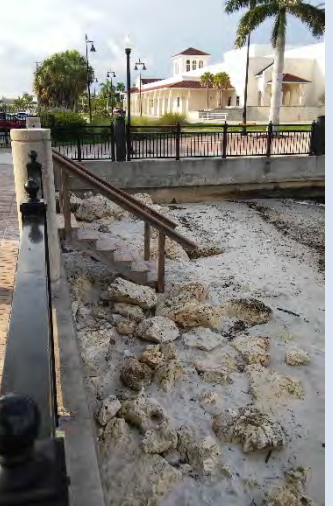
<b>A3</b>	<p>There is only stair access to the small beach.</p> <p>Either add a ramp to provide an accessible entrance to the beach or remove all access to the area.</p>

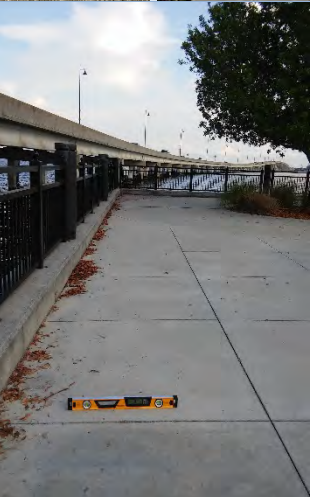
Map Item	Description & Recommendation	Photo
<b>C2</b>	<p>The cross slope is approximately 4.4%.</p> <p>Repave/resurface the trail so that the cross slope is no greater than 2%.</p>

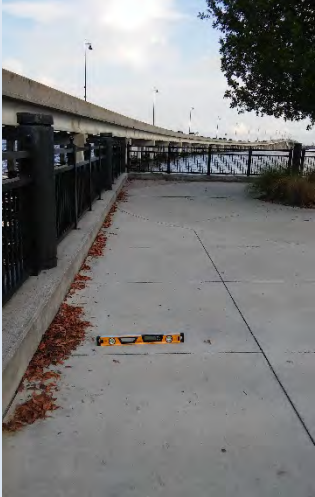
<b>C3</b>	<p>The cross slope is approximately 3.5%.</p> <p>Repave/resurface the trail so that the cross slope is no greater than 2%.</p>

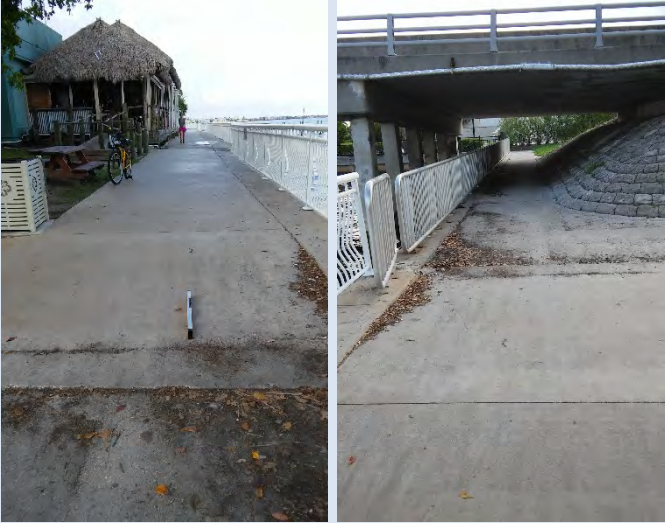
R2	<p>This section of trail has a 6% running slope for approximately 10 feet. There is also a 0.75" tripping at the cement joint.</p> <p>Repave/regrade the trail to have a slope no greater than 5%. Resurface the cement joint to remove the tripping hazard.</p>

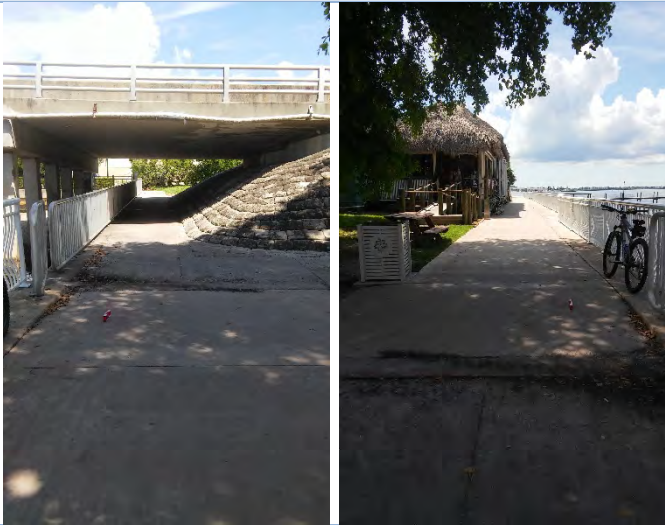
R3	<p>This section of trail has a 6% running slope.</p> <p>Regrade &amp; reset the brick pavers so the running slope is no greater than 5%.</p>

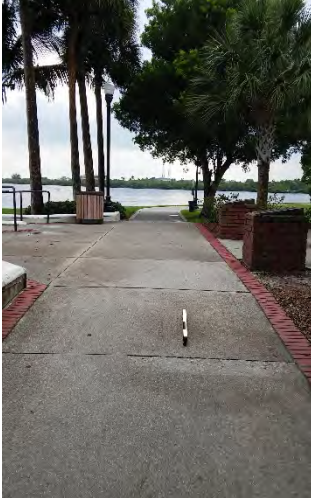
<b>R11</b>	<p>This section of trail has a 6.3% running slope.</p> <p>Repave &amp; regrade the trail to have a slope no greater than 5%. Or, designate this section of trail as a ramp and add handrails and landings.</p>
