CITY OF PUNTA GORDA ADA TRANSITION PLAN FINAL REPORT Harborwalk East

October 4, 2017

Prepared For:
City of Punta Gorda
326 West Marion Avenue
Punta Gorda, Florida, 33950

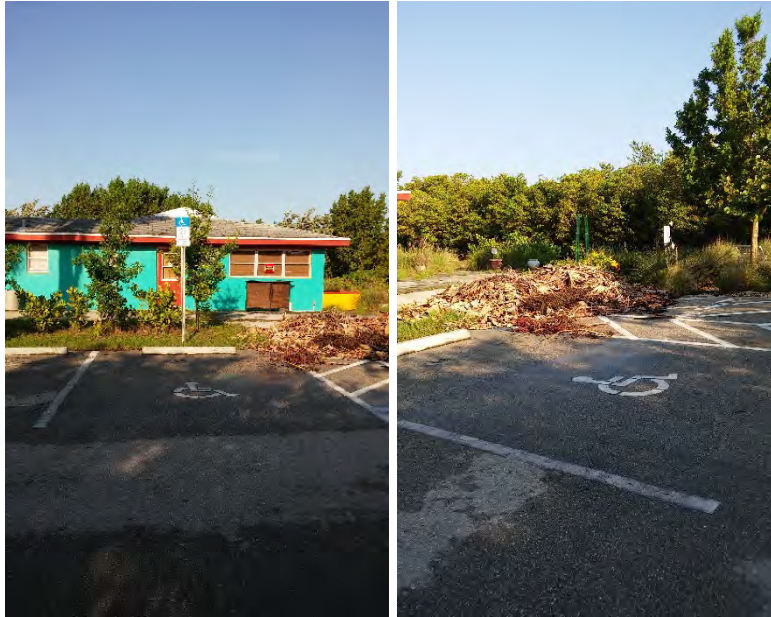
Figure 4-1: Accessible Parking

- The striping for the accessible parking space is white, not blue.
- There is some debris in the parking space and accessible aisle.
- The parking space does not have a sign identifying it as being van accessible.

FS 553.5041 (6) “Each such parking space must be striped in a manner that is consistent with the standards of the controlling jurisdiction for other spaces and prominently outlined with blue paint, and must be repainted when necessary, to be clearly distinguishable as a parking space designated for persons who have disabilities.”

ADAAG 502.6 Identification “Signs identifying van parking spaces shall contain the designation “van accessible.”

- Restripe the accessible parking space so that it is outlined in blue.
- Remove the debris from the accessible parking space and aisle.
 - Maintain the parking space and aisle so that debris does not build up in these areas.
- Add a “Van Accessible” sign to the accessible parking space sign.

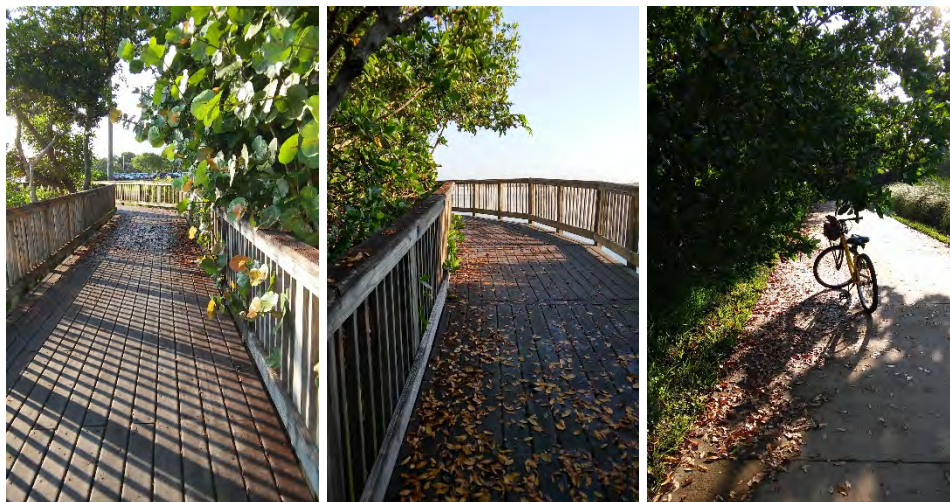
Figure 4-2 – Low hanging tree branches

Vertical clearance is defined as the minimum unobstructed vertical passage space. Vertical clearance is often limited by obstacles such as building overhangs, tree branches, signs, and awnings. Shown below in Figure 4-2, various sections of the Harborwalk East trail contains low hanging tree branches, which protrude and obstruct the pathway. A map of these locations is provided in Appendix A.

ADAAG states that, “objects with leading edges more than 27 inches and not more than 80 inches above the finish floor or ground shall protrude 4 inches maximum horizontally into the circulation path.

Trim and maintain the tree branches so they do not protrude more than 4” onto the path for a height of at least 80 inches. This will prevent visitors with visual impairments from not being able to detect and then make contact with the hazardous object.

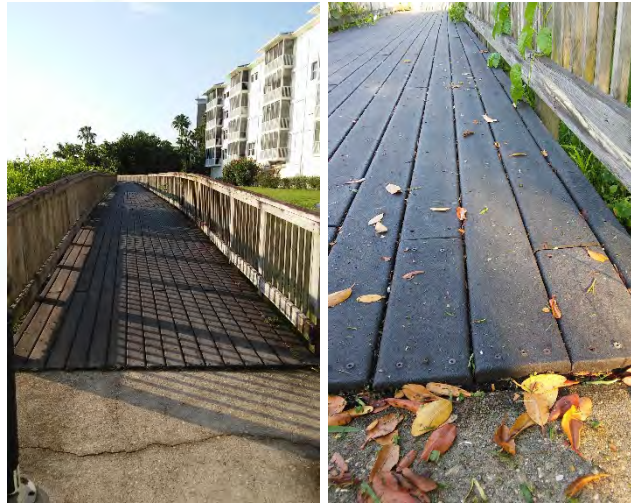
Figure 4-3 – Boardwalk ramps along the pathway

Changes in level are defined as vertical height transitions between adjacent surfaces or along the surface of a path. Figure 4-3 displays two examples where the 1.5" lip at the transition from the cement path to the boardwalk can be a tripping hazard as well as a barrier to accessibility to a person in a wheelchair. A map of these locations is provided in Appendix A.

ADAAG 303.2 states that, "Changes in level of $\frac{1}{4}$ " high maximum shall be permitted to be vertical."

ADAAG 303.3 states that, "Changes in level of $\frac{1}{4}$ " high minimum and $\frac{1}{2}$ " high maximum shall be beveled with a slope not steeper than 1:2."

Either bevel or provide an accessible transition plate at the wood/cement transition to minimize the lip between the two section of trail.

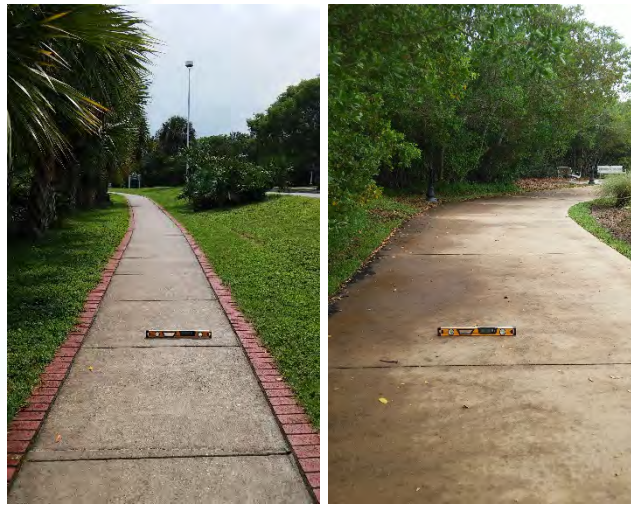
Figure 4-2 – Select locations with non-compliant cross slopes.

Per **ADAAG 403.3**, the cross (perpendicular) slope of a walking surface shall not be steeper than 2%. As such, 16 points of the Harborwalk East multiuse trail were found to have slopes in excess of this requirement, as shown in the photos below and detailed in Appendix A.

The locations that have non-compliant cross slope must be resurfaced so that the cross slope does not exceed 2%, as specified in **ADAAG 403.3**.

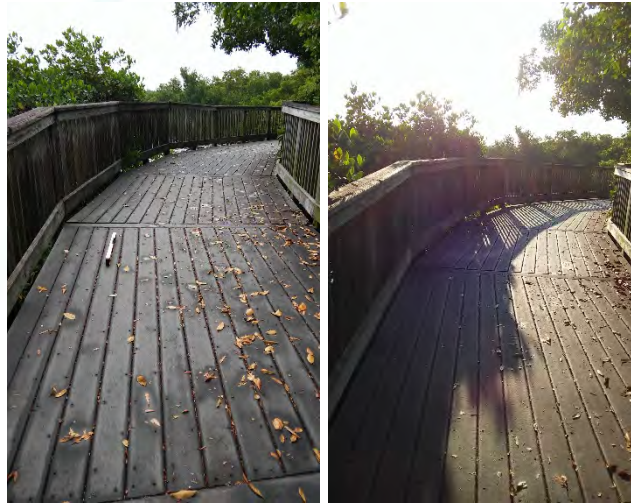
Figure 4-3 – Select locations with non-compliant cross slopes.

Per **ADAAG 403.3**, the running (perpendicular) slope of a walking surface shall not be steeper than 5%. If a slope exceeds 5%, it is considered a ramp, per **ADAAG 405.2**, and the running slope must not exceed 8.33%. In addition, ramps must have landings, handrails, and edge protection, per **ADAAG 405**.

As such, 8 segments of the Harborwalk East multiuse trail were found to have slopes in excess of this requirement, as shown in the photos below and detailed in Appendix A.

The locations that have non-compliant running slopes must be either resurfaced/reconstructed or include the addition of handrails and landings, as long as their slope is not steeper than 8.33%, as specified in **ADAAG 405**.

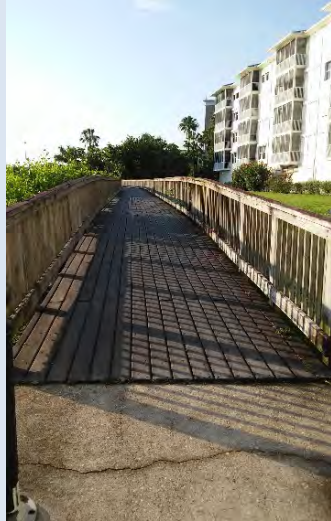
Map Item	Description & Recommendation	Photo
M1	<p>There is a 1.5" lip at the entrance to the walkway.</p> <p>Resurface the cement/wood transition to minimize the lip, per ADAAG 303.</p>

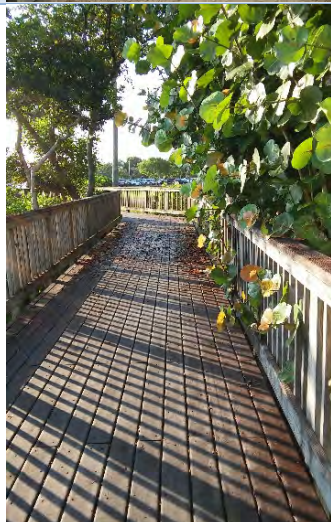
M2	<p>Tree branches extend below 80" into the accessible route.</p> <p>Trim and maintain the foliage so the accessible route is clear of obstructions, per ADAAG 307.</p>

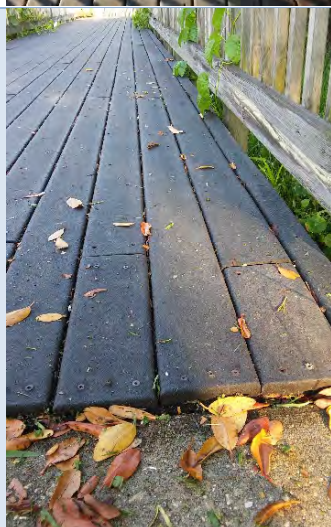
M3	<p>There is a 1.5" lip at the entrance to the walkway.</p> <p>Resurface the cement/wood transition to minimize the lip, per ADAAG 303.</p>

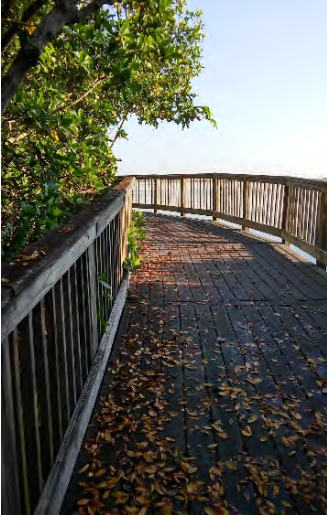
Map Item	Description & Recommendation	Photo
M4	<p>Tree branches extend below 80" into the accessible route.</p> <p>Trim and maintain the foliage so the accessible route is clear of obstructions, per ADAAG 307.</p>

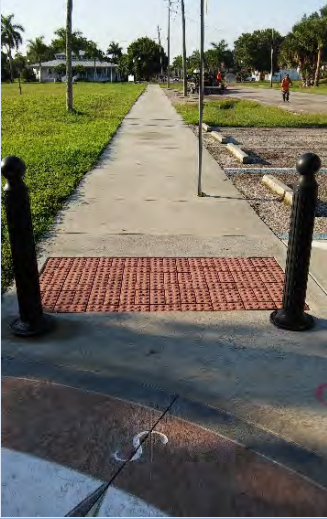
M5	<p>A detectable warning is not required at this location and may be confusing to a person with a vision impairment.</p> <p>Remove the detectable warning.</p>

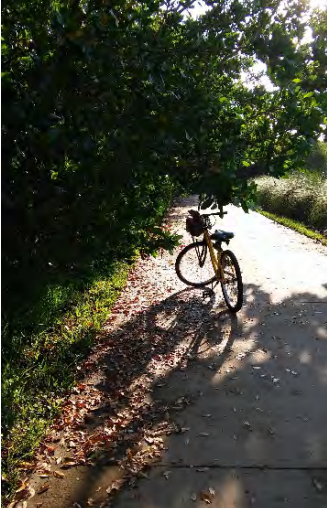
M6	<p>Tree branches extend below 80" into the accessible route.</p> <p>Trim and maintain the foliage so the accessible route is clear of obstructions, per ADAAG 307.</p>

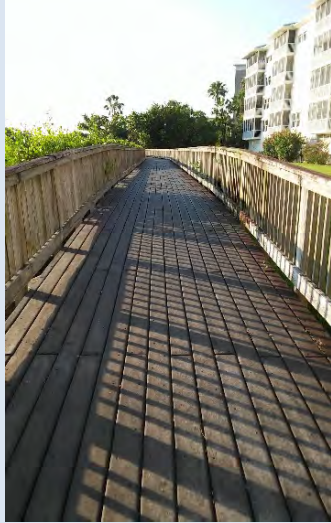
Map Item	Description & Recommendation	Photo
R1	<p>The running slope is greater than 5% for about 20' in length and there are no handrails.</p> <p>Either minimize the running slope to be no greater than 5% or add handrails and landing areas per ADAAG 405.8 and ADAAG 405.7.</p>

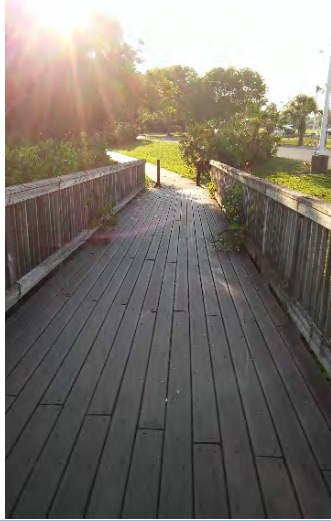
R2	<p>The running slope is 6%, and there are no handrails.</p> <p>Either minimize the running slope to be no greater than 5% or add handrails and landing areas per ADAAG 405.8 and ADAAG 405.7.</p>

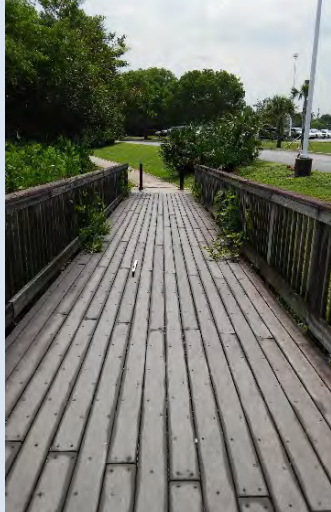
R3	<p>The running slope is 5.5%, and there are no handrails.</p> <p>Either minimize the running slope to be no greater than 5% or add handrails and landing areas per ADAAG 405.8 and ADAAG 405.7.</p>

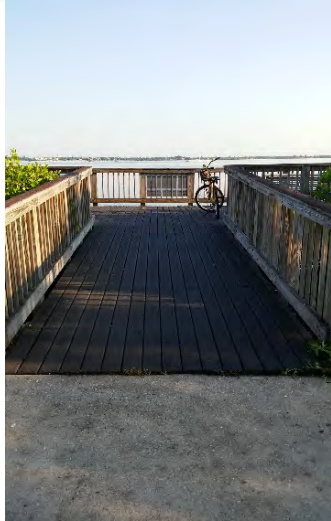
Map Item	Description & Recommendation	Photo
R4	<p>The running slope is greater than 5% and there are no handrails. There is a 1.5" lip at the entrance to the pier.</p> <p>Either minimize the running slope to be no greater than 5% or add handrails and landing areas per ADAAG 405.8 and ADAAG 405.7. Resurface the cement/wood transition to minimize the lip, per ADAAG 303.</p>

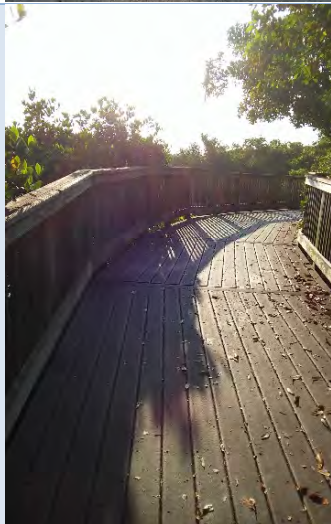
R5	<p>The running slope is 8% with 2-4% cross slope at the curved section of walkway. There are no handrails.</p> <p>Reconstruct the walkway so the cross slope is no greater than 2%. Either minimize the running slope to be no greater than 5% or add handrails and landing areas per ADAAG 405.8 and ADAAG 405.7.</p>

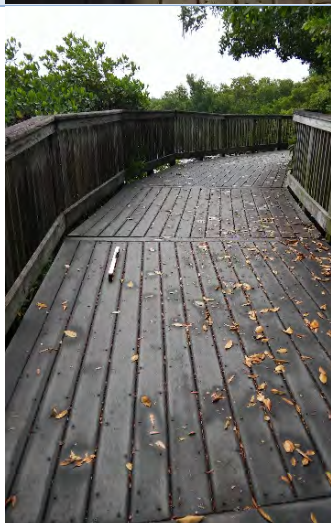
R6	<p>The running slope is 8.7%, and there are no handrails.</p> <p>Either minimize the running slope to be no greater than 5% or add handrails and landing areas per ADAAG 405.8 and ADAAG 405.7.</p>

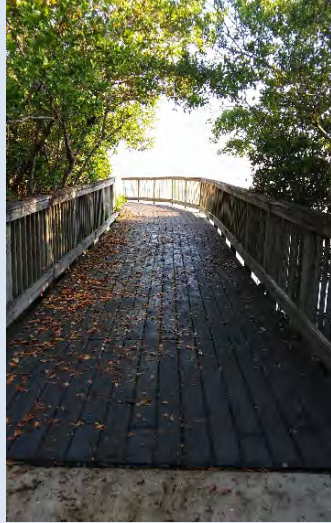
Map Item	Description & Recommendation	Photo
R7	<p>The running slope is between 5-7% and there are no handrails. There is a 1.5" lip at the entrance to the walkway.</p> <p>Either minimize the running slope to be no greater than 5% or add handrails and landing areas per ADAAG 405.8 and ADAAG 405.7. Resurface the cement/wood transition to minimize the lip, per ADAAG 303.</p>

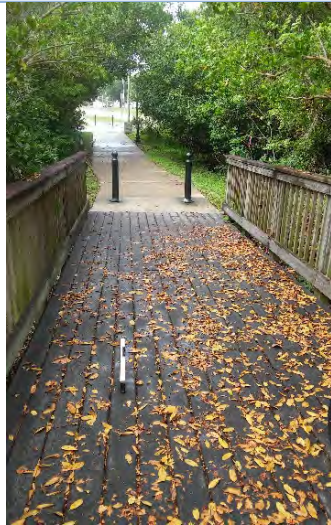
R8	<p>The running slope is 5.8%, and there are no handrails.</p> <p>Either minimize the running slope to be no greater than 5% or add handrails and landing areas per ADAAG 405.8 and ADAAG 405.7.</p>

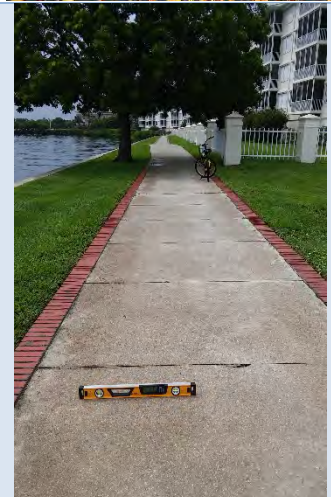
C1	<p>The cross slope at this point is 2.1%.</p> <p>Resurface the paved trail so the cross slope is a maximum of 2%, per ADAAG 403.3.</p>

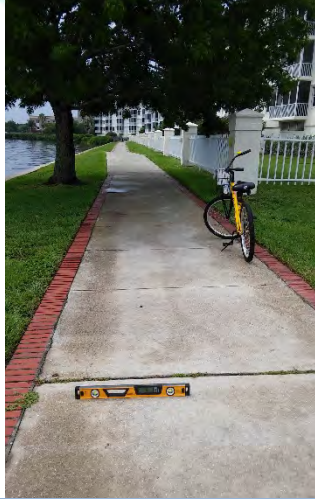
Map Item	Description & Recommendation	Photo
C2	<p>The cross slope at this point is 4.0%.</p> <p>Resurface the paved trail so the cross slope is a maximum of 2%, per ADAAG 403.3.</p>

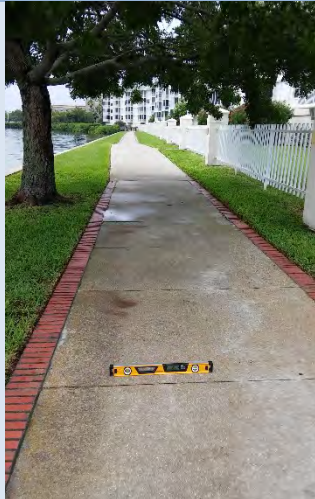
C3	<p>The cross slope at this point is 3.5%.</p> <p>Resurface the paved trail so the cross slope is a maximum of 2%, per ADAAG 403.3.</p>

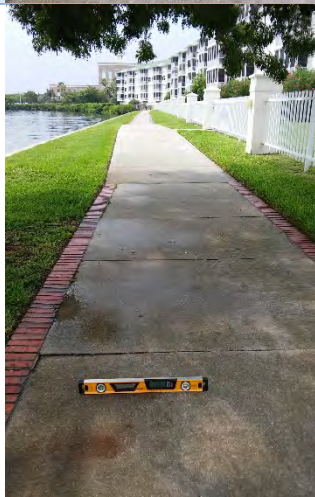
C4	<p>The cross slope at this point is 3.5%.</p> <p>Resurface the paved trail so the cross slope is a maximum of 2%, per ADAAG 403.3.</p>

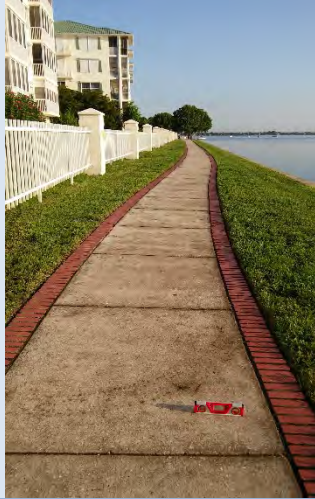
Map Item	Description & Recommendation	Photo
C5	<p>The cross slope at this point is 2.5%.</p> <p>Resurface the paved trail so the cross slope is a maximum of 2%, per ADAAG 403.3.</p>

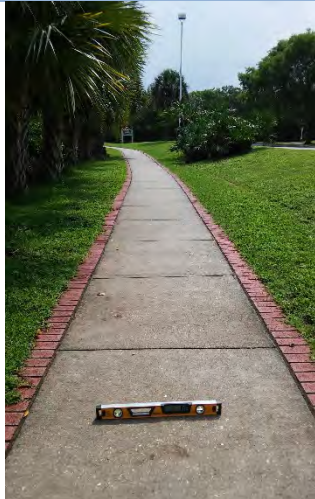
C6	<p>The cross slope at this point is 2.6%.</p> <p>Resurface the paved trail so the cross slope is a maximum of 2%, per ADAAG 403.3.</p>

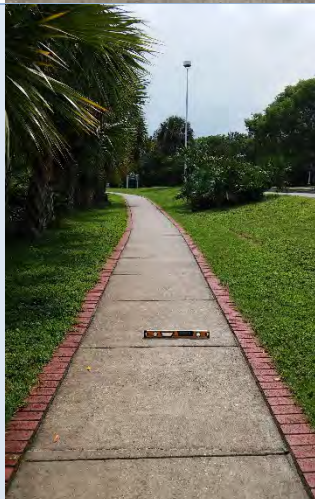
C7	<p>The cross slope at this point is 3.1%.</p> <p>Resurface the paved trail so the cross slope is a maximum of 2%, per ADAAG 403.3.</p>

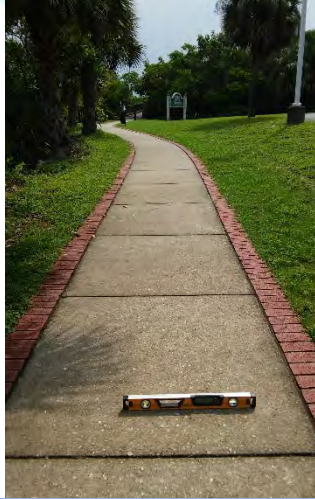
Map Item	Description & Recommendation	Photo
C8	<p>The cross slope at this point is 2.6%.</p> <p>Resurface the paved trail so the cross slope is a maximum of 2%, per ADAAG 403.3.</p>

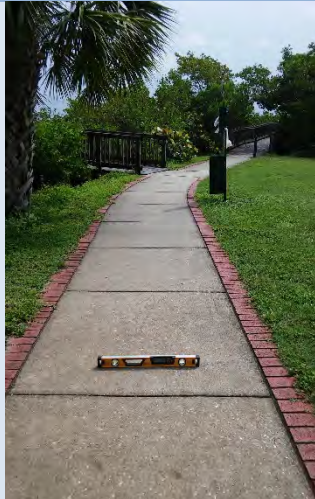
C9	<p>The cross slope at this point is 2.4%.</p> <p>Resurface the paved trail so the cross slope is a maximum of 2%, per ADAAG 403.3.</p>

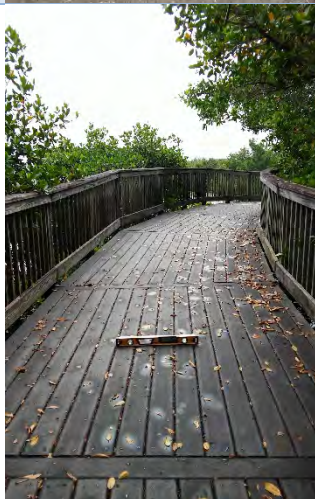
C10	<p>The cross slope at this point is 3.7%.</p> <p>Resurface/reconstruct the boardwalk so the cross slope is a maximum of 2%, per ADAAG 403.3.</p>

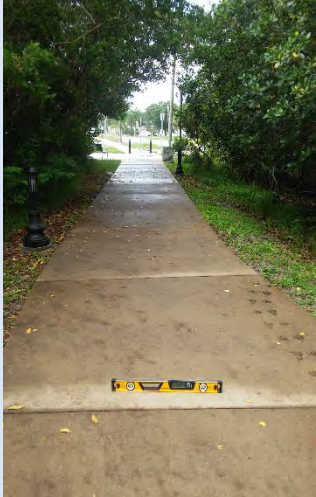
Map Item	Description & Recommendation	Photo
C11	<p>The cross slope at this point is 2.3%.</p> <p>Resurface the paved trail so the cross slope is a maximum of 2%, per ADAAG 403.3.</p>

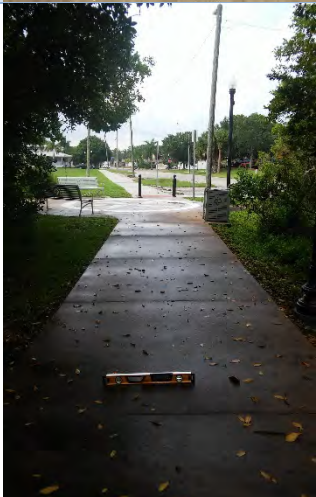
C12	<p>The cross slope at this point is 2.4%.</p> <p>Resurface the paved trail so the cross slope is a maximum of 2%, per ADAAG 403.3.</p>

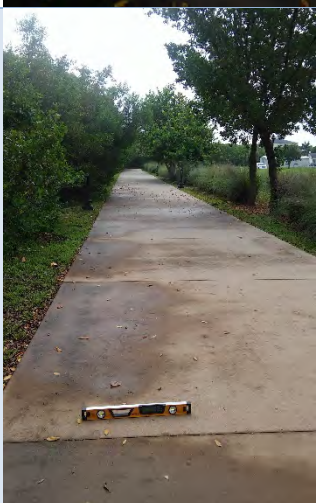
C13	<p>The cross slope at this point is 2.3%.</p> <p>Resurface the paved trail so the cross slope is a maximum of 2%, per ADAAG 403.3.</p>

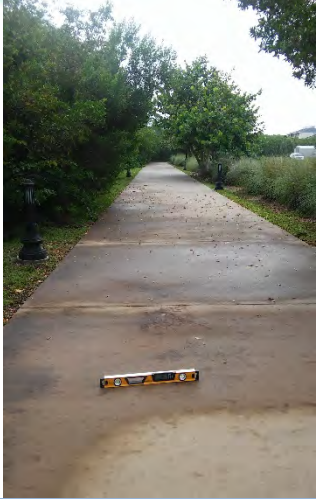
Map Item	Description & Recommendation	Photo
C14	<p>The cross slope at this point is 2.6%.</p> <p>Resurface the paved trail so the cross slope is a maximum of 2%, per ADAAG 403.3.</p>

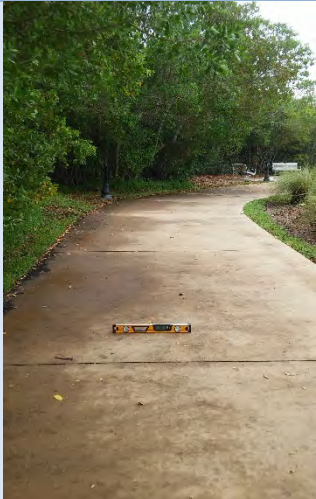
C15	<p>The cross slope at this point is 2.8%.</p> <p>Resurface the paved trail so the cross slope is a maximum of 2%, per ADAAG 403.3.</p>
