CITY OF PUNTA GORDA ADA TRANSITION PLAN FINAL REPORT Herald Court Centre

October 4, 2017

Herald Court Centre, located at 117 Herald Court, is a 4-level 400-parking space parking garage with 17,000 square feet of ground-level retail and office space. The facility was built in 2009 and general public access to the facility is allowed.

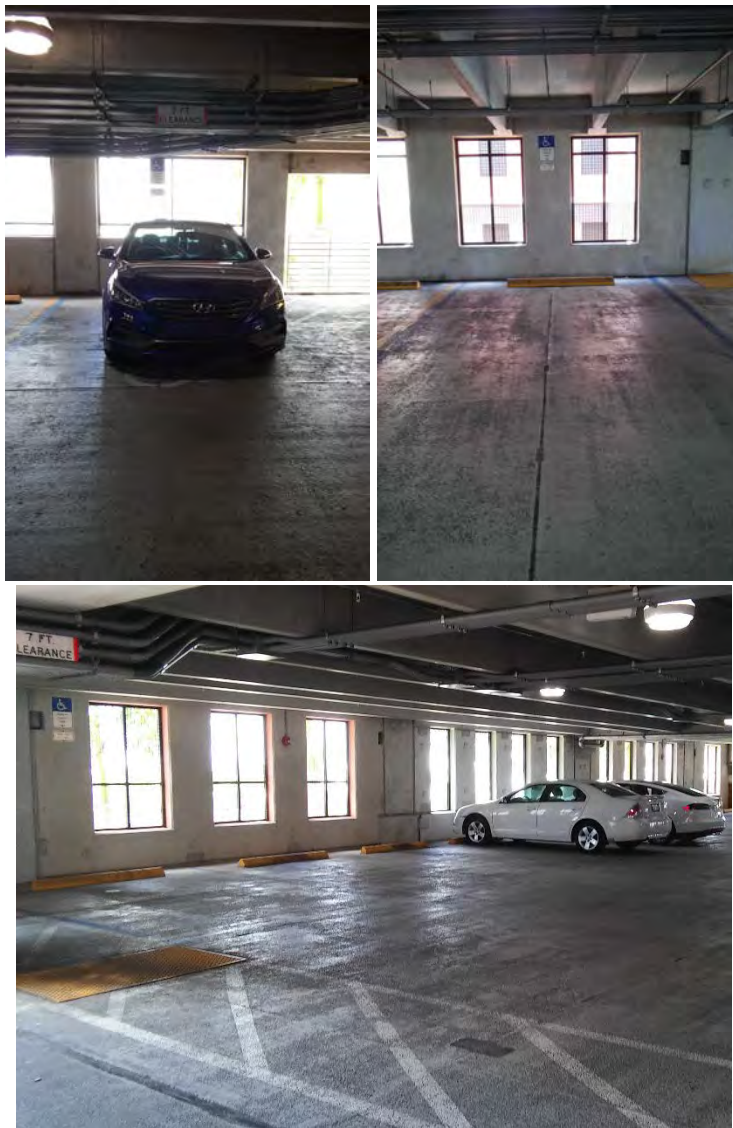
Figure 4-1 – 2nd Floor Parking Area

- The striping and ISA symbols are fading.
- The width of the accessible parking spaces are less than 144" wide, violating **FAC 502.2**.
- The access aisles have detectable warning unnecessarily placed on them.
- The width of the marked accessible route narrows to 30" for 36" in length.

- Restripe and repaint the faded parking spaces and ISA symbols.
- The width of the accessible parking spaces must be 144 minimum, per **FAC 502.2**. The adjacent access aisle must be 60” minimum, per **FAC 502.3.1**.
 - Note, **ADAAG 502.1** states that “Where parking spaces or access aisles are not adjacent to another parking space or access aisle, measurements shall be permitted to include the full width of the line defining the parking space or access aisle.”
- Remove all detectable warning from the access aisles and accessible route within the parking garage.
- Although the width of the marked accessible route narrows to 30" for 36" in length, a portion of the vehicular traffic lane can be utilized. Widening the marked accessible route, while not required, would provide additional safety benefits, per **FAC 502.3**.

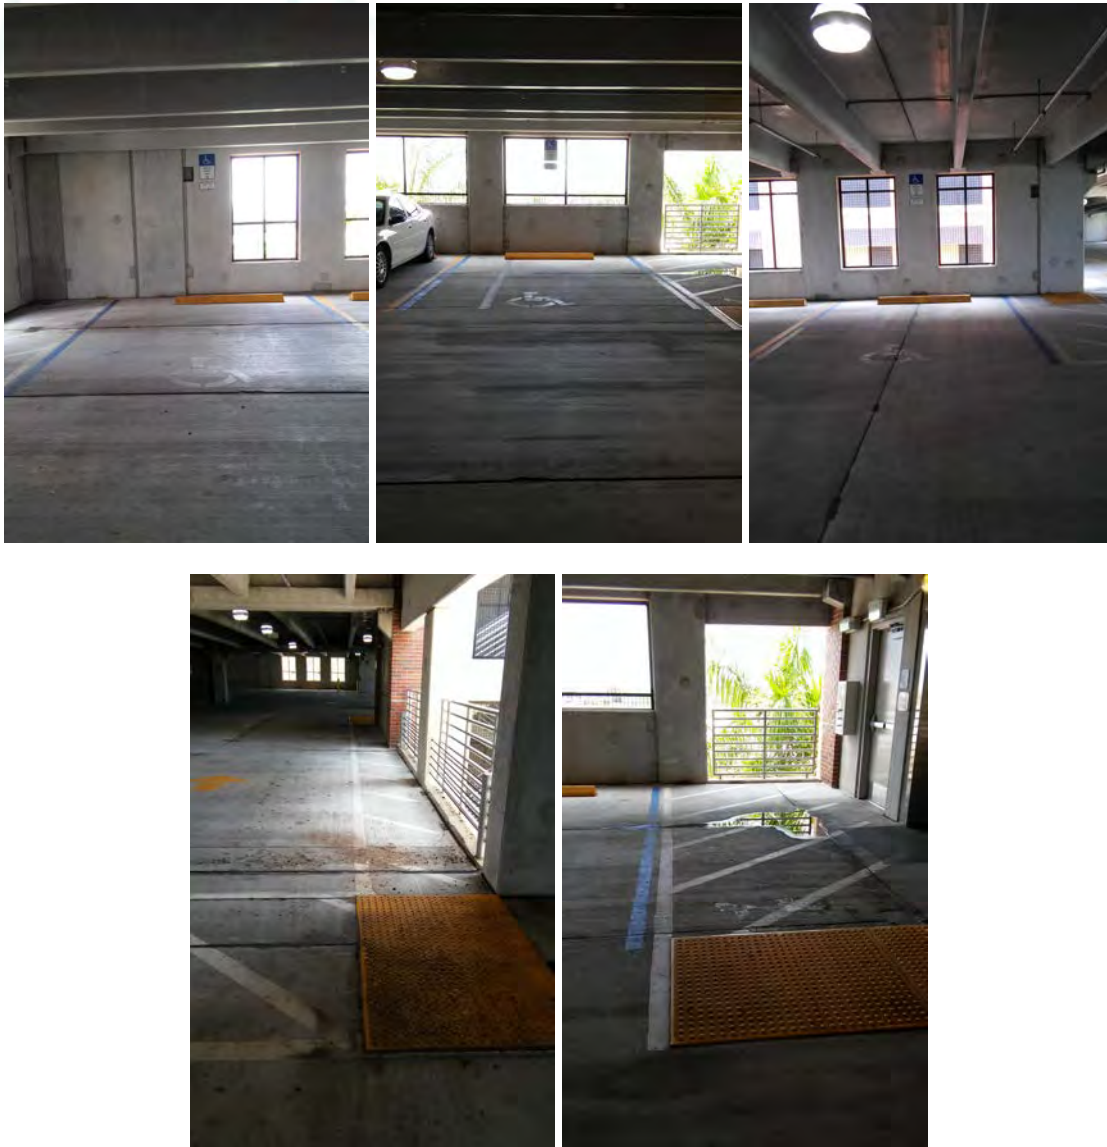
Figure 4-2 – 3rd Floor Parking Area*Assessments*

- The striping and ISA symbols are fading.
- The width of the accessible parking spaces are less than 144" wide, violating **FAC 502.2**.
- None of the accessible parking spaces are marked as being "van accessible", violating **ADAAG 208.2.4**.
- The access aisles have detectable warning unnecessarily placed on them.
- The width of the marked accessible route narrows to 30" for 36" in length.
- There is standing water in the accessible aisle, adjacent to the elevator, violating **ADAAG 502.4**.
- The accessible route is not slip resistant, due to the large quantity of pigeon droppings located within it, violating **ADAAG 302.1**.

- Restripe and repaint the faded parking spaces and ISA symbols.
- The width of the accessible parking spaces must be 144 minimum, per **FAC 502.2**. The adjacent access aisle must be 60" minimum, per **FAC 502.3.1**.

- At least two accessible parking spaces within the garage shall be marked as being "van accessible", per **ADAAG 208.2.4**. Due to the 84" of vertical clearance above the accessible parking on the second floor, the van accessible parking must only be on the third or fourth floors, where there is at least 98" minimum of vertical clearance, per **ADAAG 502.5**.

- Remove all detectable warning from the access aisles and accessible route within the parking garage.
- Although the width of the marked accessible route narrows to 30" for 36" in length, a portion of the vehicular traffic lane can be utilized. Widening the marked accessible route, while not required, would provide additional safety benefits, per **FAC 502.3**.

- The access aisle needs to be resurfaced so standing water does not buildup within it.
- The accessible route need to be maintained on a regular basis so as to not accumulate debris, such as pigeon droppings.

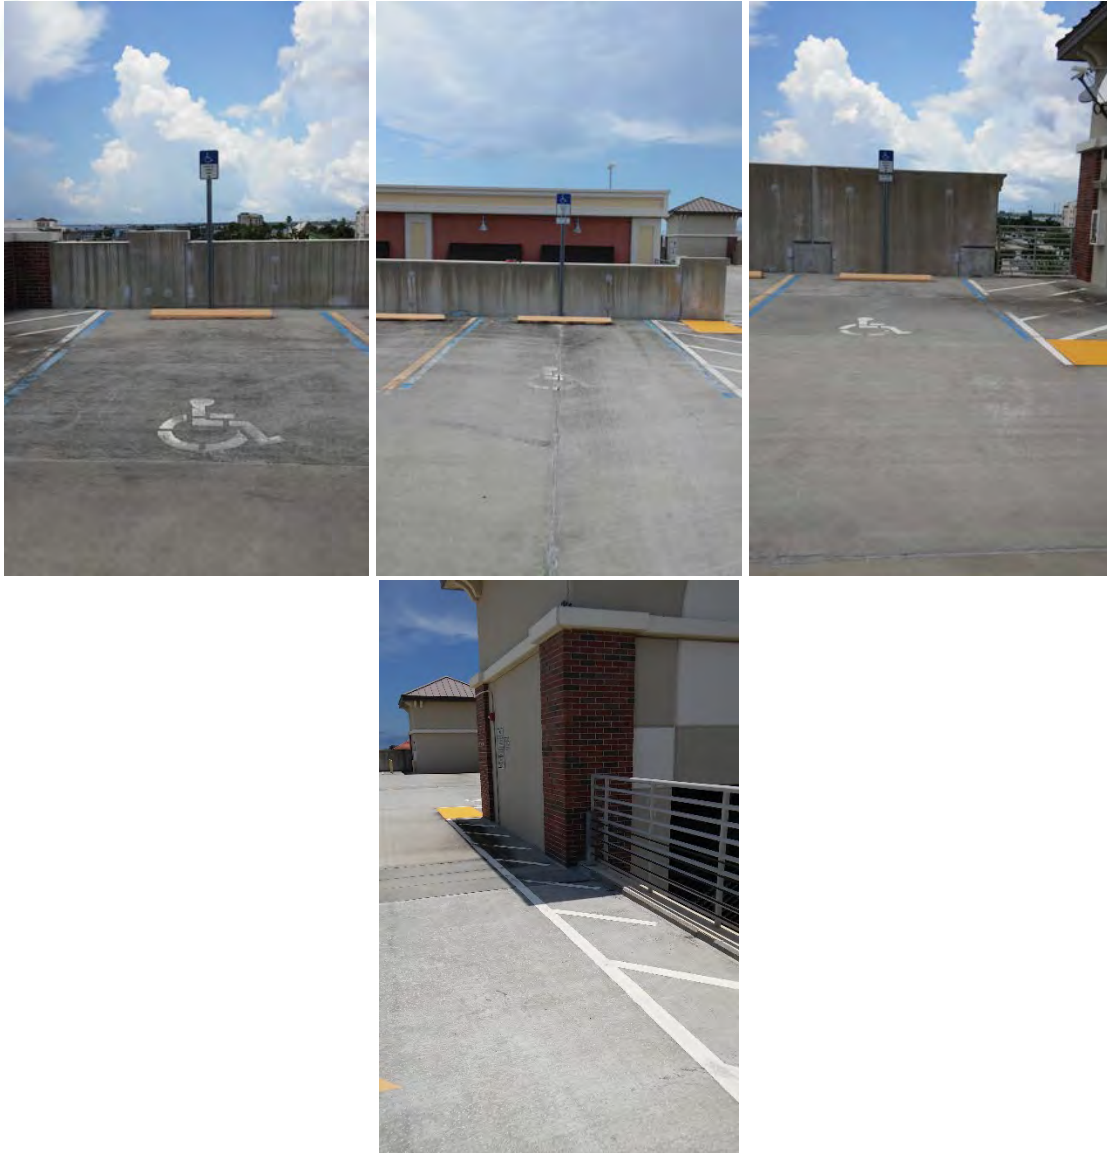
Figure 4-3 – 4th Floor Parking Area*Assessments*

- The striping and ISA symbols are fading.
- The width of the accessible parking spaces are less than 144" wide, violating **FAC 502.2**.
- There is no fine sign on one of the accessible parking space signs.
- None of the accessible parking spaces are marked as being "van accessible", violating **ADAAG 208.2.4**.
- The access aisles have detectable warning unnecessarily placed on them.
- The width of the marked accessible route narrows to 30" for 36" in length.

- Restripe and repaint the faded parking spaces and ISA symbols.
- The width of the accessible parking spaces must be 144 minimum, per **FAC 502.2**. The adjacent access aisle must be 60" minimum, per **FAC 502.3.1**.

- Place a fine sign on the accessible parking space sign that it is missing from.
- At least two accessible parking spaces within the garage shall be marked as being "van accessible", per **ADAAG 208.2.4**. Due to the 84" of vertical clearance above the accessible parking on the second floor, the van accessible parking must only be on the third or fourth floors, where there is at least 98" minimum of vertical clearance, per **ADAAG 502.5**.

- Remove all detectable warning from the access aisles and accessible route within the parking garage.
- Although the width of the marked accessible route narrows to 30" for 36" in length, a portion of the vehicular traffic lane can be utilized. Widening the marked accessible route, while not required, would provide additional safety benefits, per **FAC 502.3**.

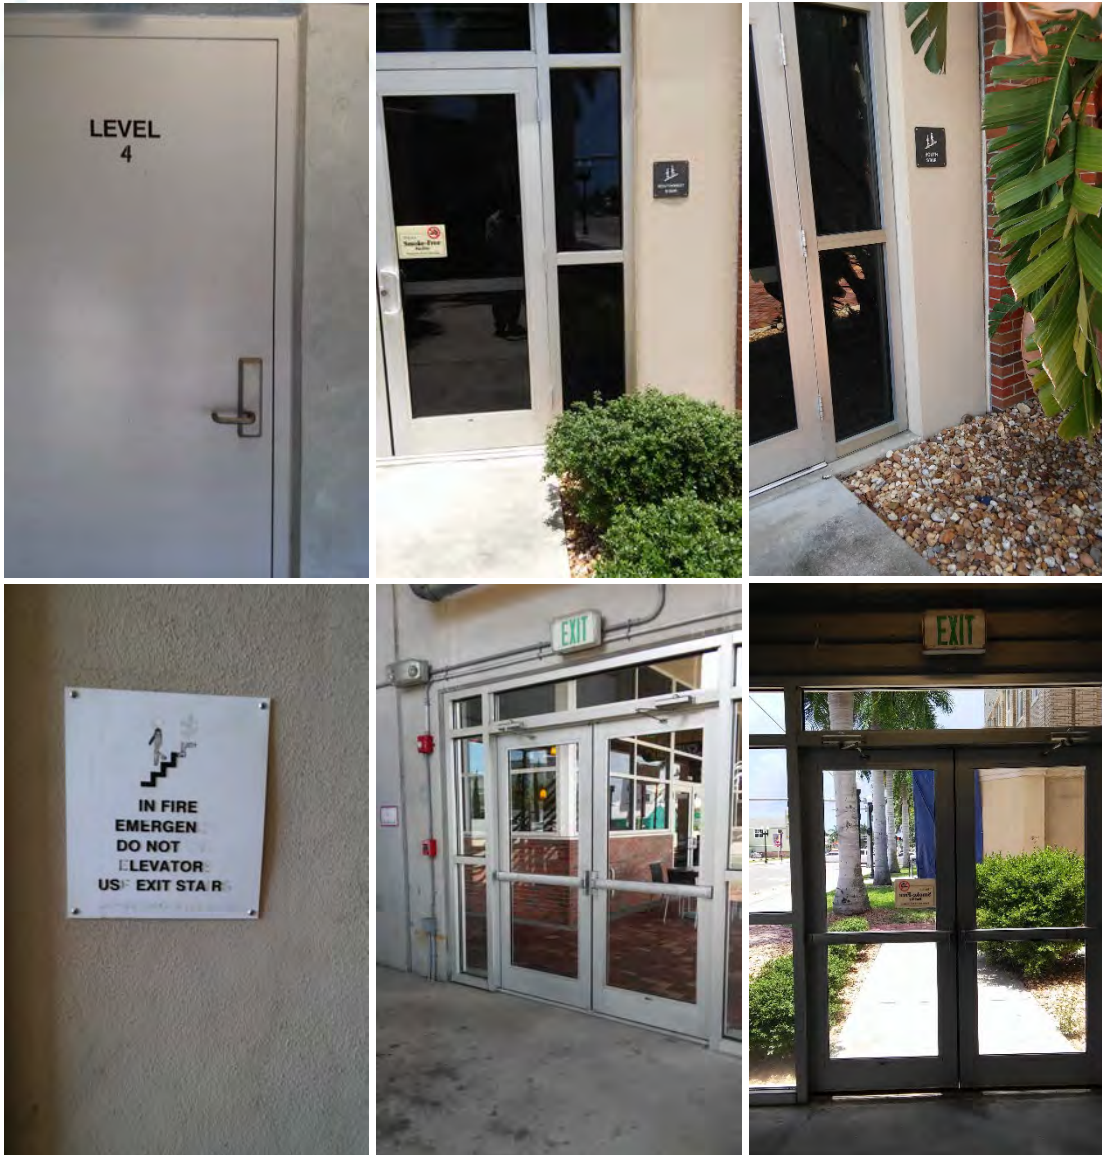
- Not all doorways/permanent rooms ADA compliant signage, such as with the "Level 4" doorway.
- The braille sign for the southwest and south stairs are located behind the bushes and is therefore not in an accessible location.
- The sign warning patrons to not take the elevator in case of an emergency is in poor condition.
- The doorways leading outside, from each of the stairwells do not have tactile exit signs adjacent to them.

Figure 4-4 – Examples of doorways without ADA compliant signage.

- At all permeant rooms, make sure the room's signage has visual characters, raised characters, and Braille.
- Relocate the signs located in the bushes to an accessible location. Per **ADAAG 703.4.2**, where a tactile sign is provided at a door, the sign shall be located alongside the door at the latch side.
- Replace the worn "Use Stairs" sign.
- At all stairwell exit doors, provide a tactile exit sign with raised characters and braille.

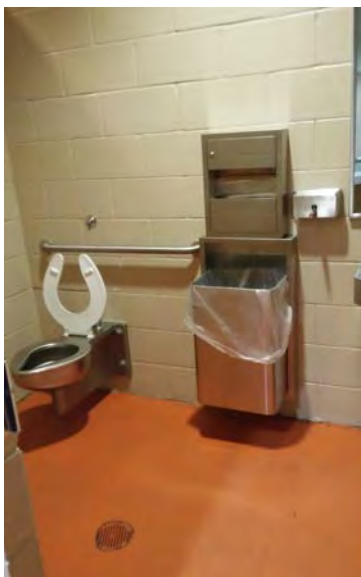
Figure 4-5 – Men's Restroom

- There is no side grab bar adjacent to the toilet, violating **ADAAG 604.5.1**
- The garbage can overlaps the clearance around the toilet, violating **ADAAG 604.3.2**.

- Add a side grab bar, compliant with **ADAAG 604.5.1**.
- Relocate the paper towel dispenser and garbage can to the side wall, so it does not overlap the toilet's clearance, per **ADAAG 604.3.2**.

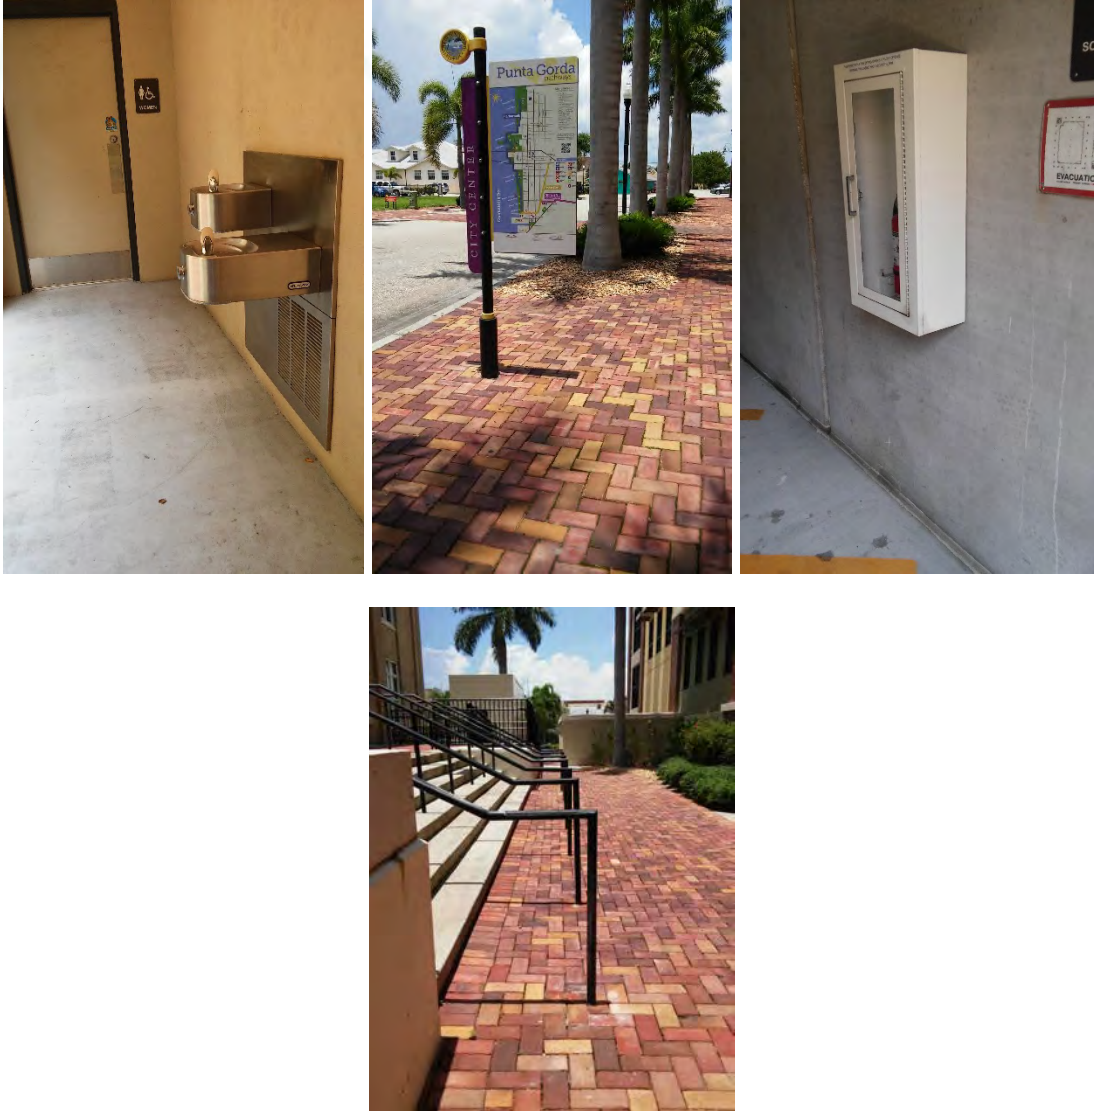
Figure 4-7 – Protruding Objects

- The low water fountains, adjacent to the restrooms on the first floor protrudes from the wall 17" at a height of 27.5".
- The high water fountains, adjacent to the restrooms on the first floor protrudes from the wall 12" at a height of 34".
- The pathway sign adjacent to the road protrudes out 24" at a height of 35".
- The fire extinguisher, located by the southwest stairwell, protrudes out 7" at a height of 33".
- The handrails leading to the adjacent historic courthouse property, which is owned and maintained by the Charlotte County Board of County Commissioners, protrude out 24" at a height of 36".

(Note: The handrails shown in the bottom photo are owned and maintained by the Charlotte County BOCC)

- Recess the water fountains or add a cane apron or fountain skirt under them so they do not protrude into the circulation path per **ADAAG 307.2**.
- Relocate the pathway sign so as to be centered on the pole and therefore not protrude beyond 12" on either side of the pole, per **ADAAG 307.3**. Or, extend the sign so that the bottom of the sign is less than 27" above the ground.
- Either relocate the fire extinguisher so that the bottom edge is less than 27" above the ground per **ADAAG 307.2** or add a pipe or a similar barrier below the fire extinguisher box to make it cane detectable.
- Charlotte County BOCC must either shorten the handrail extension to be no more than 12" in length or add an additional section of handrail, parallel to the existing extension connecting to the vertical section at a height no greater than 27".

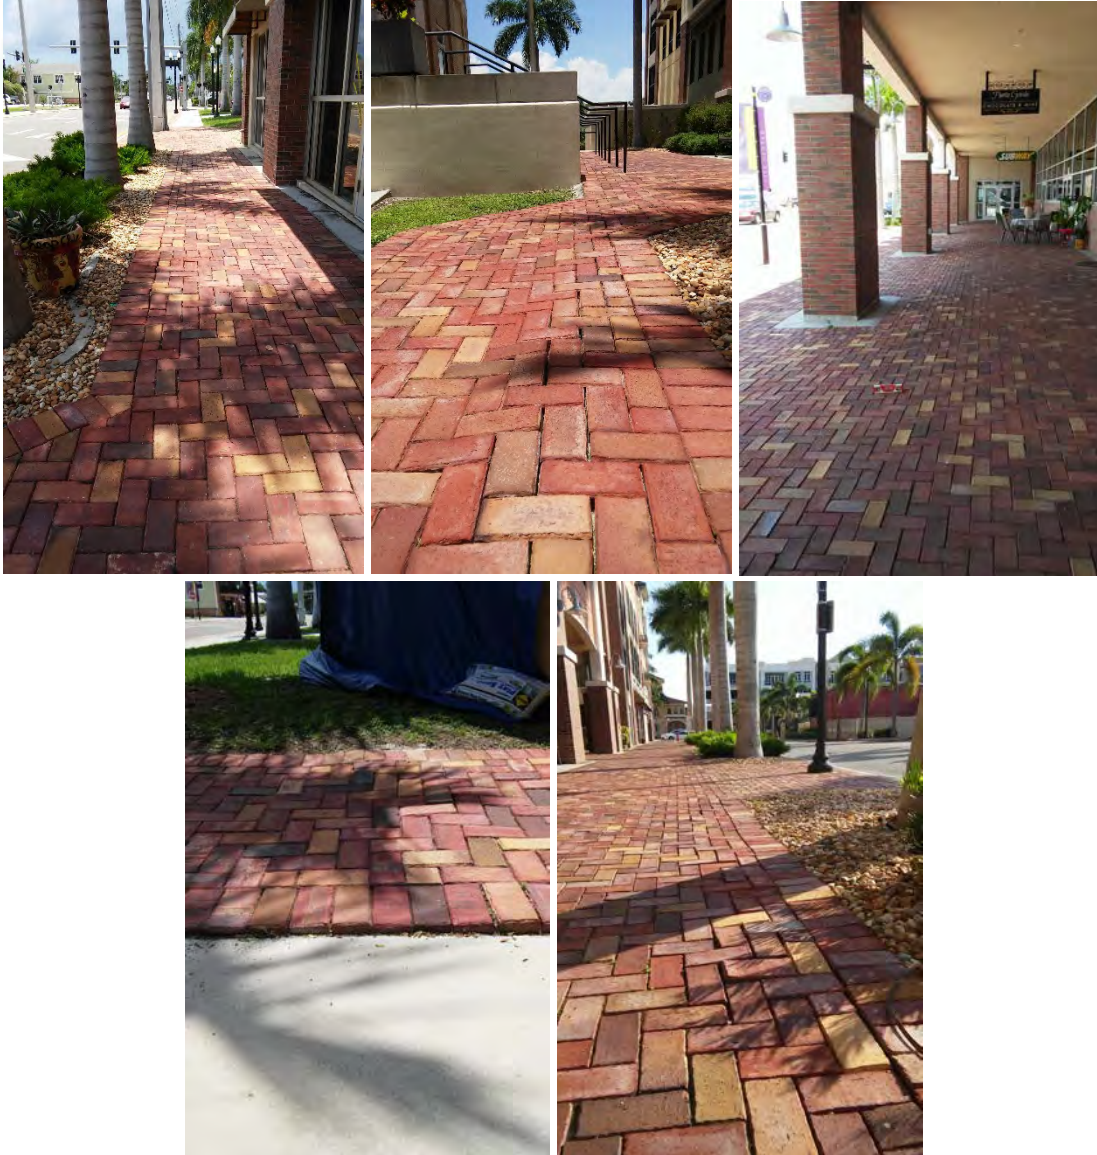
Figure 4-8 – Accessible Route

- The brick walkway, shown in the first photo, on the south side of the parking facility, adjacent to the Artisans store has a cross slope of 6%, violating **ADAAG 403.3**.
- The second photo shows the brick path adjacent to the rear of the courthouse, which has a running slope of 6%, violating **ADAAG 403.3**.
- The third photo, on the north-east side of the facility, adjacent to US-41, has an 8% cross slope, violating **ADAAG 403.3**
- The last two photos show two locations where there are tripping hazards due to the bricks not settling in an even and level manner, , violating **ADAAG 303**.

- Resurface the brick walkway around the perimeter of the parking garage to have a running slope no greater than 5% and a cross slope no greater than 2%, per **ADAAG 403.3**.
 - An accessible route is required to be a minimum of 36" wide and have 60" passing spaces every 200', per **ADAAG 403.5.1** and **ADAAG 403.5.3**. While it is not required that the entire width of the walkway be of compliant slope, at its current configuration it is difficult for people to distinguish where it is safe to traverse and where there are barriers to accessibility.
- Resurface any tripping hazards so they are no higher than 0.25" high or 0.5" high if beveled, per **ADAAG 303**.
