CITY OF PUNTA GORDA ADA TRANSITION PLAN FINAL REPORT Laishley Marina

October 4, 2017

City of Punta Gorda 326 West Marion Avenue Punta Gorda, Florida, 33950

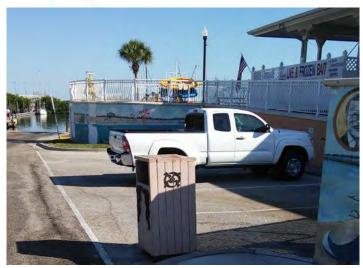
Figure 4-2 - Parking Spaces by Boat Launch

This temporary parking area serves the marina and boat launch along a closer and more direct route than the general accessible parking area located in front of the larger building, however, there is no accessible parking space in this section of the lot, violating §208.3.1.

- Restripe/repave two of the spaces, closest to the marina entrance, so that there is at least one level accessible space with an access aisle in this area of parking. Restripe the remaining spaces as necessary to ensure proper width is given to the accessible space.
 - o The width of the parking space shall be 12' wide, the width of the access aisle shall be 5' wide.
- Install accessible signage at this space compliant with §502.6, including a sign that states the fine for parking illegally in an accessible space as well as stating that this space is van accessible.
- Create an accessible route from the new access aisle to the surrounding amenities.

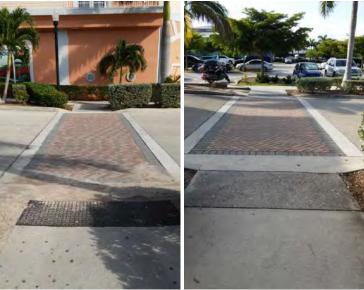
Figure 4-4 - East Crosswalk and Path to Leased Facility

- The ramp on the east crosswalk leading from the main accessible parking spaces is depressed enough that water is ponding and accumulating sand. The water is a hazard when it is raining, and the sand is a hazard when it is dry, violating §405.10.
- There are two crosswalks leading from the accessible parking spaces to the large leased building. The two ramps on the side of the street closest to the building serving these crosswalks are missing detectable warning surfaces, violating §406.8.

- Reconstruct the ramp, or the curb leading to the ramp, so that water does not pond at the ramp.
- Install detectable warning surfaces on both ramps on the side of the crosswalks closest to the building.

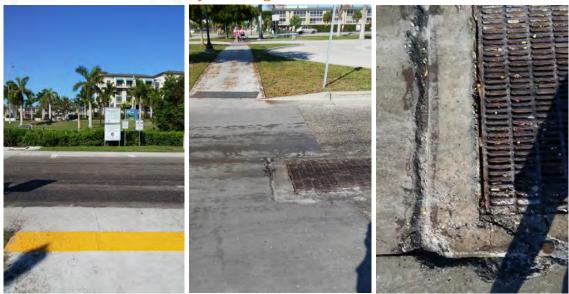
Figure 4-5 – Two Crosswalks across Drive Aisle for Boat Launch

- Both crosswalks across the boat launch access aisle are faded and not visible.
- The western side of the crosswalk across the boat launch is missing a detectable warning surface, violating §406.8.
- There is a 2" gap between the asphalt concrete crosswalk and the concrete inlet located in the drive aisle, violating §302.3.

- Stripe the crosswalks leading across driveway access to the boat launch.
- Install one detectable warning surface on the curb ramp to the west side of the crosswalk leading across the boat launch, closest to the water.
- Re-pave the area around the drainage grate in the crosswalk further from the water so that it is flush and smooth with the concrete crosswalk area surrounding the grate.

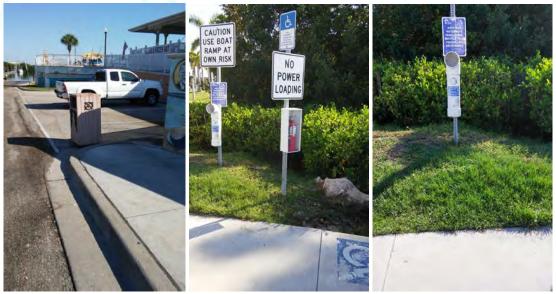
Figure 4-6 - Amenities by Boat Launch

- The trash can near the boat launch is placed in the parking lot and would not be in reach range for someone approaching it from the sidewalk.
- The fire extinguisher and fishing line return are placed on poles in a non-accessible surface.

- Relocate the trash can onto a level area so that it can be reached from the sidewalk/accessible route.
- Relocate the fire extinguisher to be within 10 inches of a level portion of the sidewalk.
- Relocate the fishing line return to be within 10 inches of a level portion of the sidewalk, making sure the return section of the PVC pipe is a maximum of 48 inches above the ground.

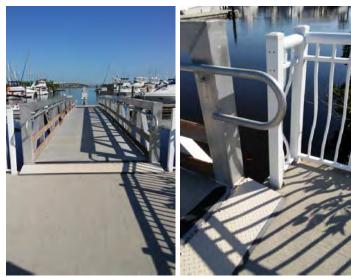
Figure 4-8 - Top of Gangway to Boat Slips

- As shown in Figure 4-7, the concrete ramp spurring off from the Harborwalk, leading to the gate, has handrails for the last 8 feet closest to the gate, however, is missing handrails for the first 16 feet of the ramp, violating §505.2.
- The transition plate at the top of the gangway, shown in Figure 4-8, has a slope of 20% for a rise of about 2.5", exceeding the maximum allowable slope of 8.3%, violating §405.2.

- Install 16' of handrails, complying with §505, along the concrete ramp leading to the gate.
- Replace the transition plate at the top of the gangway with a longer plate so that the slope is no greater than 8.3%.

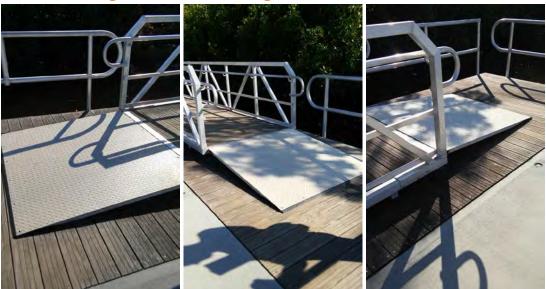
Figure 4-9 - Gangway and Transition Plates at Ends of Floating Dock along Harborwalk

- Both the transition plates leading to the pier extend approximately 5' long and over 6" high, with no handrails or edge protection on the outside of the transition plate, allowing the potential for a person using a wheelchair to fall off the plate, violating §405.8 and §405.9.
- The expansion joints between the concrete platforms on the floating dock have a 1.5" to 2" gap, violating §302.3.

- Install handrails, complying with §505, and edge protection, complying with §405.9, onto the two transition plates leading from the gangways on either side of the floating platform.
- Fill the 7 joints along the floating dock with concrete expansion joint fill material.

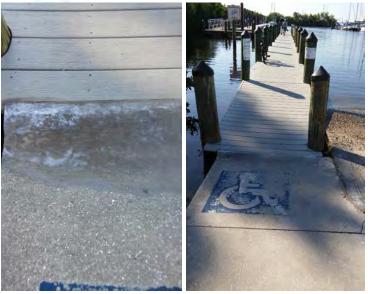
Figure 4-11 - Entrance to Boat Launch - Marked with ISA

- The concrete lip connecting the sidewalk to the pier has a max running slope of 14% and a cross slope of 4%, violating §403.3.
- The dock is sloped at 10% for 10', exceeding the max running slope for a ramp, violating §405.2.

Reconstruct this sloped portion of the dock so that it extends at least an additional 2' over the concrete sidewalk, achieving a max running slope of 8.33%.

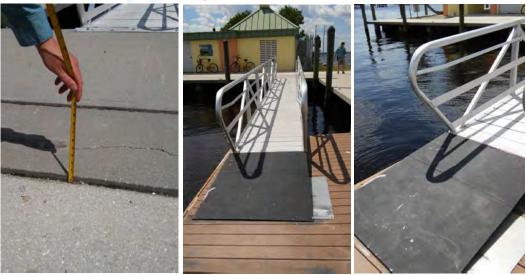
Figure 4-12 - Gangway and Transition Plate Leading to Single Floating Boat Slips

- The concrete dock at the top of the floating dock's gangway has a joint with a vertical change in level of 1", violating §303.4.
- The cross slope of the gangway is 4%, violating §403.3.
- The transition plate extends over 5' long and over 6" high, with no handrails or edge protection the outside of the transition plate, allowing the potential for a person using a wheelchair to fall off the plate, violating §405.8 and §405.9.

- Correct the joint along the dock by installing a ramped transition that will allow the 1" change in level to be sloped to 8.33% or less.
- Inspect the gangway and the floating dock for the reason the cross slope is at 4% and look to correct it.
 - This may involve resetting or adjusting the gangway, or it could involve correcting the floating dock.
- Add handrails, complying with §505, and adequate edge protection, compliant with §405.9, to both sides of the transition plate.

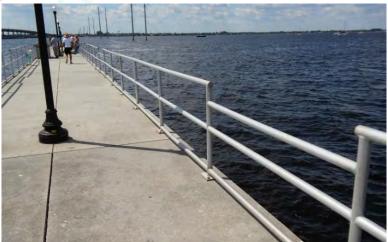
Figure 4-15 - Fishing Areas

• The regular railing height is 42", however, every 30' there are 34" high accessible railings for a width of 6'. This means that about 20% of the railings that are able to be fished from are accessible. The code requires 25% to be accessible, thus this violates §1005.2.1.

• The current arrangement is nicely dispersed, offers plenty of options and locations for fishing, however, it is not technically compliant due to the percentage of railing space that should be lowered. It's not likely to generate any complaints in its current arrangement, however, to become technically compliant at 25% the City must lower approximately an additional 25' of railing on each side of the pier to a maximum height of 34".

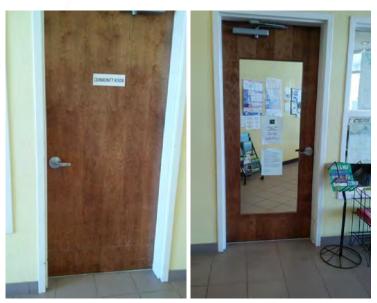
Figure 4-17 - Signage for Public Rooms - Community Room and Dock Master's Office

All permanent rooms in the building, including the Community Room, Dock Master's Room, Custodial Room, Electrical Room, Laundry Room and others, are all missing appropriate tactile signage identifying the room, violating §216.2.

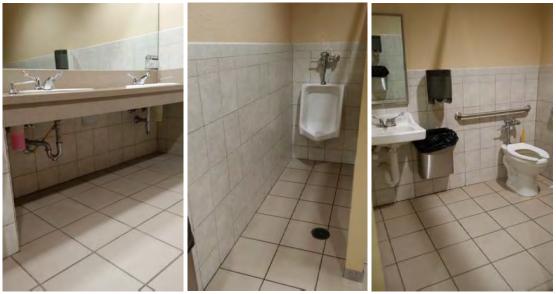
Figure 4-20 - Restrooms

Summary: There are two restrooms in the marina building, one public male restroom and one public female restroom. The Men's restroom was assessed and only minor issues were found that can be fixed with little effort. The woman's room is similar and also only has minor issues.
