CITY OF PUNTA GORDA ADA TRANSITION PLAN FINAL REPORT

Laishley Park

October 4, 2017

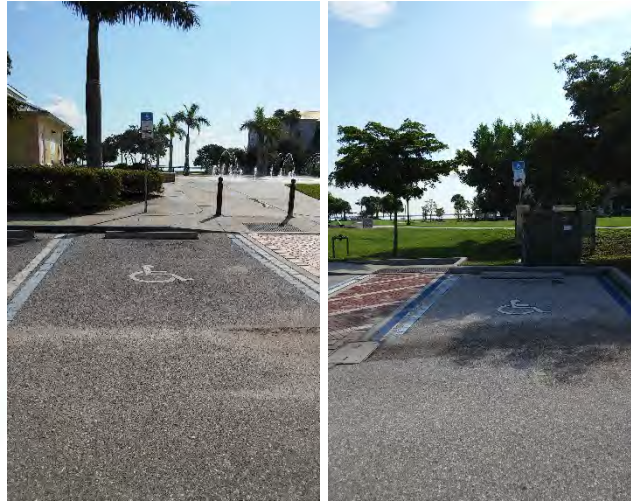
Figure 4-1: Accessible Parking Spaces

There are 26 total parking spaces within the Laishley Park parking lot, with additional parking located adjacent to the nearby marina. Two of these parking spaces are marked as being accessible, but have some minor slope issue, as described below.

- The northern-most accessible parking space, located adjacent to the park's restrooms, has a running slope of 2.5% at the top of the access aisle, violating **ADAAG 502.4**, which states "Slopes not steeper than 2% shall be permitted within (Accessible) parking spaces and access aisles serving them."
- The southern-most accessible parking space, has a running slope of 2.5% at the bottom of the parking space, violating **ADAAG 502.4**, which states "Slopes not steeper than 2% shall be permitted within (Accessible) parking spaces and access aisles serving them."

- Resurface the access aisle and accessible parking space so that the running and cross slopes are no greater than 2%.

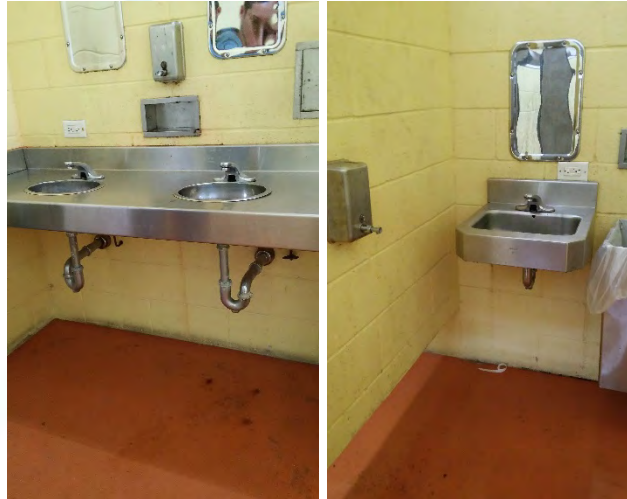
Figure 4-2: Pedestrian crossings

There are two restrooms at the park. However, due to the public nature of the park and the male-only staff performing the assessment, only the Men's restrooms were assessed, the woman's restrooms are assumed to have similar issues.

- The sinks in the main section of the restroom as well as the one in the accessible stall have exposed pipes, violating **ADAAG 606.5** which states "Water supply and drain pipes under lavatories and sinks shall be insulated or otherwise configured to protect against contact."
- The soap dispenser located in the main section of the restroom is located 50" high, violating **ADAAG 308.2.1** which states "The high forward reach shall be 48" maximum ... above the ground."
- The toilet in the accessible stall is located 18.5" from the side wall and 19.5" from the ground, violating **ADAAG 604.2** which states "The centerline of the water closet shall be 16" minimum to 18" maximum from the sidewall." **ADAAG 604.4** states that "The seat height of a water closet above the finish floor shall be 17" minimum and 19" maximum."

- Cover the pipe to all the sinks to protect people in wheelchairs from scraping their legs on the sharp edges.
- Lower the soap dispenser to a height of 48" maximum above the floor.
- Relocate the toilet so that it is centered between 16" and 18" from the sidewall and that the seat is no more than 19" high above the floor.
 - American Standard has a patented toilet design, called Access Pro, that allows the toilet to be shifted up to 3.5" in either direction without relocating the drain or flange.

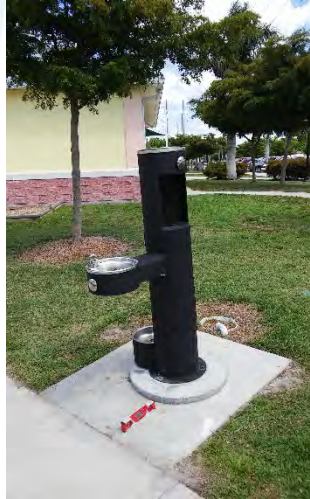
Figure 4-3 – Waterfountains

One set of water fountains were found to have barriers to accessibility, as described below.

This water fountain has a ground level fountain for pets, a mid-level fountain with a spout height of 36" and a bottle refill station with a button located 51" high. In addition, the slope of the pavement adjacent to the water fountain has an 11% slope.

ADAAG 211.2 states that "No fewer than two drinking fountains shall be provided. One drinking fountain shall comply with **ADAAG 602.1** through **ADAAG 602.6** and one drinking fountain shall comply with **ADAAG 602.7**."

ADAAG 305.2 and **305.3** generally state that "The clear floor space shall be a minimum of 30" by 48" with slopes no greater than 2%."

ADAAG 308.2.1 states that "The high forward reach shall be 48" maximum ... above the ground."

ADAAG 602.4 states that "Spout outlets shall be 36" maximum above the finished floor."

ADAAG 602.7 states that "Spout outlets of drinking fountains for standing persons shall be 38" minimum and 43" maximum above the finished floor."

- Adjust the slope of the adjacent pavement so that a clear and level floor space is available to patrons using the fountains.
- Add a second drinking fountain nearby that has a spout outlet 38" to 43" above the floor.
- Either adjust the height of the water bottle refill station or add a secondary water bottle refill station that has a button located a maximum of 48" above the ground.

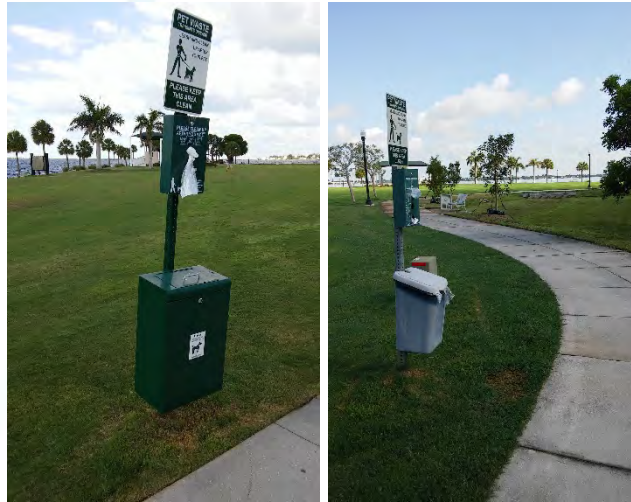
Figure 4-4 – Dog Stations

Two dog stations were found to have barriers to accessibility. One was located too far from the paved trail to be accessible. The other had its doggy bags located 56" high from the ground, too high and far to be reached by a person in a wheelchair.

ADAAG 308.3 states that, “Where a clear floor space allows a parallel approach to an element, the high side reach shall be 48” maximum above the ground... An obstruction shall be permitted between the clear floor space and the element where the depth of the obstruction is 10” maximum.”

- Relocate the dog stations/doggy bags to be no more than 48” above the ground and no more than 10” from the edge of the sidewalk.

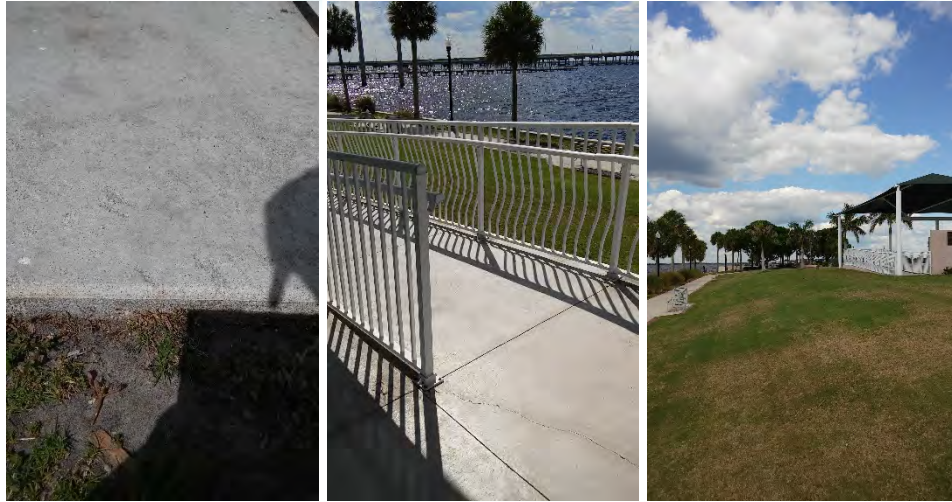
Figure 4-5 – Ramp to Stage

The ramp leading to the rear of the stage has some barriers to accessibility, as described below.

- There is no accessible connection to the stage **ADAAG 302.1**.
 - To access the stage, a visitor needs to either traverse approximately 125' of the Laishley Park great lawn, violating or, make their way over 40' of grass and an embankment that has a running slope of approximately 30%.
 - In addition, there is a 1.5" lip between the cement ramp and the adjacent grass/dirt.
- The south handrail, at the top of the ramp, does not have a handrail extension, violating **ADAAG 505.10**.

ADAAG 302.1 states that, "Floor and ground surfaces shall be stable, firm, and slope resistant."

ADAAG 505.10 states that, "Tamp handrails shall extend horizontally above the landing for 12 inches minimum beyond the top and bottom of the ramp runs."

- Connect the stage's ramp to an accessible route that in turn connects to the accessible parking. This can either be accomplished by paving a route from the southwest for a distance of approximately 125' or by paving a series of switchback ramps from the north.
- Extend the handrail at the top of the stage's ramp to include a 12" minimum handrail extension.

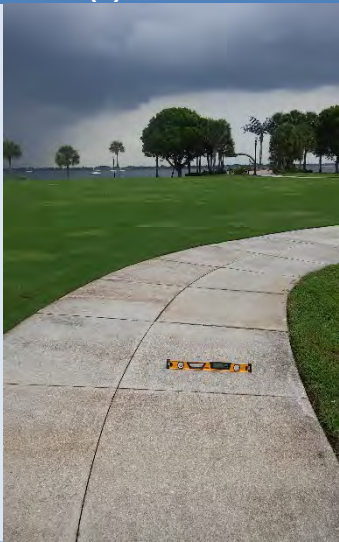
Map Item	Description & Recommendation	Photo(s)
C1	3.3% cross slope – Resurface so the cross slope is no greater than 2%

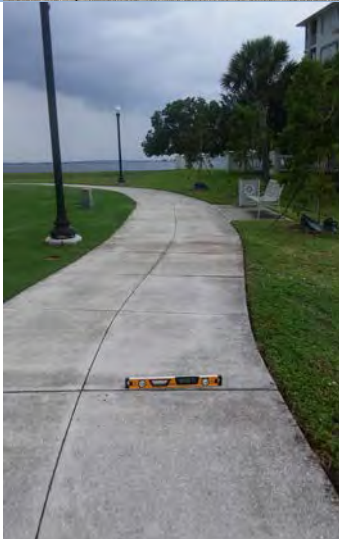
C2	3.5% cross slope – Resurface so the cross slope is no greater than 2%

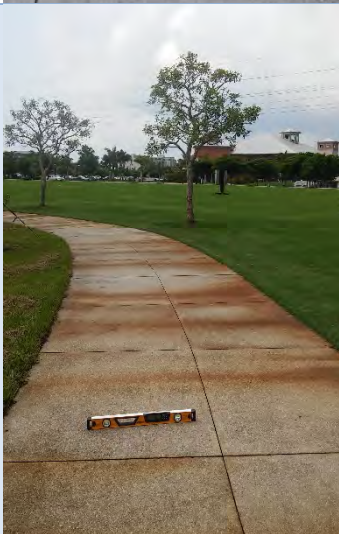
C3	2.6% cross slope – Resurface so the cross slope is no greater than 2%

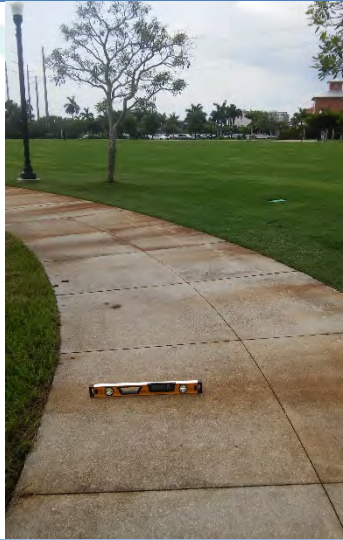
Map Item	Description & Recommendation	Photo(s)
C4	2.1% cross slope – Resurface so the cross slope is no greater than 2%

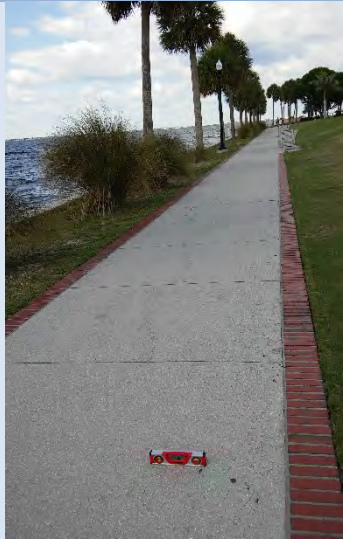
C5	3.0% cross slope – Resurface so the cross slope is no greater than 2%

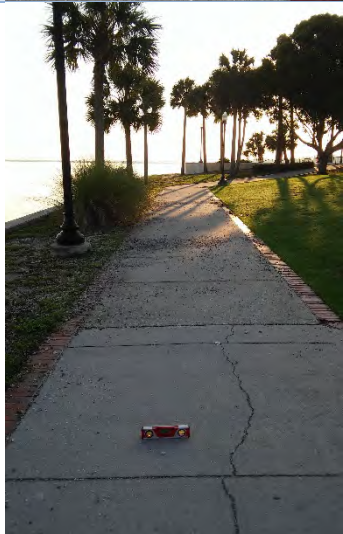
C6	4.0% cross slope – Resurface so the cross slope is no greater than 2%

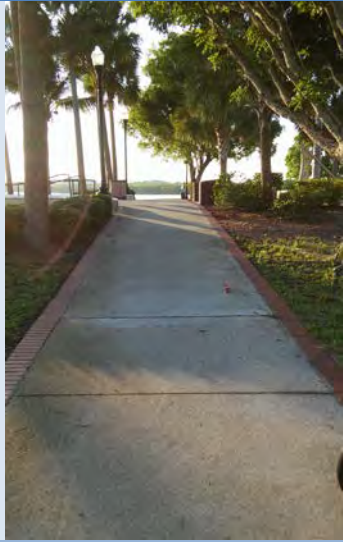
Map Item	Description & Recommendation	Photo(s)
R1	8.5% running slope –Resurface the walkway to have a slope no greater than 8.3% and re-construct it as a ramp with handrails and landings, per ADAAG 405.

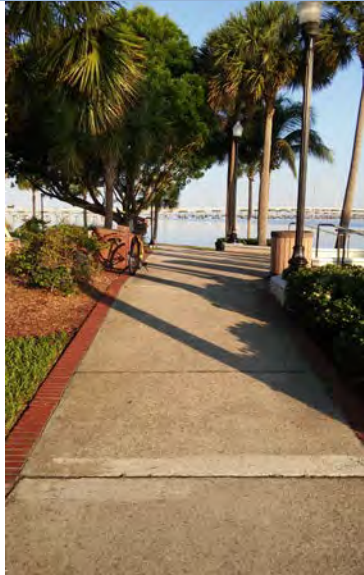
R2	6.5% to 8.4% running slope –Resurface the walkway to have a slope no greater than 8.3% and re-construct it as a ramp with handrails and landings, per ADAAG 405.

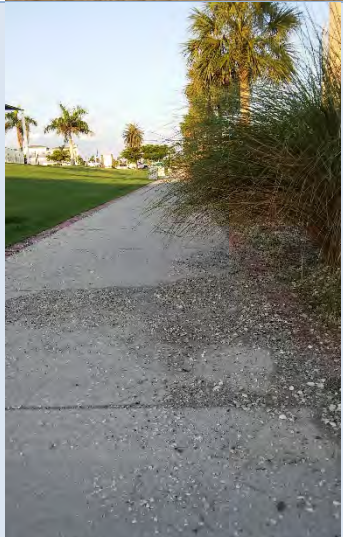
M1	Unstable surface with lots of crushed shells on the path – Maintain the pathway so there is not a buildup of debris, possibly caused by a drainage issue. This debris causes the surface of the pathway to not be firm, stable, and slip resistant.

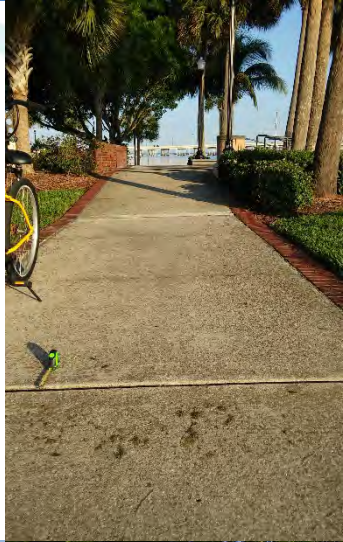
Map Item	Description & Recommendation	Photo(s)
M2	1" gap in cement slabs – Fill in the gap so that the clearance is no greater than 0.5".
