CITY OF PUNTA GORDA ADA TRANSITION PLAN FINAL REPORT US 41 MULTI-USE RECREATION TRAIL

October 4, 2017

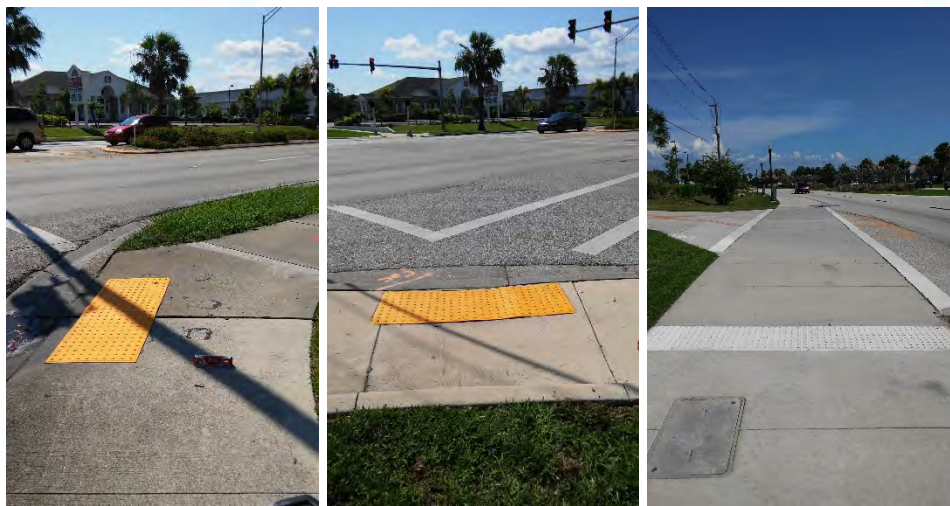
Figure 4-1 - Curb ramps and detectable warning surfaces along the multi-use trail.

Shown below, in Figure 4-2, are three curb ramps that are not ADA compliant. Issues include non-compliant slopes, detectable warnings not securely fastened, and detectable warnings that are not high contrast, respectively. A map detailing the locations of these barriers to accessibility is shown in Appendix A.

ADAAG 405.2 states that, “(Curb) ramp runs shall have a running slope not steeper than 8.33%”.

ADAAG 406.4 and **ADAAG 405.7.1** states that “Landings shall be provided at the top of curb ramps.” and “Slopes shall not be steeper than 2%.”

ADAAG 705.1.3 states that, “Detectable warning surfaces shall contrast visually with adjacent walking surfaces either light-on-dark, or dark-on-light.”

- Resurface the curb ramp so that the slope is not steeper than 8.33%. In addition, the landing at the top of the ramp shall be no steeper than 2% in any direction.
- Replace detectable warning surface that is coming unglued, and secure properly.
- Replace white detectable warning surface with a high contrast color.

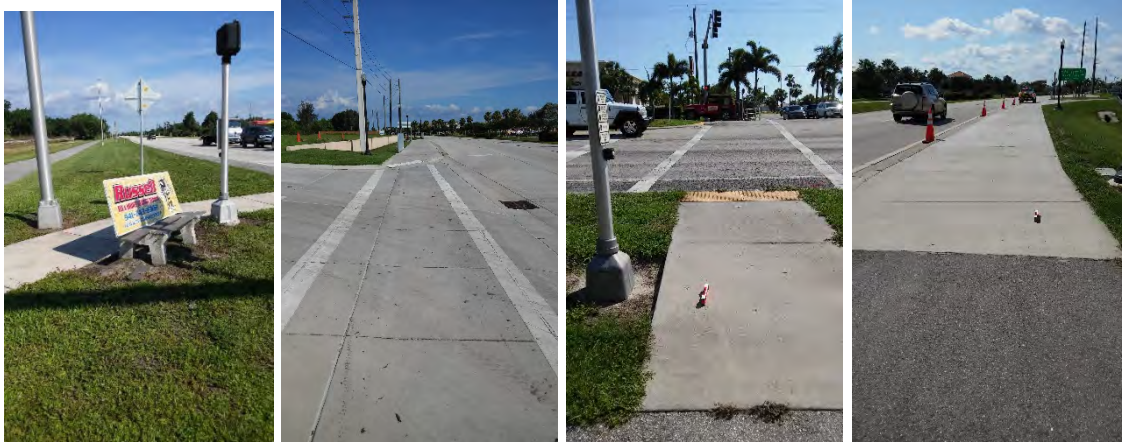
Figure 4-2 – Miscellaneous Barriers to Accessibility along the US-41 Trail

- The bench, which is part of Charlotte County’s ad bench program, does not have a clear floor space adjacent to it or an accessible route connecting to it thereby making it not accessible.

- **ADAAG 302.1** states that, “Floor and ground surfaces shall be stable, firm, and slip resistant.”
 - **ADAAG 305.3** states that, “The clear floor or ground space shall be 30 inches minimum by 48 inches minimum.”

- The Crosswalk has cross slopes in excess of 10%, violating **ADAAG 403.3**, which states “The cross slope of a walking surface shall not be steeper than 2%.”

- The slope at the pedestrian push button is 6.5%, violating **ADAAG 305.2**, which states “Slopes not steeper than 2% shall be permitted.”
- The pavement connecting the asphalt portion of the trail to the cement portion of the trail has a running slope of 7%, violating **ADAAG 403.3**, which states “The running slope of a walking surface shall not be steeper than 5%.”

- Remove the non-accessible bench or pave a clear and level accessible route to it so it is accessible to all users of the multi-use trail.
 - The accessible route to the bench shall be a minimum width of 36”, not have a cross slope of more than 2%, not have a running slope of more than 5%, and have a clear and level turning space at end point.
 - Since this bench is part of the County’s ad bench program, City action regarding this bench is subject to County approval.
- Regrade the crosswalk so that the cross slopes do not exceed 2%.
- Regrade the clear floor space adjacent to the pedestrian push button so the slope is not steeper than 2% in any direction.
- Regrade this portion of the trail so the running slope is not steeper than 5%.

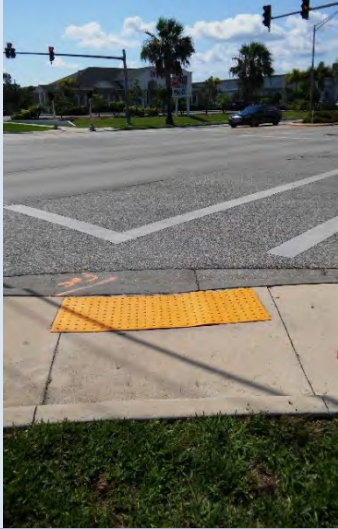
Map Item	Description & Recommendation	Photo(s)
D1	<p>The detectable warning is not securely fastened to the curb ramp and therefore may present a tripping hazard.</p> <p>Securely fasten the detectable warning.</p>

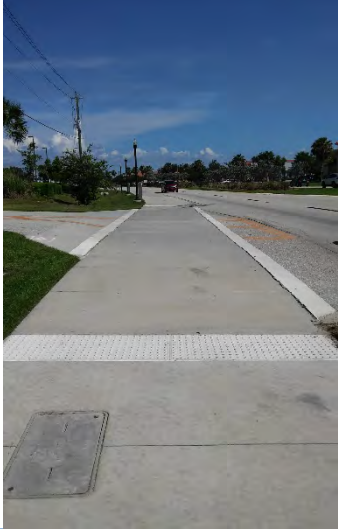
D2	<p>The white detectable warning is not high contrast when placed on cement.</p> <p>Replace the existing white detectable warning with a yellow or red detectable warning.</p>

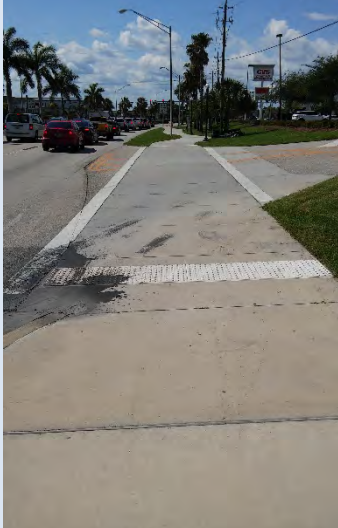
D3	<p>The white detectable warning is not high contrast when placed on cement. In addition, a portion of the detectable warning is located with the vehicular driveway.</p> <p>Replace the existing white detectable warning with a yellow or red detectable warning. Relocate the detectable warning so that it is not within the driveway's vehicular right-of-way.</p>

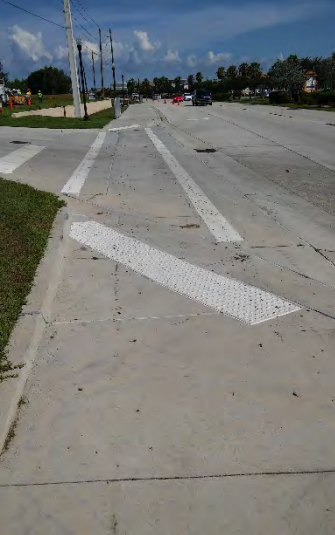
Map Item	Description & Recommendation	Photo(s)
<p>D4</p>	<p>The white detectable warning is not high contrast when placed on cement.</p> <p>Replace the existing white detectable warning with a yellow or red detectable warning.</p>

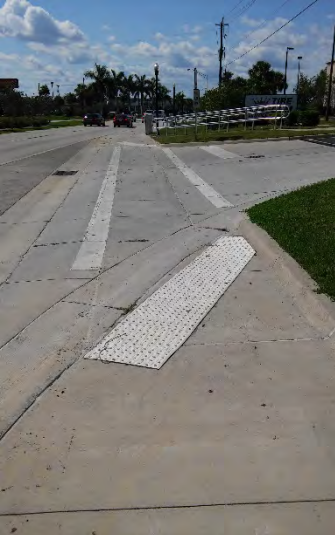
<p>D5</p>	<p>The white detectable warning is not high contrast when placed on cement.</p> <p>Replace the existing white detectable warning with a yellow or red detectable warning.</p>

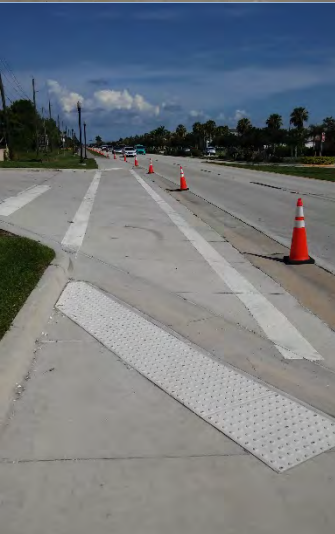
<p>D6</p>	<p>The white detectable warning is not high contrast when placed on cement.</p> <p>Replace the existing white detectable warning with a yellow or red detectable warning.</p>

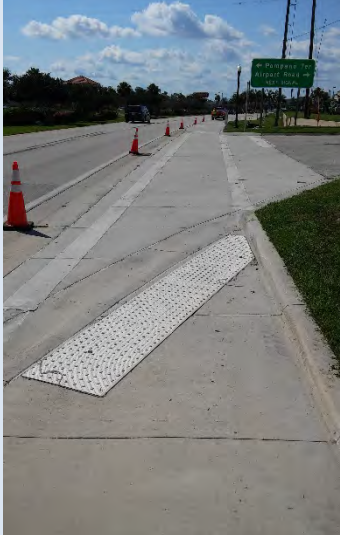
Map Item	Description & Recommendation	Photo(s)
D7	<p>The white detectable warning is not high contrast when placed on cement.</p> <p>Replace the existing white detectable warning with a yellow or red detectable warning.</p>

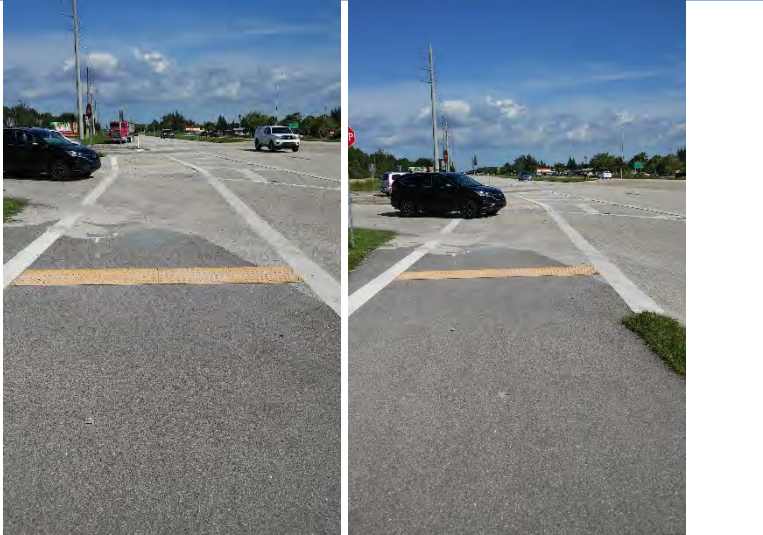
D8	<p>A portion of the detectable warning is located with the cross-street.</p> <p>Relocate the detectable warning further back so that it is not within the street.</p>

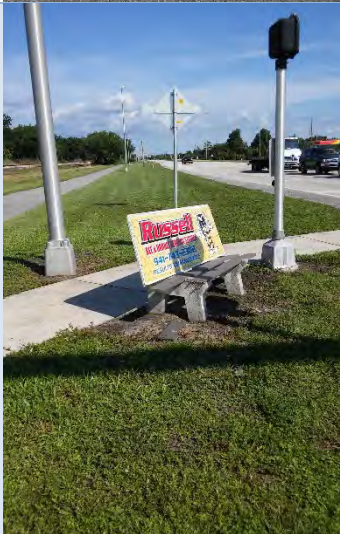
M1	<p>The 3rd party bench is not accessible.</p> <p>Remove or relocate the bench.</p>

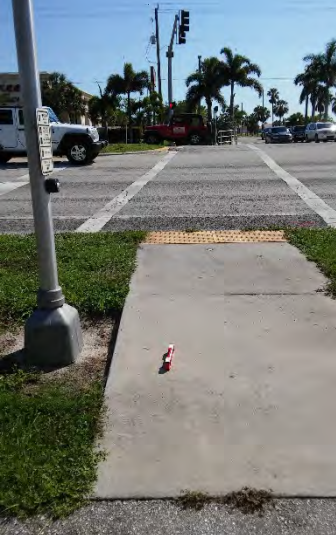
Map Item	Description & Recommendation	Photo(s)
<p>M2</p>	<p>There is a 6.5% running slope at pedestrian push button.</p> <p>Either relocate the pedestrian push button to a location with a clear and level floor space or resurface a 30"x48" section of pavement adjacent to the pedestrian button to be level in all directions. Lastly, repave the 6.5% ramp to have a slope no greater than 5%.</p>

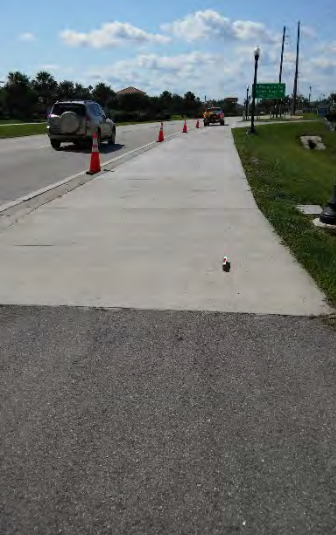
<p>M3</p>	<p>There is a 7% running slope at the section where the cement transitions to asphalt.</p> <p>Extend the transition so that the running slope is no greater than 5%.</p>

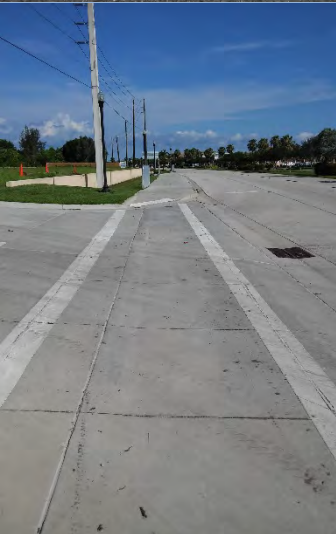
<p>M4</p>	<p>The crosswalk has a cross slope of up to 10%, violating ADAAG 403.3.</p> <p>The accessible route must have a cross slope no greater than 2% for a minimum width of 36". Either repave the driveway or relocate the crosswalk to a level location.</p>
