CITY OF PUNTA GORDA ADA TRANSITION PLAN FINAL REPORT City Hall

October 4, 2017

Prepared For:

City of Punta Gorda 326 West Marion Avenue Punta Gorda, Florida, 33950

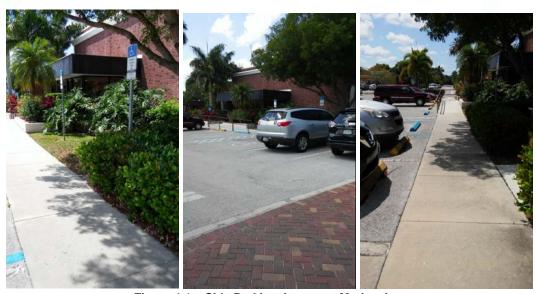
Figure 4-1 - Side Parking Area near Marion Ave

- The access aisle for the 2 accessible parking spaces in the side lot is 56" wide, when it should be 60" wide according to **ADAAG 502.3.1** and **FAC 502.3**.
- The two accessible parking spaces in the rear parking lot were measured at 110" and 118", respectively, too narrow violating **FAC 502.2**.
- The two parking spaces in the rear are not outlined with blue FAC 502.6.1.

- Widen the access aisle in the side parking by at least 4", for a total minimum width of 60" by taking space away from an adjacent non-accessible parking space, per **FAC 502.3.1**.
- Widen the accessible parking spaces in the rear parking lot to a minimum width of 144 inches each, per FAC 502.2.
 - o Outline the two spaces and access aisle with blue paint, per FAC 502.6.1.

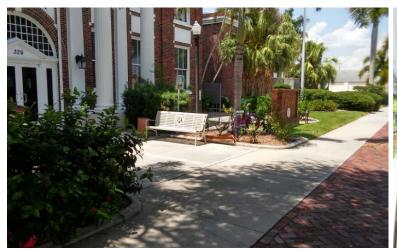
Figure 4-3 - Front Entrance

- The sign directing people from the inaccessible front entrance to the accessible side entrance is faded and due to its location behind the bench, it may be difficult to see.

- Replace the sign directing individuals to the accessible side entrance with a new sign and relocate it to a more visible location.
- Replace the sign at the rear entrance ramp so that it reads "Accessible Entrance", opposed to "Handicap Entrance".

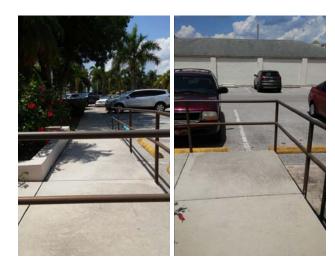
Figure 4-4 - Ramp to Side Entrance

- The ramp leading to the accessible side entrance does not have adequate edge protection, per ADAAG 405.9 which requires a curb or barrier at ramp surface drop-offs that provide a minimum 4" diameter sphere from reaching the edge of the ramp. The front wheels of a wheelchair could easily roll off of the ramp or landing surface and trap the user or potentially cause injury. Lack of edge protection poses a hazard for a wheelchairs getting caught over the edge.

- Add a bottom railing on the handrail to the side entrance that is no more than 4" from the ramp surface, to provide adequate edge protection.
- Modify the right side handrails (going up the ramp) so that they are continuous and wrap around the protruding stanchions.

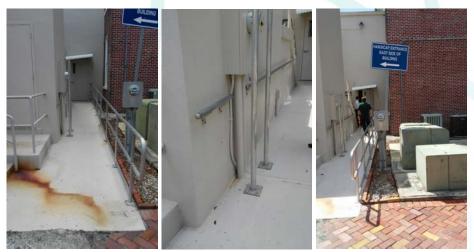
Figure 4-5 - Ramp to Rear Entrance

- The ramp at the rear entrance has signage that directs individuals with disabilities to the side ramp entrance, however, the sign reads "Handicap Entrance". This should read "Accessible Entrance". Although this is not a direct violation of the ADA or FAC, using the terms "handicap or handicapped" is considered a negative connotation to individuals with disabilities and should not be used.

- The railing along the rear ramp is not continuous because of the stanchions that
 protect the protruding object presented by the electric meter on the wall adjacent
 to the ramp. This does not meet ADAAG 505.6 which requires handrails to be
 continuous and unobstructed.

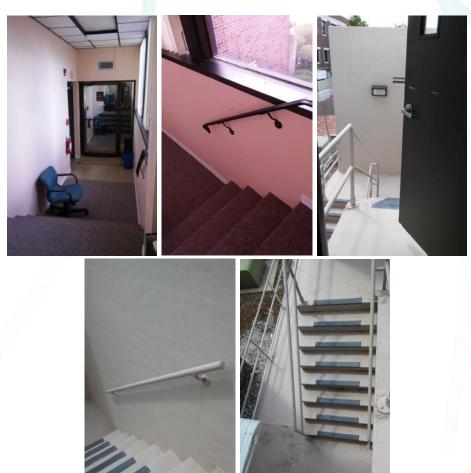
Figure 4-6 – Emergency Exit Stairs 1

- Stairway 1 serves as an emergency exit. This exit is not signed appropriately with an illuminated sign or a tactile exit sign prescribed by **ADAAG 216.4.1**.
- The handrails along Stairway 1, which serves as an emergency egress do not have adequate 12" handrail extensions, not meeting **ADAAG 505.10.1.**
- There are several additional exit doors that are missing tactile exit signs, not meeting ADAG 216.4.1.
- There are several doors throughout the facility serving as exit doors that are identified with exit signs that are not illuminated, including inside the front entrance.

- Add an illuminated exit sign above the doorway to Stairway 1, along with a tactile exit sign, complying with ADAAG 703.1, ADAAG 703.2, and ADAAG 703.5, adjacent to the doorway.
- Modify the handrails along Stairway 1, both internal and external, so that there is adequate 12" handrail extensions complying with ADAG 505.
- Ensure that that exit doorways have tactile exit signs complying with ADAAG 703.1, ADAAG 703.2 and ADAAG 703.5.
- While not an ADA violation, illuminated exit signs should be installed instead of the existing non-illuminated variety currently installed.

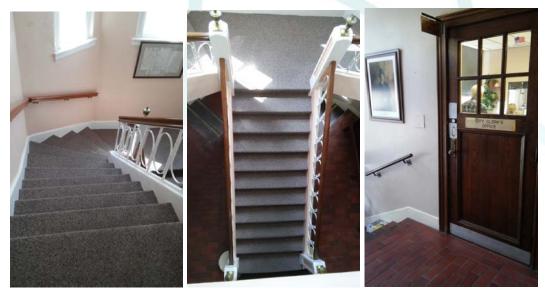
Figure 4-8 - Stairway to Second Floor / Doorway to Clerk's Office

- The main stairway to the 2nd floor is the only route to the second floor services and offices in City Hall. This means all services on the second floor are not accessible (no vertical means of access), per **ADAAG 206.2.3**.
- The door hardware to the Clerk's Office requires a twisting motion to operate, in violation of **ADAAG 309.4**.
- The handrails along the stairs at the front entrance, leading to the Clerk's Office, do not have compliant handrail extensions, in violation of **ADAAG 505.10.1**.

- Option 1: Relocate all public access services on the 2nd floor to the 1st floor or another building that is accessible. Only office space should remain on the 2nd floor.
- Option 2: Provide a means for the general public to request services on the 2nd floor to be brought to them on the first floor. This should be done via an accessible receptionist desk or a call box located near the accessible entrance on the 1st floor.
- Option 3: Construct an elevator to provide accessibility to the 2nd floor.
- Either replace the door knob with a handle that can be operated with a closed fist
 and does not require gripping or pinching to open, or ensure that the door knob
 does not engage in the locked position during operating hours, so that a person
 can simply pull the door open using the installed handle above the knob, without
 utilizing the door knob.

Replace the existing handrail, adjacent to the Clerk's Office, with a compliant handrail that has 12" extensions at the top and the bottom and are positioned parallel to the floor.

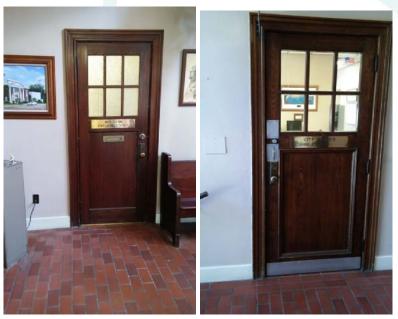
Figure 4-9 – Restricted Rooms & Office Signage

The signage to the permanent rooms are located on the door, violating ADAAG 703.4, and do not have ADA compliant tactile signage identifying the room, violating ADAAG 216.2.

- Place tactile signs, complying with ADAAG 703, on the side wall of each of the interior door that designates a permanent room.
 - o Signs must designate the room by its name or a room number.
 - o Signs must be braille with raised lettering.
 - The sign should be placed in the center of an 18" clear space adjacent to the latch side of the door.
- The height of the sign should be placed between 48" and 60" high from the floor, measured to the baseline of the lowest and highest line of raised characters per ADAAG 703.4.1.

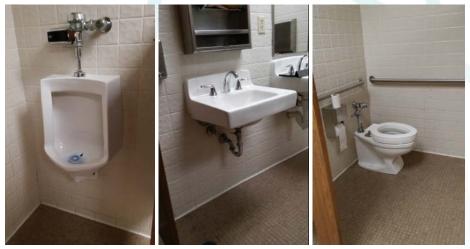
Figure 4-10 - First Floor Men's Room

- The door to the restroom is only 28" wide, violating **ADAAG 404.2.3**, which requires a width of 32".
- The door into the accessible stall is only 29", violating ADAAG 404.2.3.
- The door to accessible stall door is not self-closing, violating ADAAG 604.8.1.2.
- The toilet paper is hung on the back wall, not the side wall, violating ADAAG
 604.7.
- The wall hung urinals are 24" from the ground, violating **ADAAG 605.2**.
- The pipes beneath one of the two sinks has exposed pipes, violating ADAAG 606.5.
- The accessible stall does not have a sink or mirror within the stall, violating FAC 604.8.1.6.

- The door to the restroom was likely constructed during the construction of the building and is therefore not required to be widened unless other renovations are performed to the restroom. To bring into compliance the door must be widened 4" to 32".
- Replace the partition and the door to the accessible stall with a doorway compliant with **ADAAG 404.2.3**, with a minimum width of 32".
- The accessible stall door needs to be modified to comply with **ADAAG 604.8.1.2**, by adding a spring or other self-closing device to the door.
- Relocate the toilet paper dispenser to the side wall of the toilet in compliance with ADAG 604.7.
 - It should be located 7" to 9" in front of the rim of the toilet.
 - o It should be installed at a height of 15" min to 48" max.

- o If located below the handrail, it should leave a min of 1.5" clearance. If placed above, it should leave a min of 12" clearance.
- Lower the urinal to a height of 17" max so that it complies with ADAAG 605.2.
- Wrap the pipes beneath the sink with soft protective wrap to comply with ADAAG
 606.5.
- Relocate the second sink and mirror into the accessible stall. Relocate the divider to make the stall larger if necessary. Or, install a new lavatory in the toilet stall.

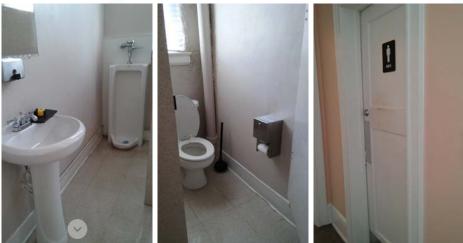
Figure 4-12 – 2nd Floor Men's Room

• Several elements of the restroom are not accessible and would require significant structural modifications to enhance the restroom to be accessible including the overall size of the space.

- The second floor restroom should be allocated for a future programmed project to renovate the space to meet ADAAG and FAC requirements.
 - o In order to provide an accessible restroom facility on the 2nd floor while preserving all the authentic interior features of the historic structure, another alternative is to construct a new accessible restroom facility. If this new facility were designated as an accessible unisex restroom, then it may not be necessary to completely renovate the existing 2nd floor men's and women's restrooms.

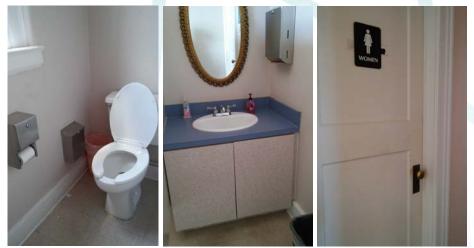
Figure 4-13 – 2nd Floor Women's Room

- The door to the accessible stall is only 27" wide, violating **ADAAG 404.2.3**, which requires a width of 32".
- The door to the accessible stall is not self-closing, violating ADAAG 604.8.1.2.
- The door hardware is a traditional door knob which violates ADAAG requirements for accessible hardware per ADAAG 309.4.
- The restroom identification sign is mounted on the face of the door in violation of ADAAG 703.4.2.
- The toilet paper dispenser is mounted at 47" above the floor in violation of ADAG 604.7.

- The door to the restroom was likely constructed during the construction of the building and is therefore not required to be widened unless other renovations are performed to the restroom. To bring into compliance, the door must be widened 5" to 32".

- Install spring or other hardware to make the stall door self-closing.
- Replace the traditional door knob hardware with accessible hardware.
- Remove and remount the Women's Room space identification sign to the latch side of the door on the facing wall and in accordance with ADAAG 703 mounting requirements.

- Relocate the toilet paper dispenser to the side wall of the toilet in compliance with ADAG 604.7.
 - o It should be located 7" to 9" in front of the rim of the toilet.

- o It should be installed at a height of 15" min to 48" max.
 - If located below the handrail, it should leave a min of 1.5" clearance. If placed above, it should leave a min of 12" clearance.

In order to provide an accessible restroom facility on the 2nd floor while
preserving all the authentic interior features of the historic structure, another
alternative is to construct a new accessible restroom facility. If this new facility
were designated as an accessible unisex restroom, then it may not be necessary
to completely renovate the existing 2nd floor men's and women's restrooms.

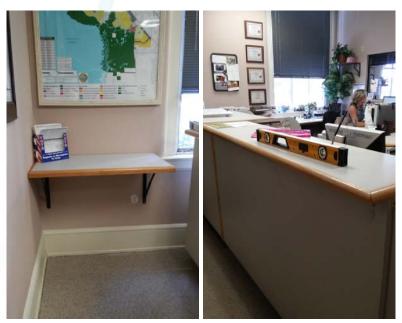
Figure 4-14 – City Clerk's Office Service Area

• The main counter is 43" high, 7" higher than an accessible service counter, not complying with ADAAG 904.4.1.

The adjacent wall-mounted table is 35" high with sufficient leg clearance for a
forward approach. The receptionists would be required to direct persons using
wheelchairs to this counter, if a writing surface is required. This surface should
be kept clear and the receptionist should be trained to utilize this approach.

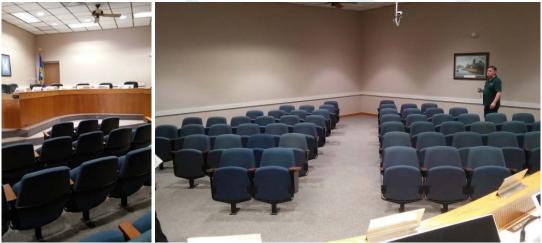
Figure 4-15 - Council Chambers

- There is no accessible route to the podium and/or the council seating due to a step up to the area.
- There is no lighted exit sign or tactile signage, which is required in large assembly areas.

- Install a ramp that will allow access to the podium and the council chamber seating and/or lower the area of the podium and seating. The ramp should level at the podium area to allow for transfer to that area, however, it should allow enough transition for a compliant 12:1 rise up to the main council seating area. The installation of the ramp may still require lowering and/or modifying the height of the podium area. Alternatively, a portable ramp assembly could be devised to provide wheelchair access to the podium seating area for those events requiring access.
- Install a lighted Exit sign over the doorway as well as a tactile exit sign.
