CITY OF PUNTA GORDA ADA TRANSITION PLAN FINAL REPORT Harborwalk Core

October 4, 2017

Prepared For:
City of Punta Gorda
326 West Marion Avenue
Punta Gorda, Florida, 33950

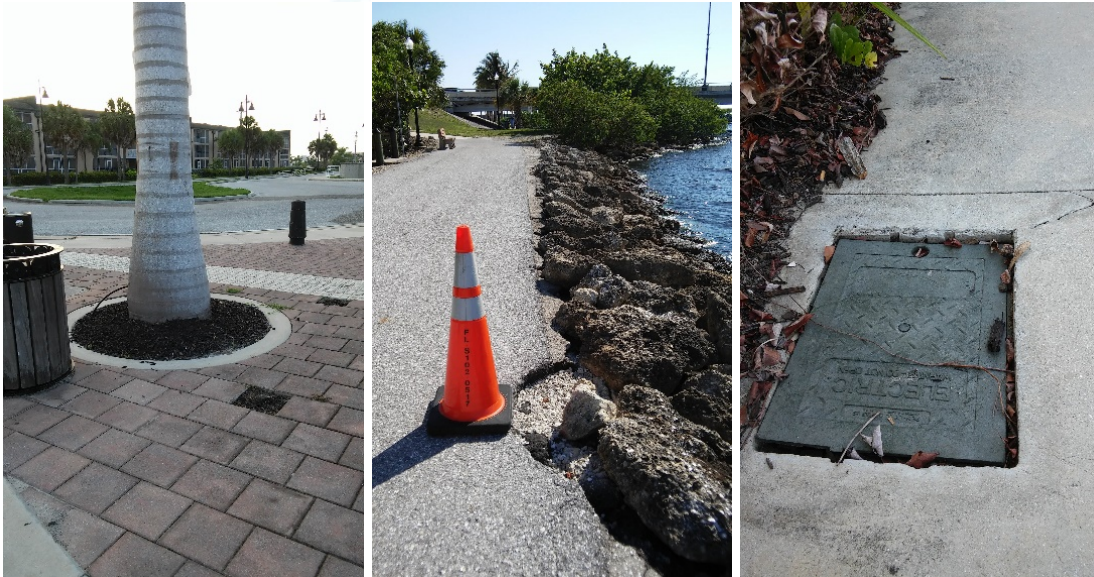
Figure 4-3 – Boardwalk ramps along the pathway

Changes in level are defined as vertical height transitions between adjacent surfaces or along the surface of a path. Figure 4-3 displays three examples where the walking surface is uneven and can be a tripping hazard as well as a barrier to accessibility to a person in a wheelchair. A map of these locations is provided in Appendix A.

Fill in/repave areas with missing bricks or pavement to minimize the potential tripping hazards.

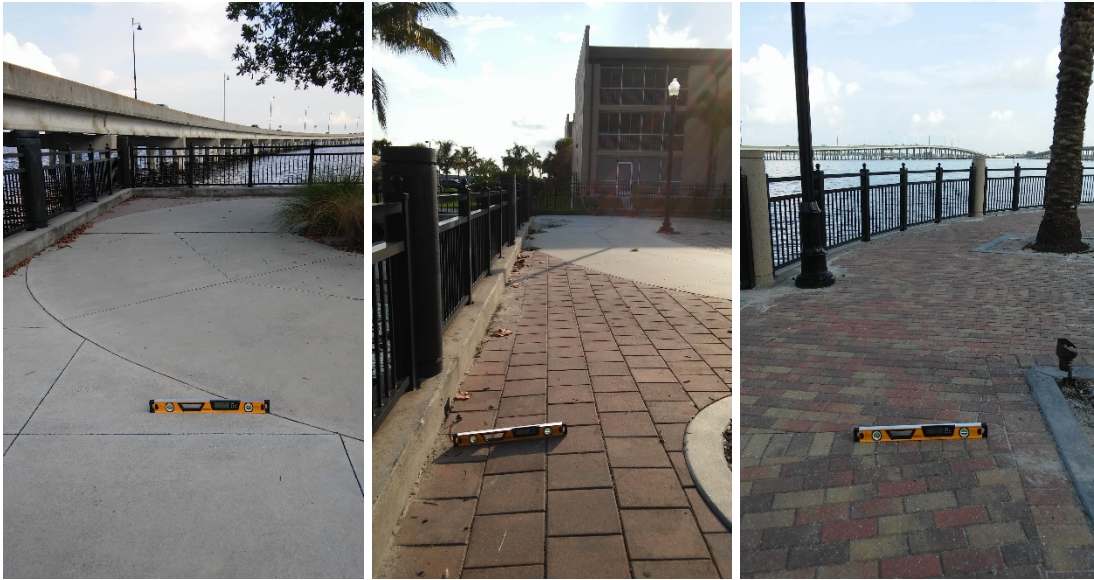
Figure 4-4 – Select locations with non-compliant cross slopes.

Per **ADAAG 403.3**, the cross (perpendicular) slope of a walking surface shall not be steeper than 2%. As such, multiple points of the Harborwalk Core multiuse trail were found to have slopes in excess of this requirement, as shown in the photos below and detailed in Appendix A.

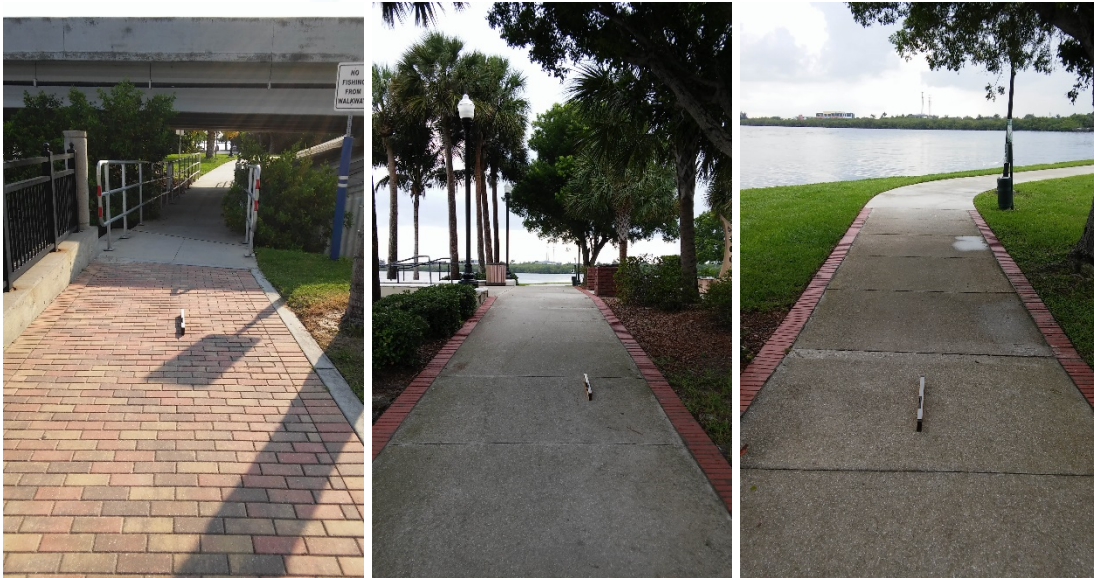
Figure 4-5 – Select locations with non-compliant cross slopes.

As such, multiple segments of the Harborwalk Core multiuse trail were found to have slopes in excess of this requirement, as shown in the photos below and detailed in Appendix A.

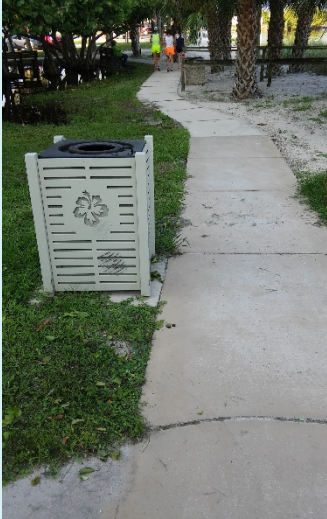
Map Item	Description & Recommendation	Photo
<p>A1</p>	<p>The garbage can is located adjacent to a 5% slope. A user in a wheelchair will not be able to use this amenity due to the excessive slope.</p> <p>Relocate the garbage can to a location that is adjacent to a clear and level floor space.</p>

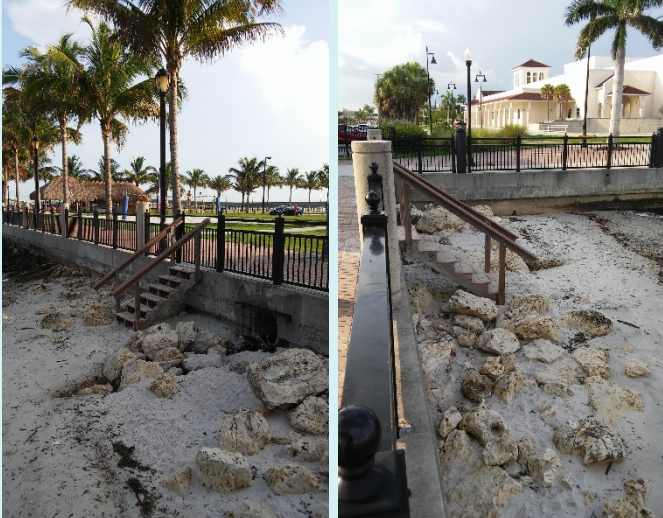
<p>A3</p>	<p>There is only stair access to the small beach.</p> <p>Either add a ramp to provide an accessible entrance to the beach or remove all access to the area.</p>

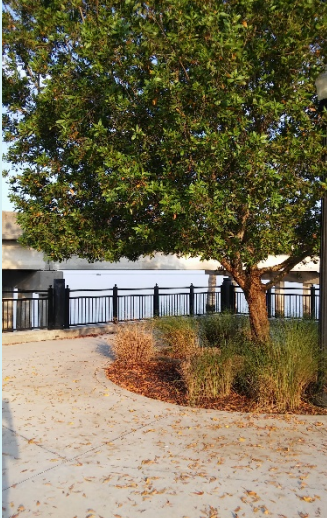
<p>P1</p>	<p>The tree branches are protruding object and have the potential to injure a visually impaired person using the multiuse trail.</p> <p>Trim the tree branches so they don't project out into the trail at a height of less than 80".</p>

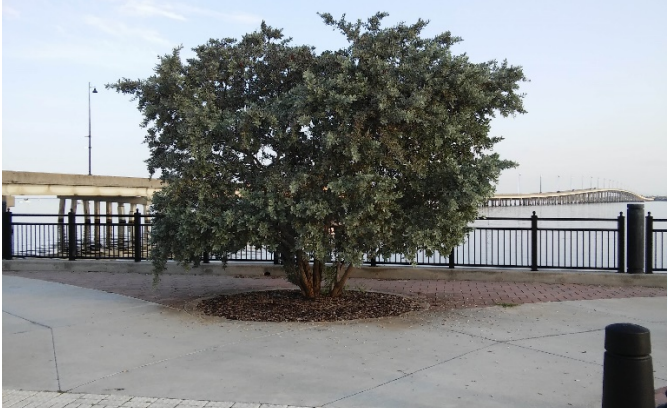
Map Item	Description & Recommendation	Photo
<p>P2</p>	<p>The tree branches are protruding object and have the potential to injure a visually impaired person using the multiuse trail.</p> <p>Trim the tree branches so they don't project out into the trail at a height of less than 80".</p>

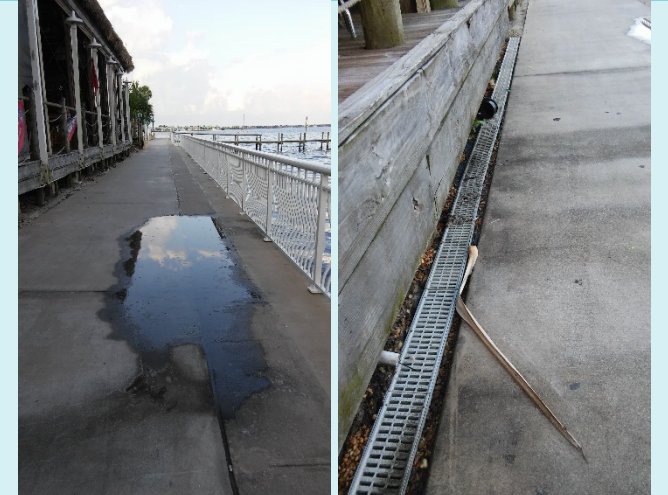
<p>T1</p>	<p>There is a large puddle of standing water that can cause the surface to be slippery.</p> <p>Repave the path to eliminate the accumulation of standing water.</p>

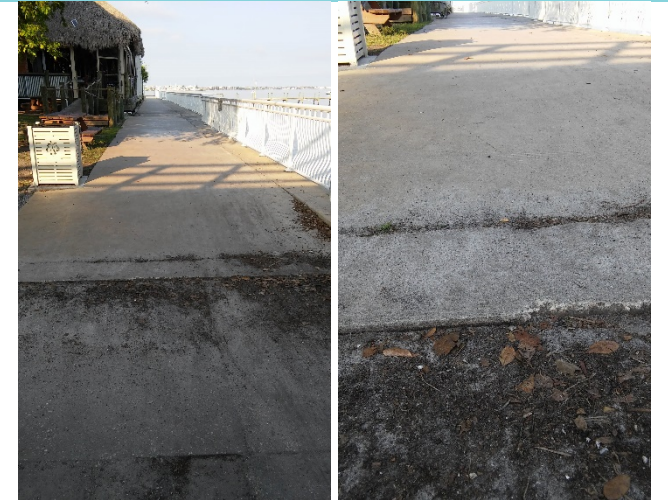
<p>T2</p>	<p>There is a raised cement lip that is a tripping hazard.</p> <p>Bevel cement lip to remove the tripping hazard.</p>

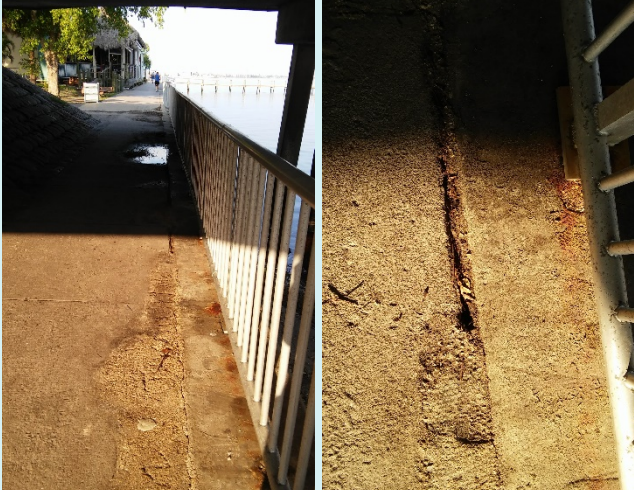
Map Item	Description & Recommendation	Photo
<p>T3</p>	<p>There is a large puddle of standing water that can cause the surface to be slippery. In addition, a hole is located near the railing that can be a tripping hazard.</p> <p>Repave the path to eliminate the accumulation of standing water and hole in the pavement.</p>

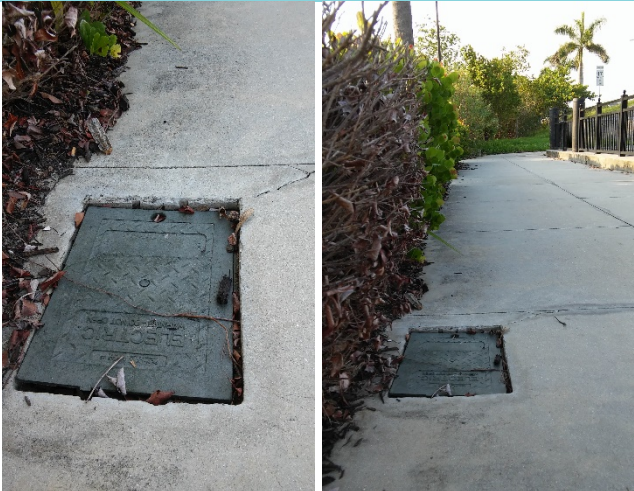
<p>T4</p>	<p>The utility cover is recessed and is a tripping hazard</p> <p>Either add additional pavement or raise the cover so that it is flush with the adjoining trail.</p>

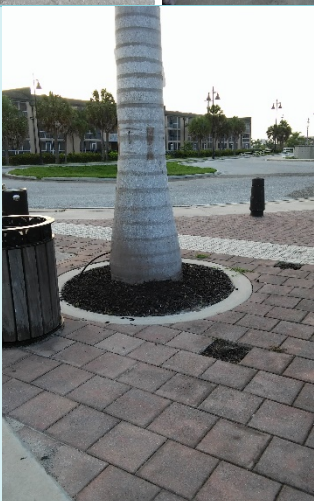
<p>T5</p>	<p>Four brick pavers are missing causing a tripping hazard.</p> <p>Replace the brick pavers to eliminate the tripping hazard.</p>

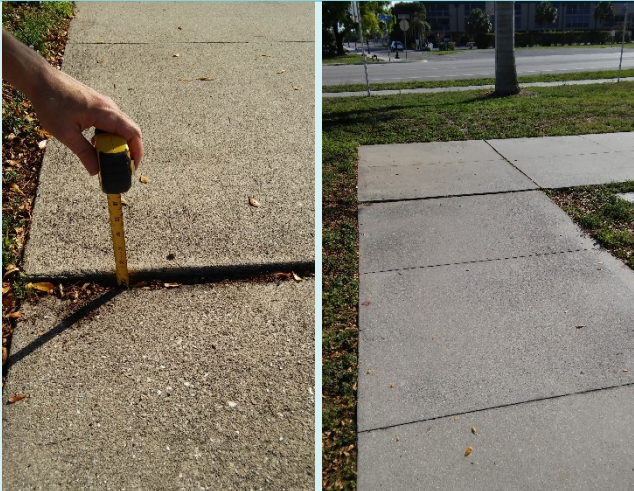
<p>T13</p>	<p>There is a raised section of sidewalk that has a 3\4" tripping hazard.</p> <p>Bevel this section of sidewalk to eliminate the tripping hazard.</p>

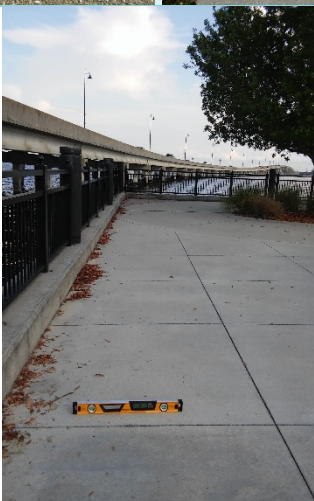
<p>C1</p>	<p>The cross slope is approximately 3.1%.</p> <p>Repave/resurface the trail so that the cross slope is no greater than 2%.</p>

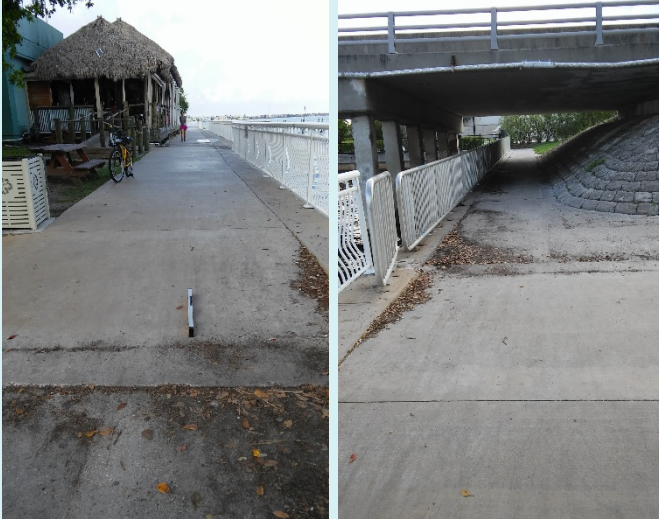
Map Item	Description & Recommendation	Photo
<p>R1</p>	<p>This section of trail has a 4% to 7% running slope. There is a lot of debris at base of the ramp.</p> <p>Repave/regrade the trail to have a slope no greater than 5%. Remove and maintain the area with excessive amounts of debris to keep the area firm, stable, and slip resistant.</p>

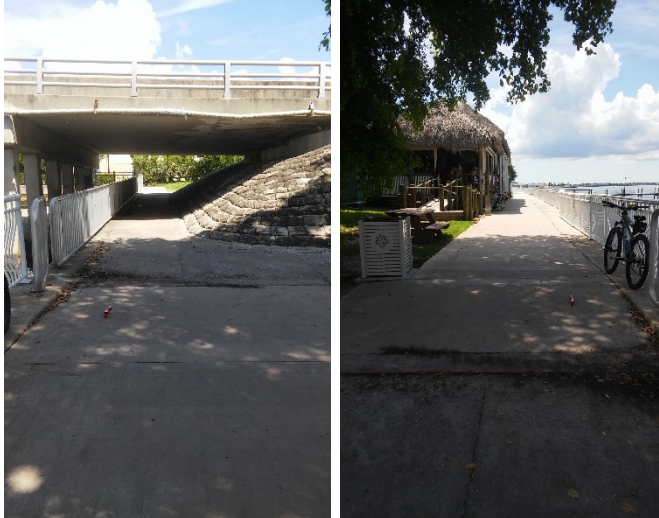
<p>R2</p>	<p>This section of trail has a 6% running slope for approximately 10 feet. There is also a 0.75" tripping at the cement joint.</p> <p>Repave/regrade the trail to have a slope no greater than 5%. Resurface the cement joint to remove the tripping hazard.</p>

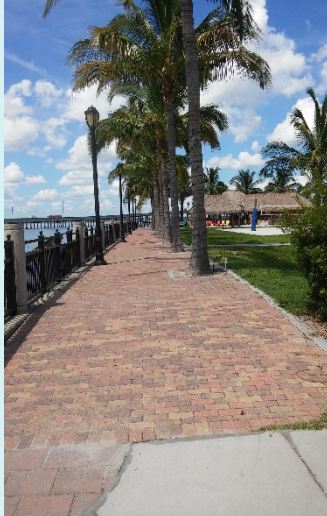
<p>R3</p>	<p>This section of trail has a 6% running slope.</p> <p>Regrade & reset the brick pavers so the running slope is no greater than 5%.</p>
