# Punta Gorda

## CITY OF PUNTA GORDA ADA TRANSITION PLAN FINAL REPORT Harborwalk East

October 4, 2017

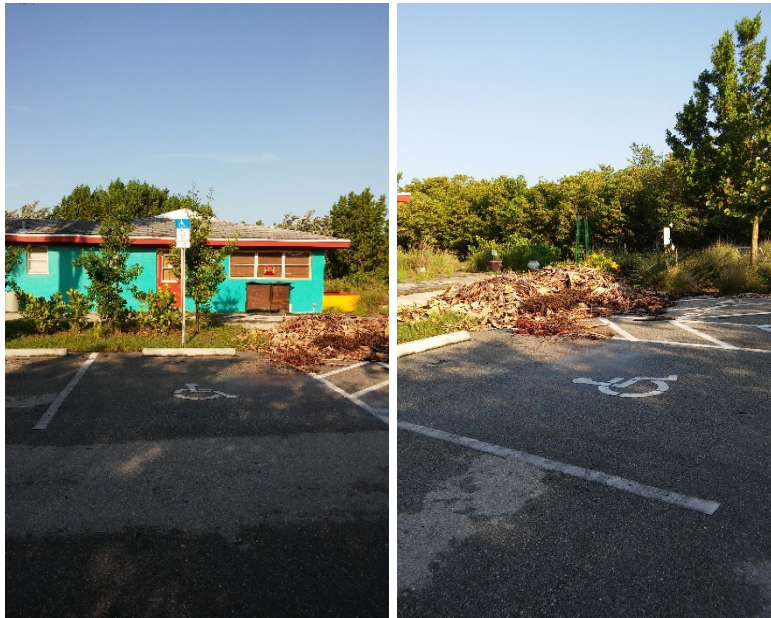
**Figure 4-1: Accessible Parking**

- The striping for the accessible parking space is white, not blue.
- There is some debris in the parking space and accessible aisle.
- The parking space does not have a sign identifying it as being van accessible.

**FS 553.5041 (6)** “Each such parking space must be striped in a manner that is consistent with the standards of the controlling jurisdiction for other spaces and prominently outlined with blue paint, and must be repainted when necessary, to be clearly distinguishable as a parking space designated for persons who have disabilities.”

**ADAAG 502.6 Identification** “Signs identifying van parking spaces shall contain the designation “van accessible.”

- Restripe the accessible parking space so that it is outlined in blue.

- Remove the debris from the accessible parking space and aisle.
  - Maintain the parking space and aisle so that debris does not build up in these areas.
- Add a “Van Accessible” sign to the accessible parking space sign.

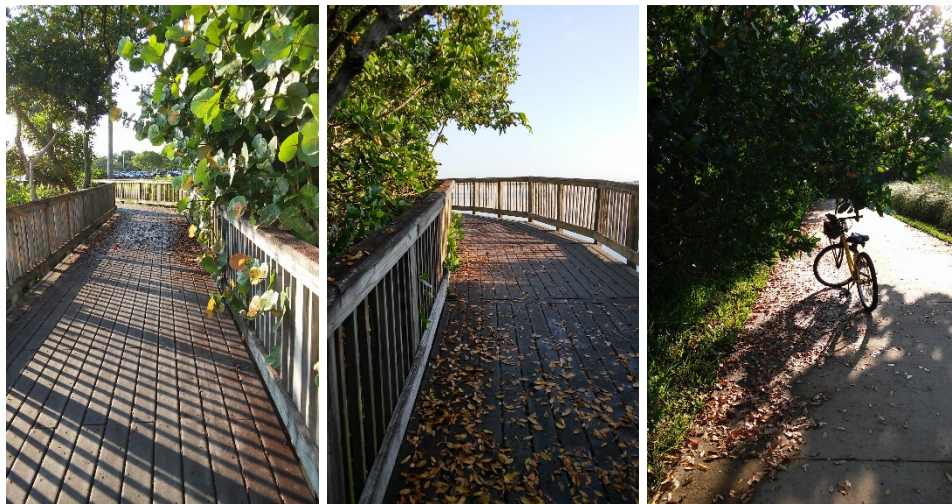
Figure 4-2 – Low hanging tree branches

Vertical clearance is defined as the minimum unobstructed vertical passage space. Vertical clearance is often limited by obstacles such as building overhangs, tree branches, signs, and awnings. Shown below in Figure 4-2, various sections of the Harborwalk East trail contains low hanging tree branches, which protrude and obstruct the pathway. A map of these locations is provided in Appendix A.

**ADAAG** states that, “objects with leading edges more than 27 inches and not more than 80 inches above the finish floor or ground shall protrude 4 inches maximum horizontally into the circulation path.

Trim and maintain the tree branches so they do not protrude more than 4” onto the path for a height of at least 80 inches. This will prevent visitors with visual impairments from not being able to detect and then make contact with the hazardous object.

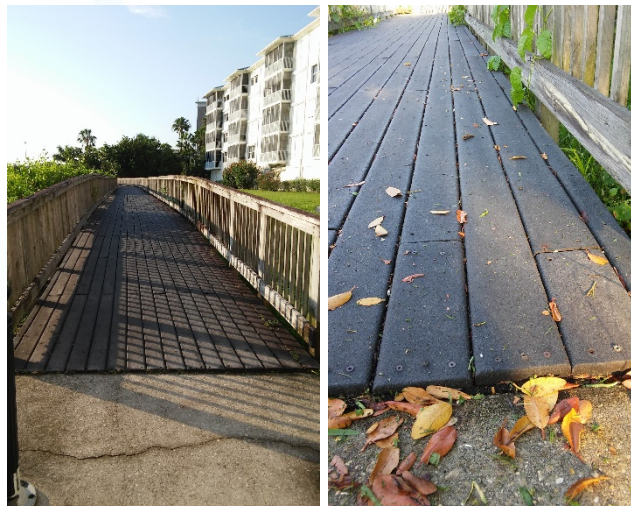
Figure 4-3 – Boardwalk ramps along the pathway

Changes in level are defined as vertical height transitions between adjacent surfaces or along the surface of a path. Figure 4-3 displays two examples where the 1.5” lip at the transition from the cement path to the boardwalk can be a tripping hazard as well as a barrier to accessibility to a person in a wheelchair. A map of these locations is provided in Appendix A.

**ADAAG 303.2** states that, “Changes in level of  $\frac{1}{4}$ ” high maximum shall be permitted to be vertical.”

**ADAAG 303.3** states that, “Changes in level of  $\frac{1}{4}$ ” high minimum and  $\frac{1}{2}$ ” high maximum shall be beveled with a slope not steeper than 1:2.”

Either bevel or provide an accessible transition plate at the wood/cement transition to minimize the lip between the two section of trail.

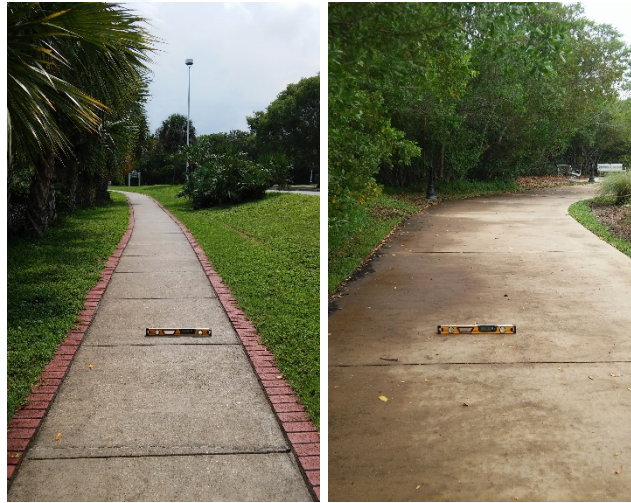
Figure 4-2 – Select locations with non-compliant cross slopes.

Per **ADAAG 403.3**, the cross (perpendicular) slope of a walking surface shall not be steeper than 2%. As such, 16 points of the Harborwalk East multiuse trail were found to have slopes in excess of this requirement, as shown in the photos below and detailed in Appendix A.

The locations that have non-compliant cross slope must be resurfaced so that the cross slope does not exceed 2%, as specified in **ADAAG 403.3**.

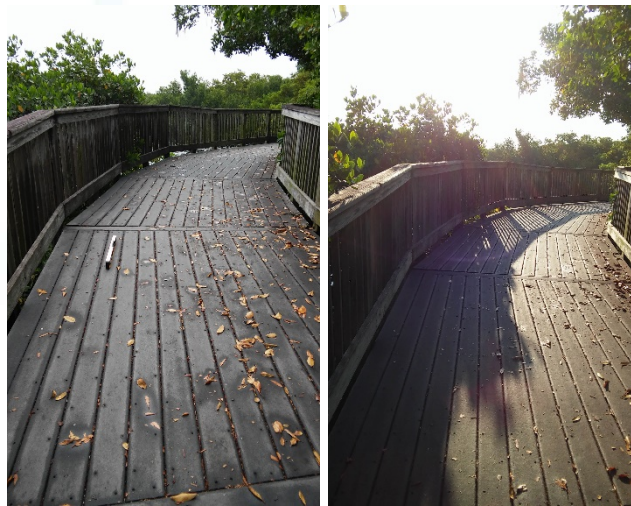
Figure 4-3 – Select locations with non-compliant cross slopes.

Per **ADAAG 403.3**, the running (perpendicular) slope of a walking surface shall not be steeper than 5%. If a slope exceeds 5%, it is considered a ramp, per **ADAAG 405.2**, and the running slope must not exceed 8.33%. In addition, ramps must have landings, handrails, and edge protection, per **ADAAG 405**.

As such, 8 segments of the Harborwalk East multiuse trail were found to have slopes in excess of this requirement, as shown in the photos below and detailed in Appendix A.

The locations that have non-compliant running slopes must be either resurfaced/reconstructed or include the addition of handrails and landings, as long as their slope is not steeper than 8.33%, as specified in **ADAAG 405**.

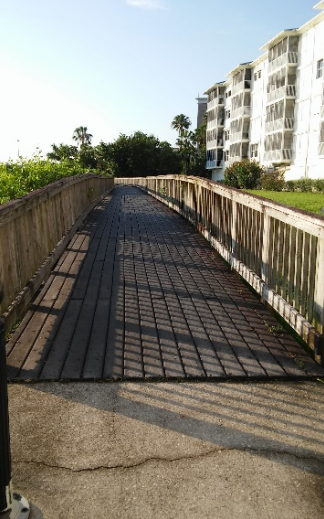
Map Item	Description & Recommendation	Photo
<p><b>M1</b></p>	<p>There is a 1.5” lip at the entrance to the walkway.</p> <p>Resurface the cement/wood transition to minimize the lip, per <b>ADAAG 303</b>.</p>

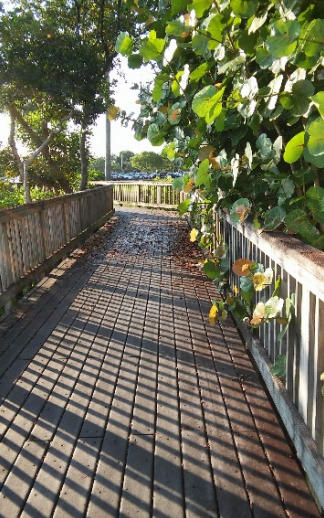
<p><b>M2</b></p>	<p>Tree branches extend below 80” into the accessible route.</p> <p>Trim and maintain the foliage so the accessible route is clear of obstructions, per <b>ADAAG 307</b>.</p>

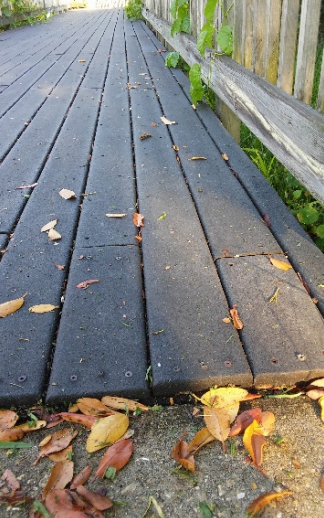
<p><b>M3</b></p>	<p>There is a 1.5” lip at the entrance to the walkway.</p> <p>Resurface the cement/wood transition to minimize the lip, per <b>ADAAG 303</b>.</p>

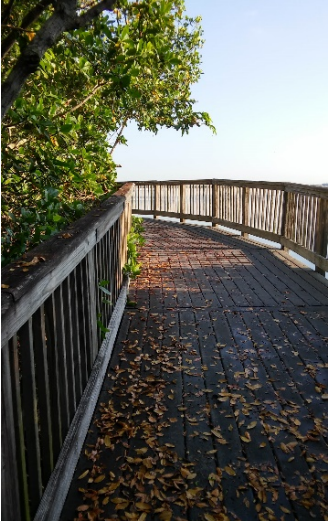
Map Item	Description & Recommendation	Photo
<p><b>M4</b></p>	<p>Tree branches extend below 80" into the accessible route.</p> <p>Trim and maintain the foliage so the accessible route is clear of obstructions, per <b>ADAAG 307</b>.</p>

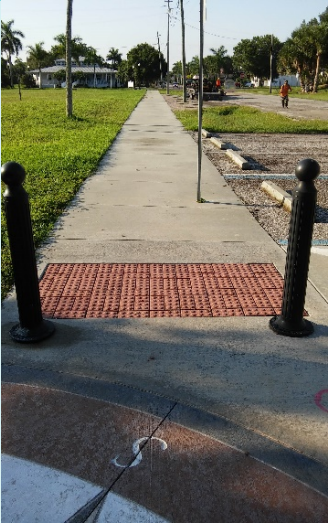
<p><b>M5</b></p>	<p>A detectable warning is not required at this location and may be confusing to a person with a vision impairment.</p> <p>Remove the detectable warning.</p>

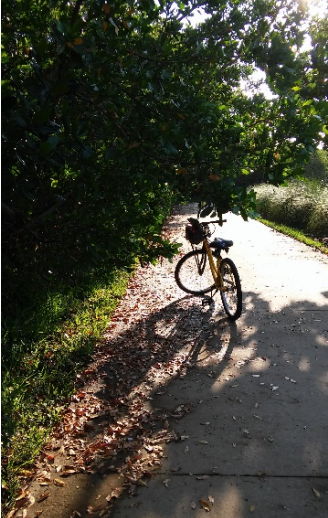
<p><b>M6</b></p>	<p>Tree branches extend below 80" into the accessible route.</p> <p>Trim and maintain the foliage so the accessible route is clear of obstructions, per <b>ADAAG 307</b>.</p>

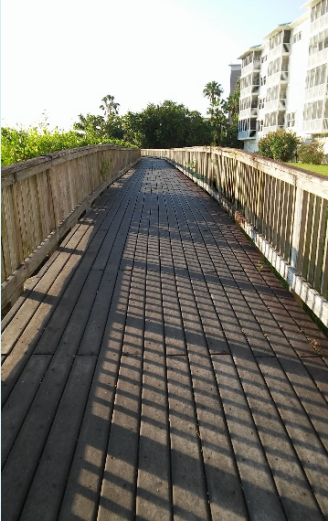
Map Item	Description & Recommendation	Photo
<p><b>R1</b></p>	<p>The running slope is greater than 5% for about 20" in length and there are no handrails.</p> <p>Either minimize the running slope to be no greater than 5% or add handrails and landing areas per <b>ADAAG 405.8</b> and <b>ADAAG 405.7</b>.</p>

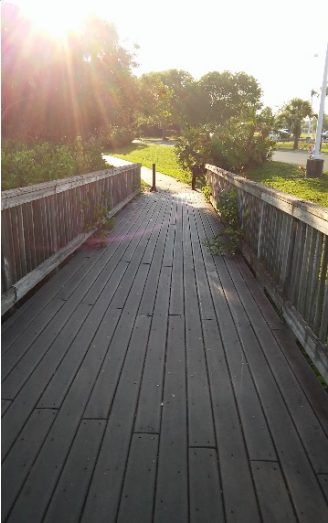
<p><b>R2</b></p>	<p>The running slope is 6%, and there are no handrails.</p> <p>Either minimize the running slope to be no greater than 5% or add handrails and landing areas per <b>ADAAG 405.8</b> and <b>ADAAG 405.7</b>.</p>

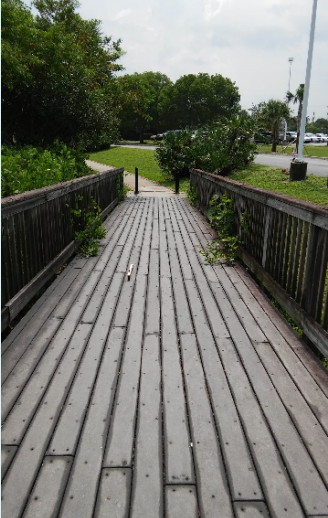
<p><b>R3</b></p>	<p>The running slope is 5.5%, and there are no handrails.</p> <p>Either minimize the running slope to be no greater than 5% or add handrails and landing areas per <b>ADAAG 405.8</b> and <b>ADAAG 405.7</b>.</p>

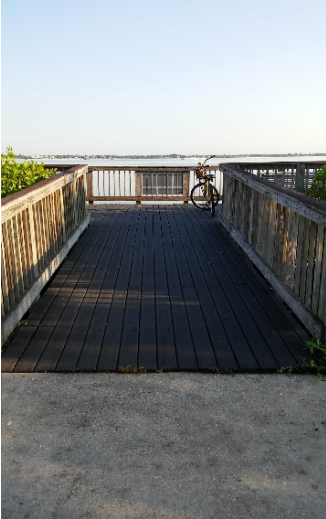
Map Item	Description & Recommendation	Photo
<p><b>R4</b></p>	<p>The running slope is greater than 5% and there are no handrails. There is a 1.5" lip at the entrance to the pier.</p> <p>Either minimize the running slope to be no greater than 5% or add handrails and landing areas per <b>ADAAG 405.8</b> and <b>ADAAG 405.7</b>. Resurface the cement/wood transition to minimize the lip, per <b>ADAAG 303</b>.</p>

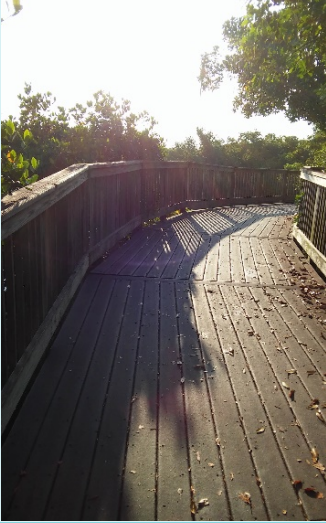
<p><b>R5</b></p>	<p>The running slope is 8% with 2-4% cross slope at the curved section of walkway. There are no handrails.</p> <p>Reconstruct the walkway so the cross slope is no greater than 2%. Either minimize the running slope to be no greater than 5% or add handrails and landing areas per <b>ADAAG 405.8</b> and <b>ADAAG 405.7</b>.</p>

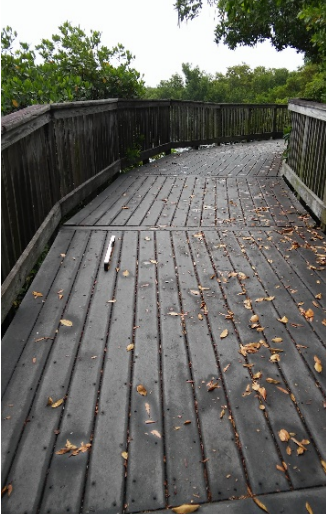
<p><b>R6</b></p>	<p>The running slope is 8.7%, and there are no handrails.</p> <p>Either minimize the running slope to be no greater than 5% or add handrails and landing areas per <b>ADAAG 405.8</b> and <b>ADAAG 405.7</b>.</p>

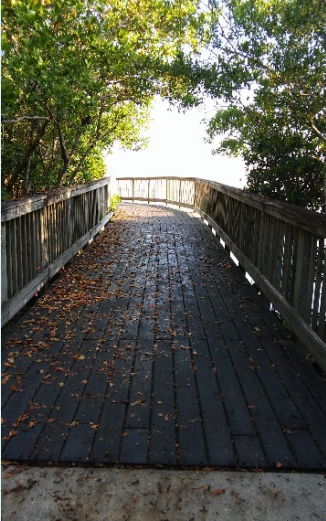
Map Item	Description & Recommendation	Photo
<p><b>R7</b></p>	<p>The running slope is between 5-7% and there are no handrails. There is a 1.5" lip at the entrance to the walkway.</p> <p>Either minimize the running slope to be no greater than 5% or add handrails and landing areas per <b>ADAAG 405.8</b> and <b>ADAAG 405.7</b>. Resurface the cement/wood transition to minimize the lip, per <b>ADAAG 303</b>.</p>

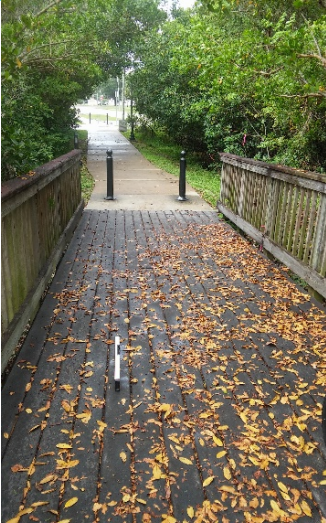
<p><b>R8</b></p>	<p>The running slope is 5.8%, and there are no handrails.</p> <p>Either minimize the running slope to be no greater than 5% or add handrails and landing areas per <b>ADAAG 405.8</b> and <b>ADAAG 405.7</b>.</p>

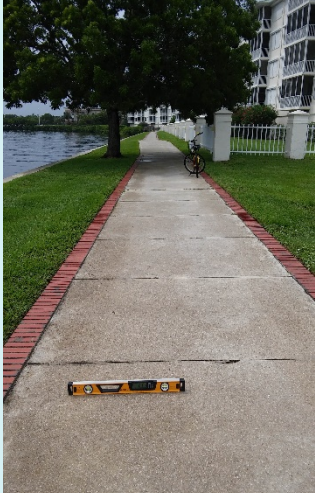
<p><b>C1</b></p>	<p>The cross slope at this point is 2.1%.</p> <p>Resurface the paved trail so the cross slope is a maximum of 2%, per <b>ADAAG 403.3</b>.</p>

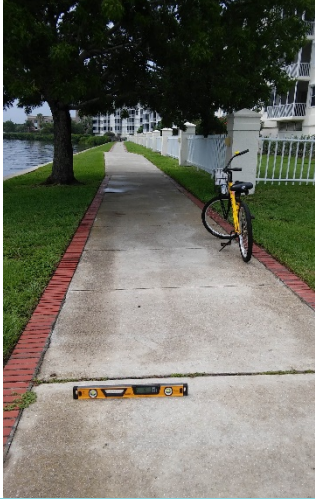
Map Item	Description & Recommendation	Photo
<p><b>C2</b></p>	<p>The cross slope at this point is 4.0%.</p> <p>Resurface the paved trail so the cross slope is a maximum of 2%, per <b>ADAAG 403.3</b>.</p>

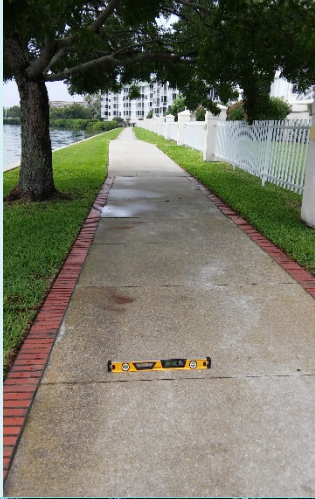
<p><b>C3</b></p>	<p>The cross slope at this point is 3.5%.</p> <p>Resurface the paved trail so the cross slope is a maximum of 2%, per <b>ADAAG 403.3</b>.</p>

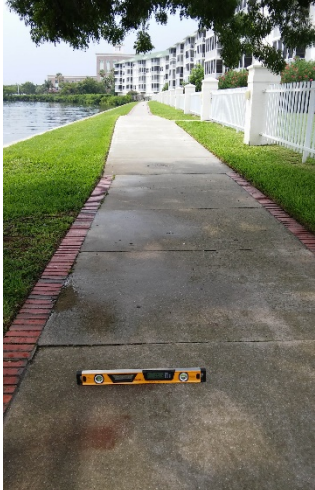
<p><b>C4</b></p>	<p>The cross slope at this point is 3.5%.</p> <p>Resurface the paved trail so the cross slope is a maximum of 2%, per <b>ADAAG 403.3</b>.</p>

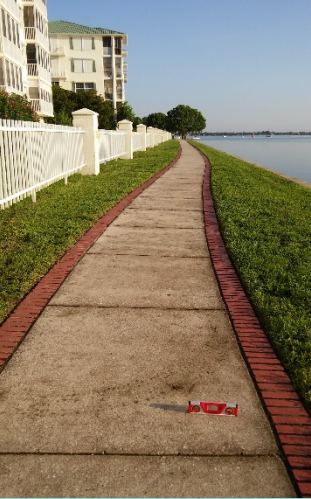
Map Item	Description & Recommendation	Photo
<p><b>C5</b></p>	<p>The cross slope at this point is 2.5%.</p> <p>Resurface the paved trail so the cross slope is a maximum of 2%, per <b>ADAAG 403.3</b>.</p>

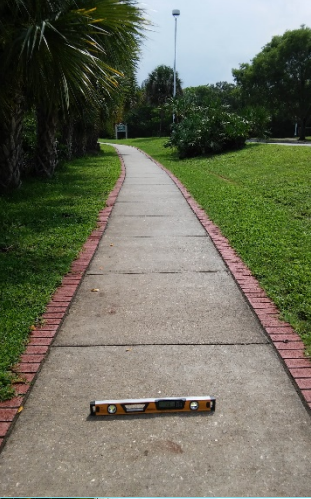
<p><b>C6</b></p>	<p>The cross slope at this point is 2.6%.</p> <p>Resurface the paved trail so the cross slope is a maximum of 2%, per <b>ADAAG 403.3</b>.</p>

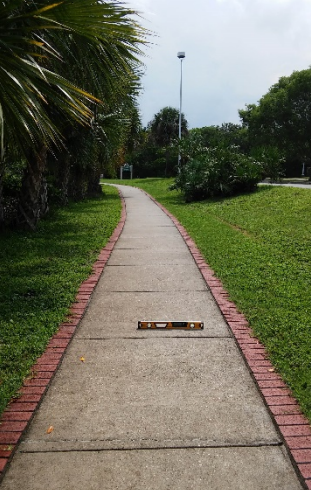
<p><b>C7</b></p>	<p>The cross slope at this point is 3.1%.</p> <p>Resurface the paved trail so the cross slope is a maximum of 2%, per <b>ADAAG 403.3</b>.</p>

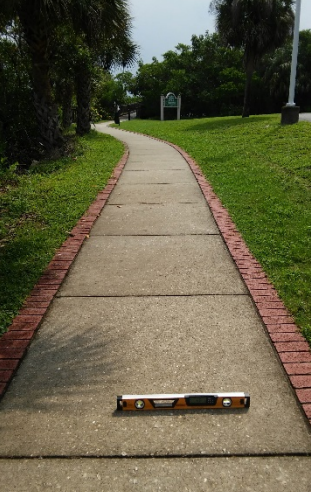
Map Item	Description & Recommendation	Photo
<p><b>C8</b></p>	<p>The cross slope at this point is 2.6%.</p> <p>Resurface the paved trail so the cross slope is a maximum of 2%, per <b>ADAAG 403.3</b>.</p>

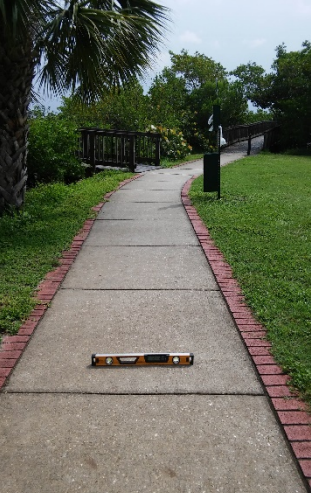
<p><b>C9</b></p>	<p>The cross slope at this point is 2.4%.</p> <p>Resurface the paved trail so the cross slope is a maximum of 2%, per <b>ADAAG 403.3</b>.</p>

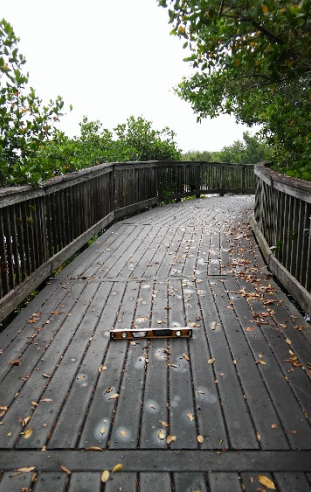
<p><b>C10</b></p>	<p>The cross slope at this point is 3.7%.</p> <p>Resurface/reconstruct the boardwalk so the cross slope is a maximum of 2%, per <b>ADAAG 403.3</b>.</p>

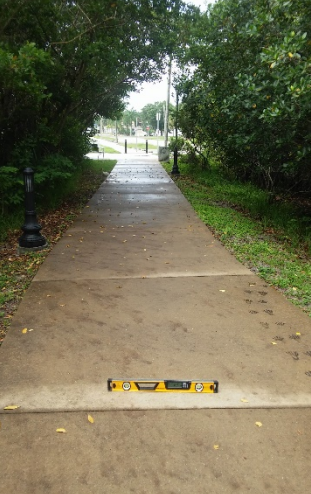
Map Item	Description & Recommendation	Photo
<p><b>C11</b></p>	<p>The cross slope at this point is 2.3%.</p> <p>Resurface the paved trail so the cross slope is a maximum of 2%, per <b>ADAAG 403.3</b>.</p>

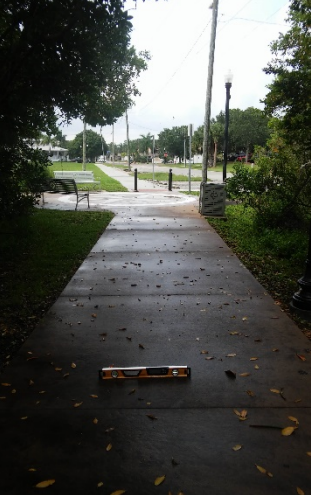
<p><b>C12</b></p>	<p>The cross slope at this point is 2.4%.</p> <p>Resurface the paved trail so the cross slope is a maximum of 2%, per <b>ADAAG 403.3</b>.</p>

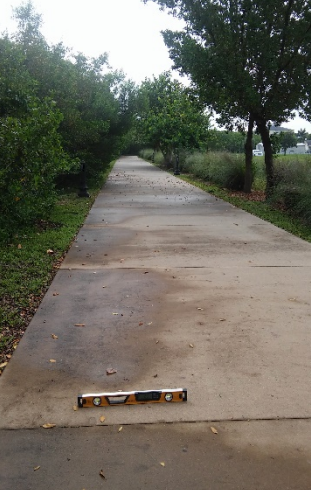
<p><b>C13</b></p>	<p>The cross slope at this point is 2.3%.</p> <p>Resurface the paved trail so the cross slope is a maximum of 2%, per <b>ADAAG 403.3</b>.</p>

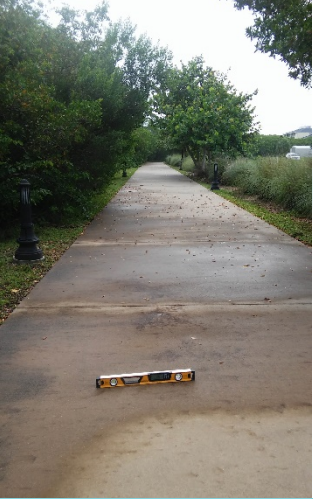
Map Item	Description & Recommendation	Photo
<p><b>C14</b></p>	<p>The cross slope at this point is 2.6%.</p> <p>Resurface the paved trail so the cross slope is a maximum of 2%, per <b>ADAAG 403.3</b>.</p>

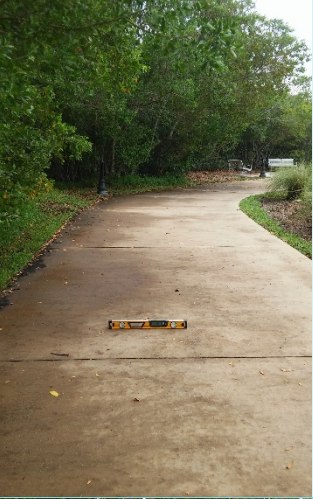
<p><b>C15</b></p>	<p>The cross slope at this point is 2.8%.</p> <p>Resurface the paved trail so the cross slope is a maximum of 2%, per <b>ADAAG 403.3</b>.</p>
