CITY OF PUNTA GORDA ADA TRANSITION PLAN FINAL REPORT Herald Court Centre

October 4, 2017

Prepared For:
City of Punta Gorda
326 West Marion Avenue
Punta Gorda, Florida, 33950

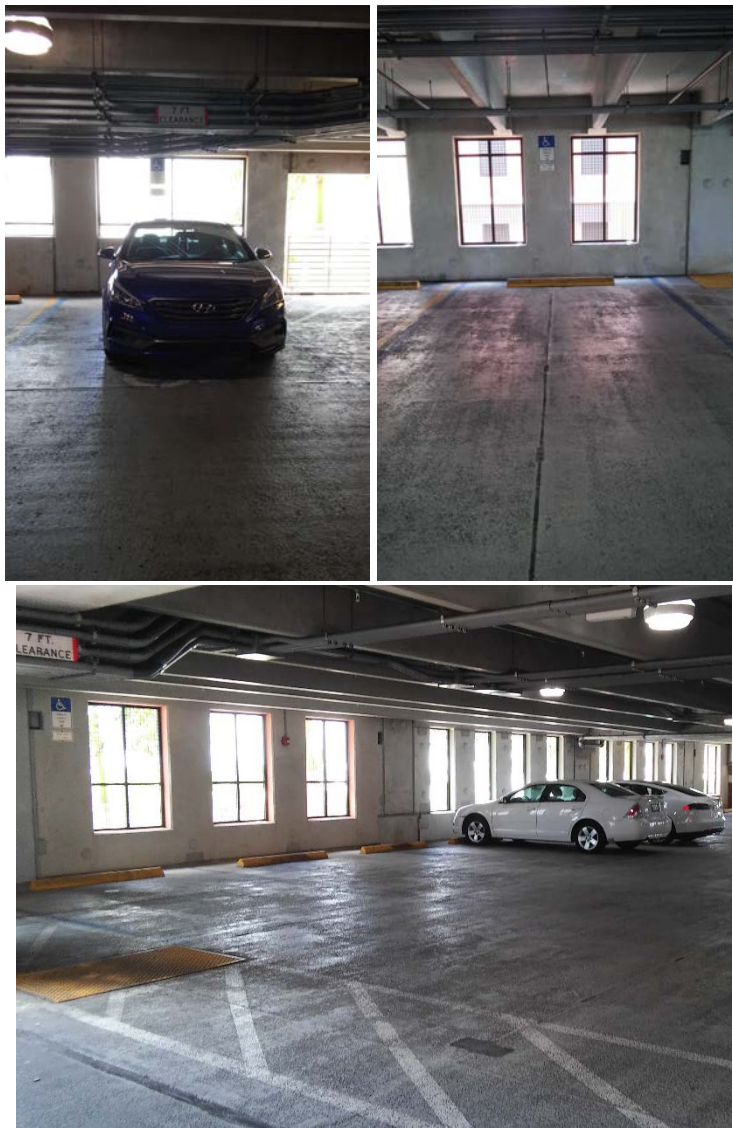
Figure 4-1 – 2nd Floor Parking Area

- The striping and ISA symbols are fading.
- The width of the accessible parking spaces are less than 144” wide, violating **FAC 502.2**.
- The access aisles have detectable warning unnecessarily placed on them.

- The width of the marked accessible route narrows to 30" for 36" in length.

- Restripe and repaint the faded parking spaces and ISA symbols.
- The width of the accessible parking spaces must be 144 minimum, per **FAC 502.2**. The adjacent access aisle must be 60" minimum, per **FAC 502.3.1**.
 - Note, **ADAAG 502.1** states that "Where parking spaces or access aisles are not adjacent to another parking space or access aisle, measurements shall be permitted to include the full width of the line defining the parking space or access aisle."
- Remove all detectable warning from the access aisles and accessible route within the parking garage.
- Although the width of the marked accessible route narrows to 30" for 36" in length, a portion of the vehicular traffic lane can be utilized. Widening the marked accessible route, while not required, would provide additional safety benefits, per **FAC 502.3**.

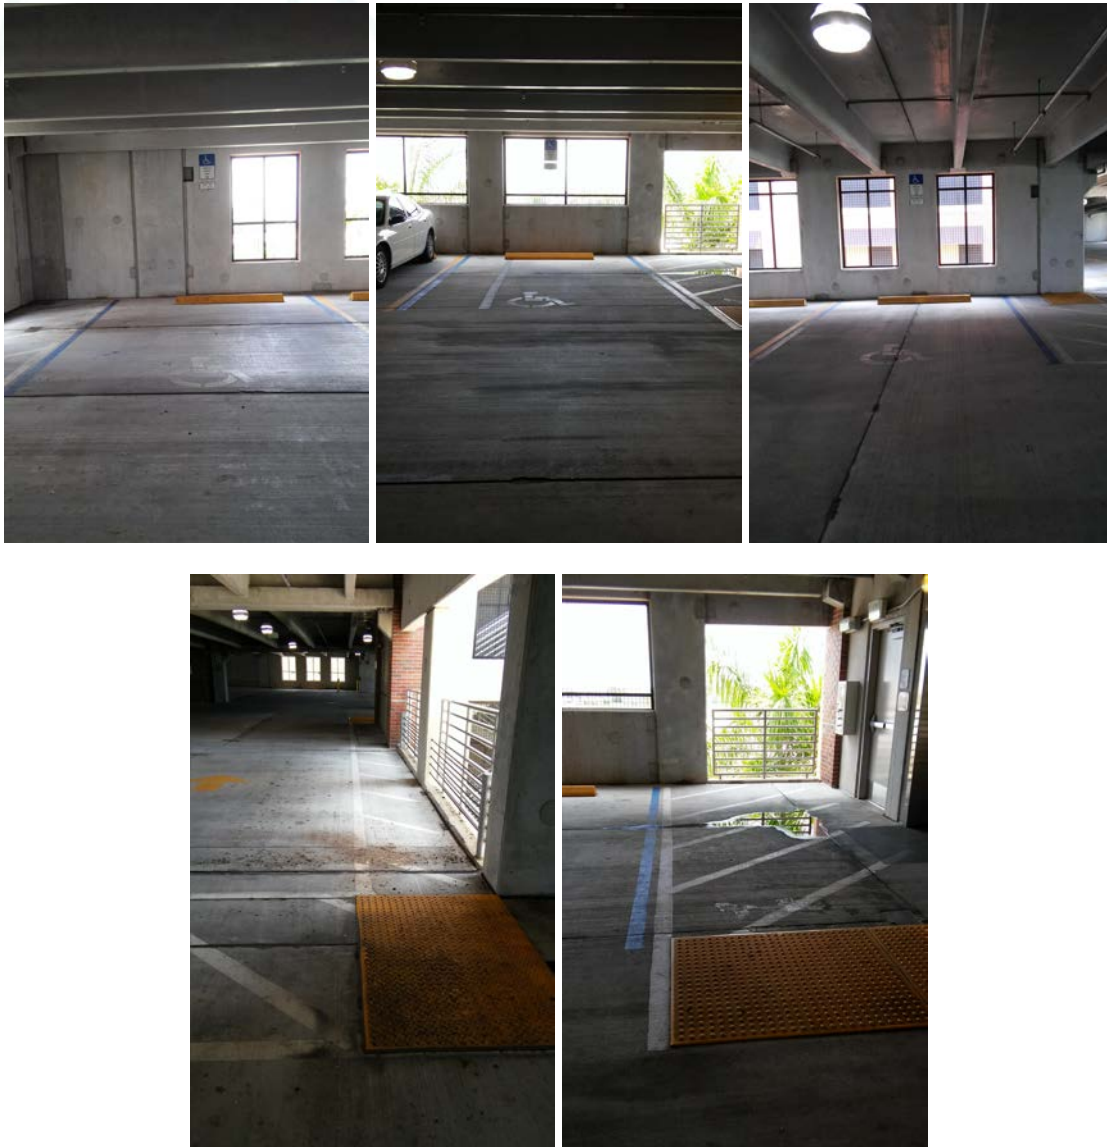
Figure 4-2 – 3rd Floor Parking Area*Assessments*

- The striping and ISA symbols are fading.
- The width of the accessible parking spaces are less than 144” wide, violating **FAC 502.2**.
- None of the accessible parking spaces are marked as being “van accessible”, violating **ADAAG 208.2.4**.
- The access aisles have detectable warning unnecessarily placed on them.
- The width of the marked accessible route narrows to 30" for 36" in length.
- There is standing water in the accessible aisle, adjacent to the elevator, violating **ADAAG 502.4**.

- The accessible route is not slip resistant, due to the large quantity of pigeon droppings located within it, violating **ADAAG 302.1**.

- Restripe and repaint the faded parking spaces and ISA symbols.
- The width of the accessible parking spaces must be 144 minimum, per **FAC 502.2**. The adjacent access aisle must be 60" minimum, per **FAC 502.3.1**.

- At least two accessible parking spaces within the garage shall be marked as being "van accessible", per **ADAAG 208.2.4**. Due to the 84" of vertical clearance above the accessible parking on the second floor, the van accessible parking must only be on the third or fourth floors, where there is at least 98" minimum of vertical clearance, per **ADAAG 502.5**.

- Remove all detectable warning from the access aisles and accessible route within the parking garage.
- Although the width of the marked accessible route narrows to 30" for 36" in length, a portion of the vehicular traffic lane can be utilized. Widening the marked accessible route, while not required, would provide additional safety benefits, per **FAC 502.3**.

- The access aisle needs to be resurfaced so standing water does not buildup within it.
- The accessible route need to be maintained on a regular basis so as to not accumulate debris, such as pigeon droppings.

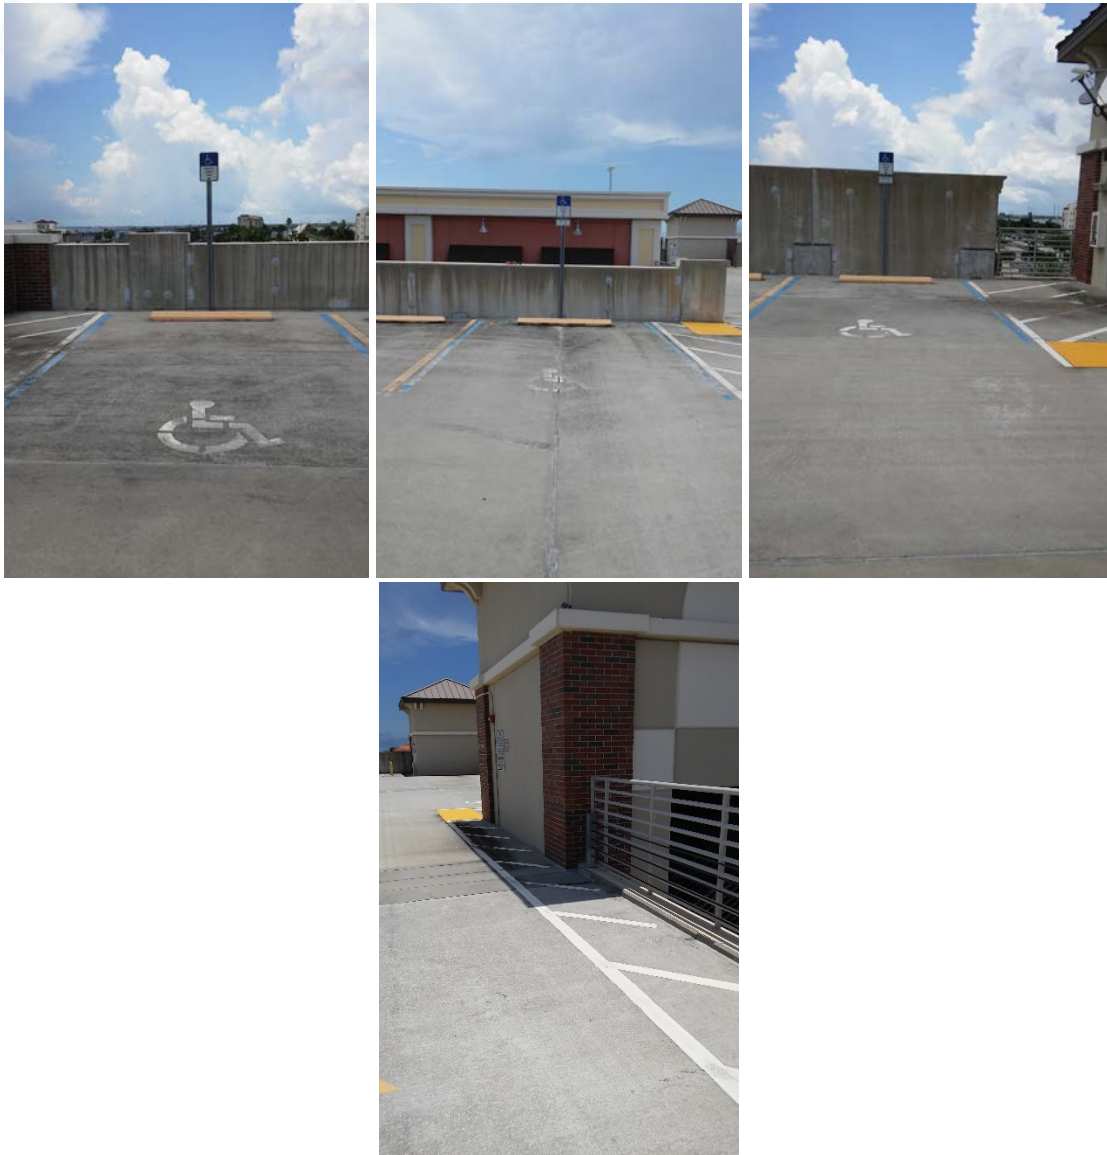
Figure 4-3 – 4th Floor Parking Area*Assessments*

- The striping and ISA symbols are fading.
- The width of the accessible parking spaces are less than 144" wide, violating **FAC 502.2**.
- There is no fine sign on one of the accessible parking space signs.
- None of the accessible parking spaces are marked as being "van accessible", violating **ADAAG 208.2.4**.
- The access aisles have detectable warning unnecessarily placed on them.
- The width of the marked accessible route narrows to 30" for 36" in length.

- Restripe and repaint the faded parking spaces and ISA symbols.
- The width of the accessible parking spaces must be 144 minimum, per **FAC 502.2**. The adjacent access aisle must be 60" minimum, per **FAC 502.3.1**.

- Place a fine sign on the accessible parking space sign that it is missing from.
- At least two accessible parking spaces within the garage shall be marked as being "van accessible", per **ADAAG 208.2.4**. Due to the 84" of vertical clearance above the accessible parking on the second floor, the van accessible parking must only be on the third or fourth floors, where there is at least 98" minimum of vertical clearance, per **ADAAG 502.5**.

- Remove all detectable warning from the access aisles and accessible route within the parking garage.
- Although the width of the marked accessible route narrows to 30" for 36" in length, a portion of the vehicular traffic lane can be utilized. Widening the marked accessible route, while not required, would provide additional safety benefits, per **FAC 502.3**.

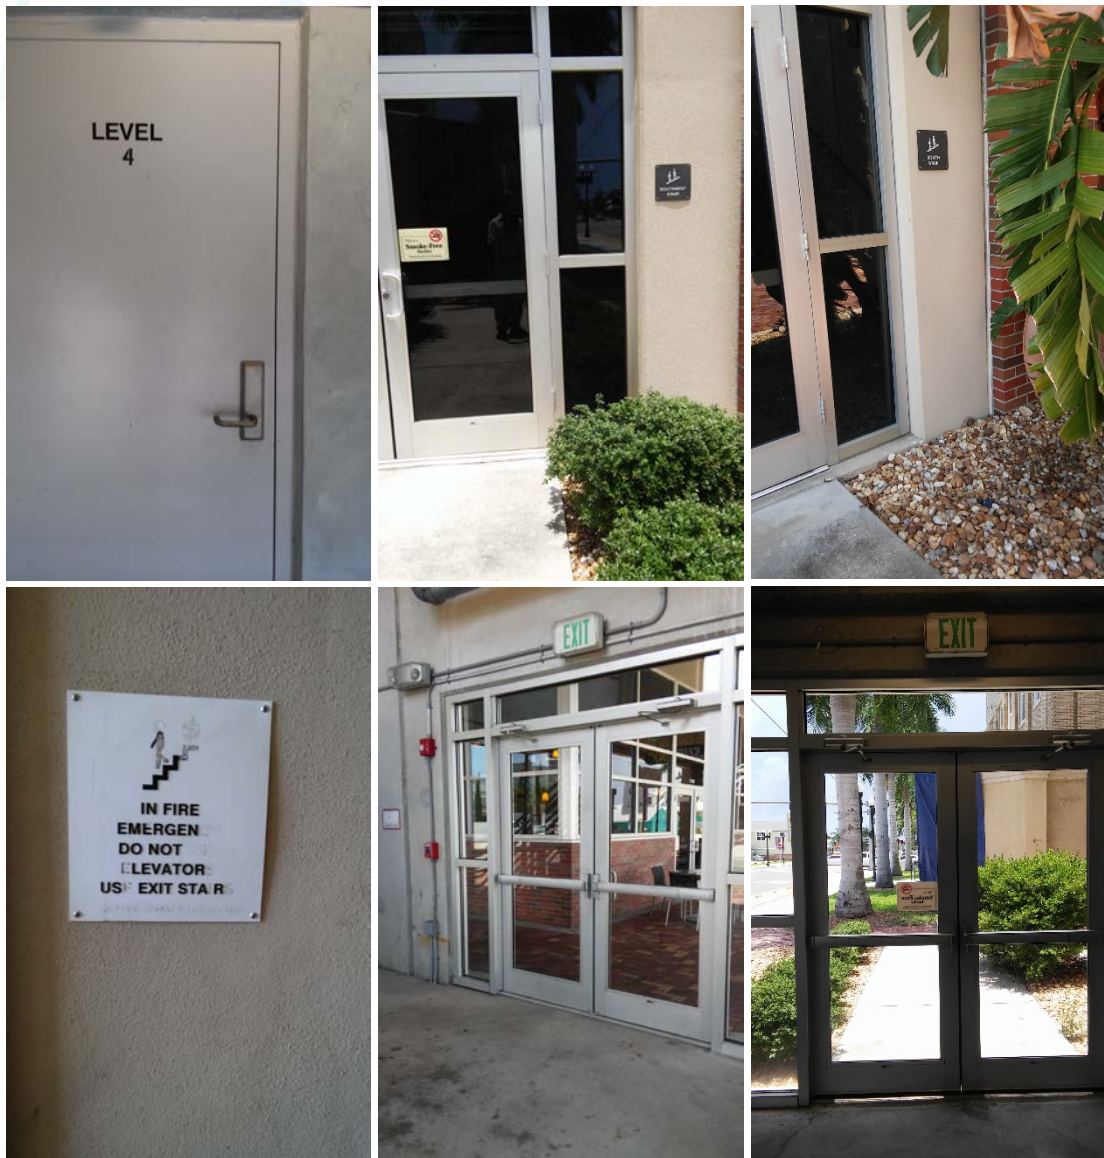
- Not all doorways/permanent rooms ADA compliant signage, such as with the "Level 4" doorway.
- The braille sign for the southwest and south stairs are located behind the bushes and is therefore not in an accessible location.
- The sign warning patrons to not take the elevator in case of an emergency is in poor condition.
- The doorways leading outside, from each of the stairwells do not have tactile exit signs adjacent to them.

Figure 4-4 – Examples of doorways without ADA compliant signage.

- At all permeant rooms, make sure the room's signage has visual characters, raised characters, and Braille.
- Relocate the signs located in the bushes to an accessible location. Per **ADAAG 703.4.2**, where a tactile sign is provided at a door, the sign shall be located alongside the door at the latch side.
- Replace the worn "Use Stairs" sign.
- At all stairwell exit doors, provide a tactile exit sign with raised characters and braille.

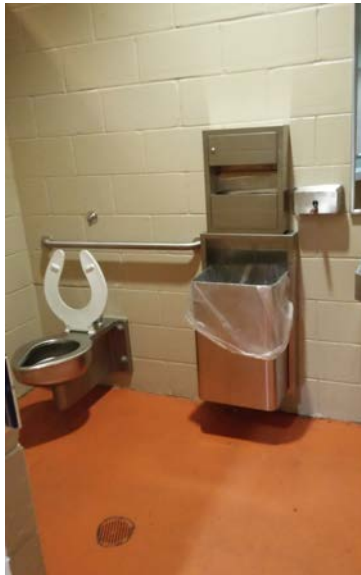
Figure 4-5 – Men's Restroom

- There is no side grab bar adjacent to the toilet, violating **ADAAG 604.5.1**
- The garbage can overlaps the clearance around the toilet, violating **ADAAG 604.3.2**.

- Add a side grab bar, compliant with **ADAAG 604.5.1**.
- Relocate the paper towel dispenser and garbage can to the side wall, so it does not overlap the toilet's clearance, per **ADAAG 604.3.2**.

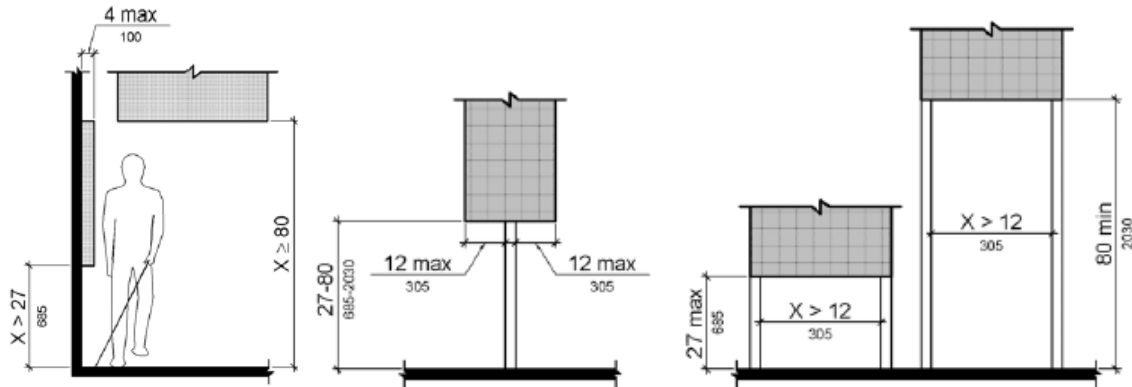
Figure 4-6 – Protruding Objects

A protruding object, as pictured below, are objects that extend out into the accessible route greater than 4" at a height greater 27 and less than or equal to 80", per **ADAAG 307.1**. In addition, a post-mounted object can overhang the circulation path no greater than 12" at a height of 27" to 80", per **ADAAG 307.3**.

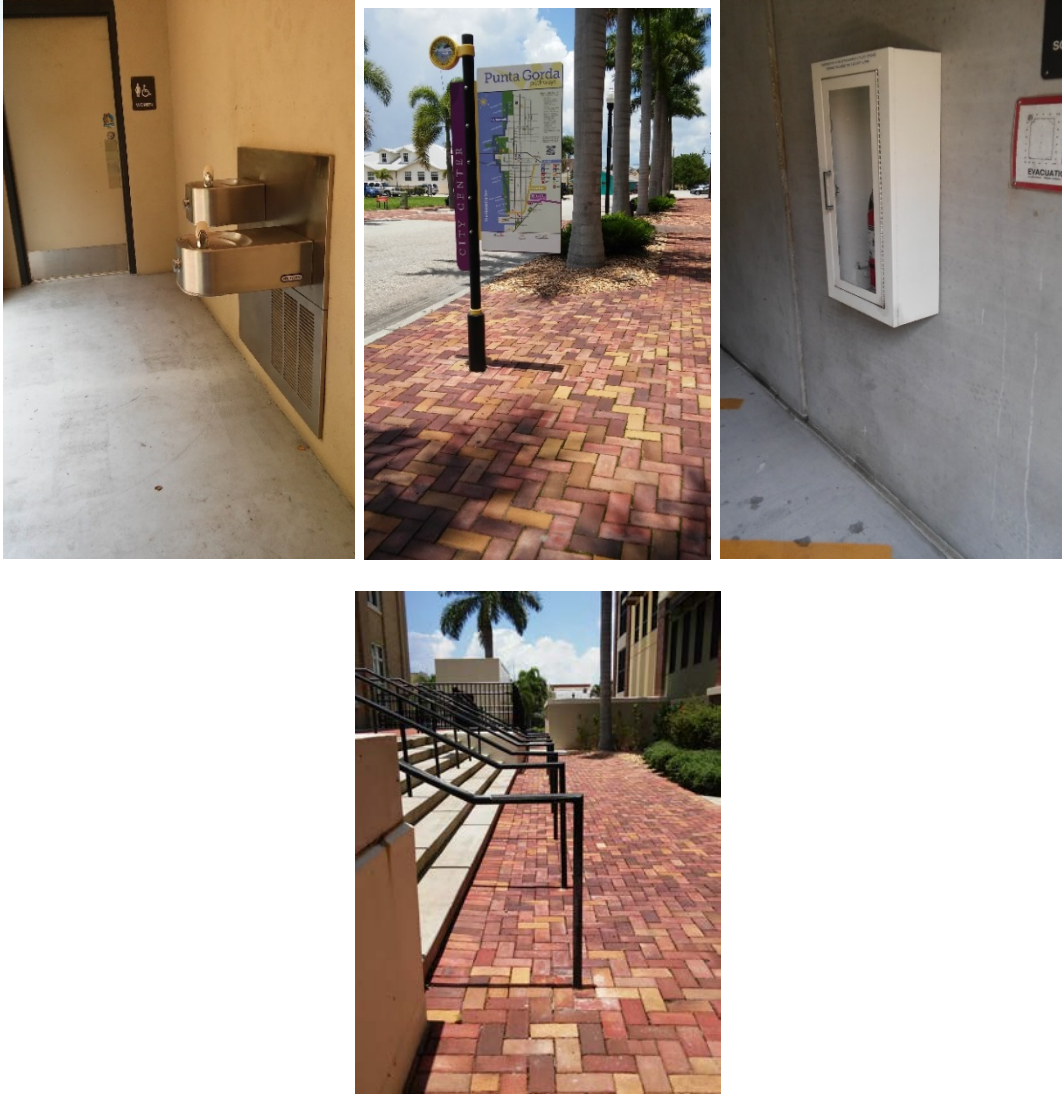
Figure 4-7 – Protruding Objects

- The low water fountains, adjacent to the restrooms on the first floor protrudes from the wall 17” at a height of 27.5”.
- The high water fountains, adjacent to the restrooms on the first floor protrudes from the wall 12” at a height of 34”.
- The pathway sign adjacent to the road protrudes out 24” at a height of 35”.
- The fire extinguisher, located by the southwest stairwell, protrudes out 7” at a height of 33”.
- The handrails leading to the adjacent historic courthouse property, which is owned and maintained by the Charlotte County Board of County Commissioners, protrude out 24” at a height of 36”.

(Note: The handrails shown in the bottom photo are owned and maintained by the Charlotte County BOCC)

- Recess the water fountains or add a cane apron or fountain skirt under them so they do not protrude into the circulation path per **ADAAG 307.2**.
- Relocate the pathway sign so as to be centered on the pole and therefore not protrude beyond 12” on either side of the pole, per **ADAAG 307.3**. Or, extend the sign so that the bottom of the sign is less than 27” above the ground.
- Either relocate the fire extinguisher so that the bottom edge is less than 27” above the ground per **ADAAG 307.2** or add a pipe or a similar barrier below the fire extinguisher box to make it cane detectable.
- Charlotte County BOCC must either shorten the handrail extension to be no more than 12” in length or add an additional section of handrail, parallel to the existing extension connecting to the vertical section at a height no greater than 27”.

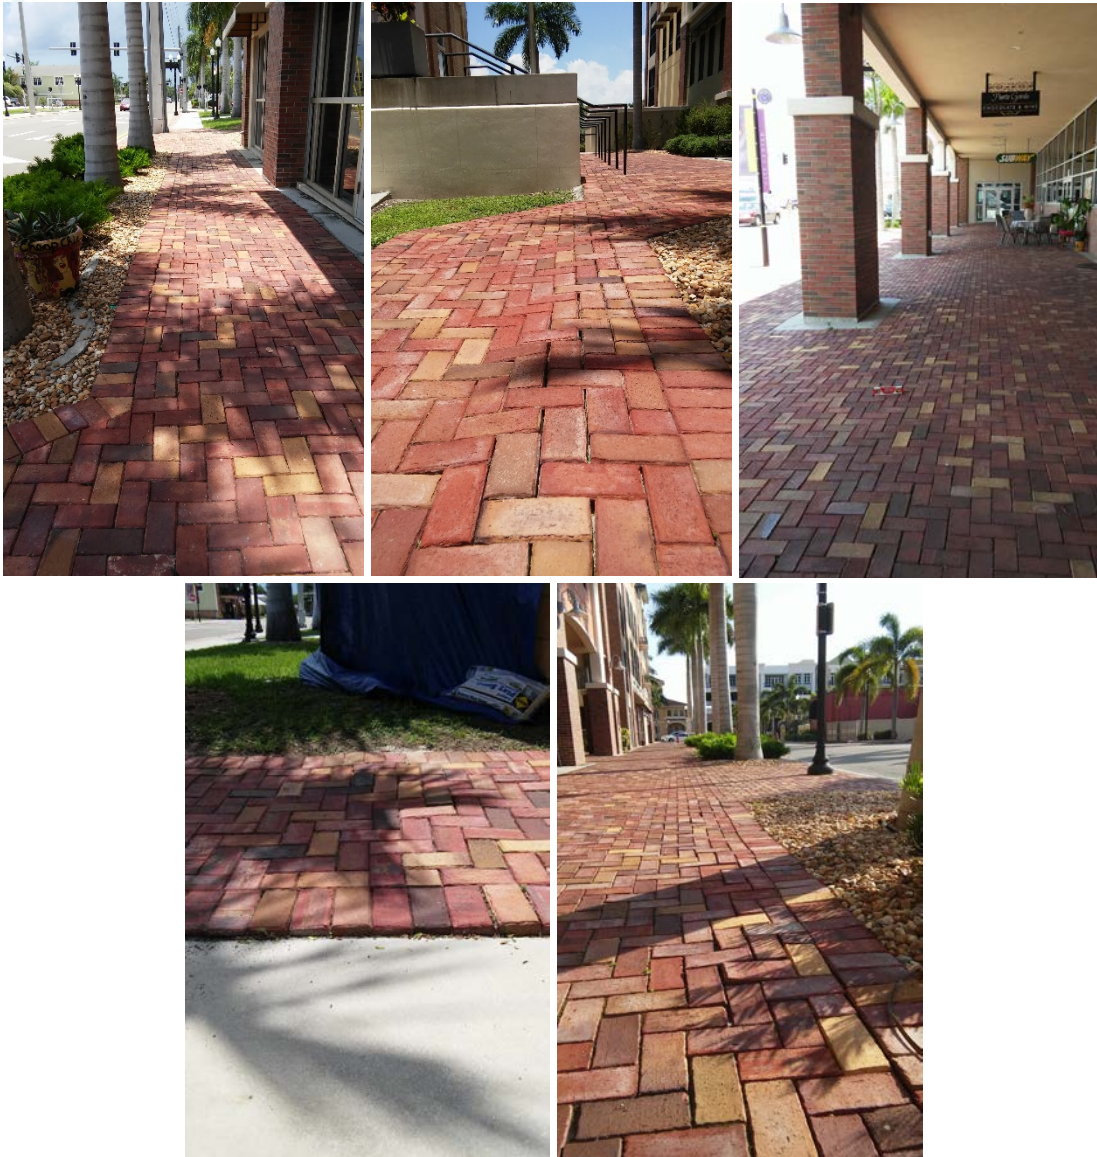
Figure 4-8 – Accessible Route

- The brick walkway, shown in the first photo, on the south side of the parking facility, adjacent to the Artisans store has a cross slope of 6%, violating **ADAAG 403.3**.
- The second photo shows the brick path adjacent to the rear of the courthouse, which has a running slope of 6%, violating **ADAAG 403.3**.
- The third photo, on the north-east side of the facility, adjacent to US-41, has an 8% cross slope, violating **ADAAG 403.3**
- The last two photos show two locations where there are tripping hazards due to the bricks not settling in an even and level manner, , violating **ADAAG 303**.

- Resurface the brick walkway around the perimeter of the parking garage to have a running slope no greater than 5% and a cross slope no greater than 2%, per **ADAAG 403.3**.
 - An accessible route is required to be a minimum of 36" wide and have 60" passing spaces every 200', per **ADAAG 403.5.1** and **ADAAG 403.5.3**. While it is not required that the entire width of the walkway be of compliant slope, at its current configuration it is difficult for people to distinguish where it is safe to traverse and where there are barriers to accessibility.
- Resurface any tripping hazards so they are no higher than 0.25" high or 0.5" high if beveled, per **ADAAG 303**.
