CITY OF PUNTA GORDA ADA TRANSITION PLAN FINAL REPORT Laishley Marina

October 4, 2017

City of Punta Gorda 326 West Marion Avenue Punta Gorda, Florida, 33950

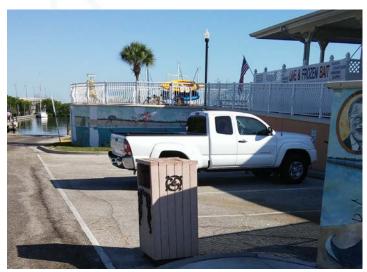
Figure 4-2 - Parking Spaces by Boat Launch

This temporary parking area serves the marina and boat launch along a closer and more direct route than the general accessible parking area located in front of the larger building, however, there is no accessible parking space in this section of the lot, violating §208.3.1.

- Restripe/repave two of the spaces, closest to the marina entrance, so that there
 is at least one level accessible space with an access aisle in this area of parking.
 Restripe the remaining spaces as necessary to ensure proper width is given to
 the accessible space.
 - The width of the parking space shall be 12' wide, the width of the access aisle shall be 5' wide.
- Install accessible signage at this space compliant with §502.6, including a sign
 that states the fine for parking illegally in an accessible space as well as stating
 that this space is van accessible.

Create an accessible route from the new access aisle to the surrounding amenities.

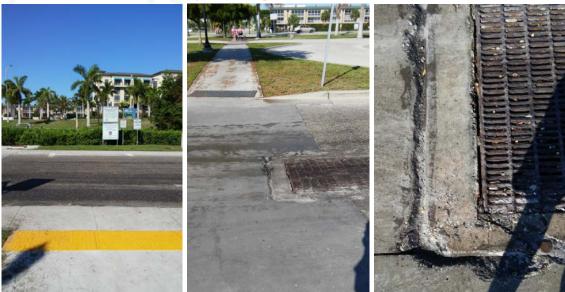
Figure 4-5 – Two Crosswalks across Drive Aisle for Boat Launch

- Both crosswalks across the boat launch access aisle are faded and not visible.
- The western side of the crosswalk across the boat launch is missing a detectable warning surface, violating §406.8.
- There is a 2" gap between the asphalt concrete crosswalk and the concrete inlet located in the drive aisle, violating §302.3.

- Stripe the crosswalks leading across driveway access to the boat launch.
- Install one detectable warning surface on the curb ramp to the west side of the crosswalk leading across the boat launch, closest to the water.
- Re-pave the area around the drainage grate in the crosswalk further from the water so that it is flush and smooth with the concrete crosswalk area surrounding the grate.

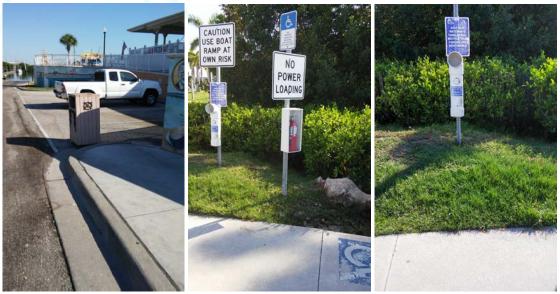
Figure 4-6 - Amenities by Boat Launch

- The trash can near the boat launch is placed in the parking lot and would not be in reach range for someone approaching it from the sidewalk.
- The fire extinguisher and fishing line return are placed on poles in a nonaccessible surface.

- Relocate the trash can onto a level area so that it can be reached from the sidewalk/accessible route.
- Relocate the fire extinguisher to be within 10 inches of a level portion of the sidewalk.
- Relocate the fishing line return to be within 10 inches of a level portion of the sidewalk, making sure the return section of the PVC pipe is a maximum of 48 inches above the ground.

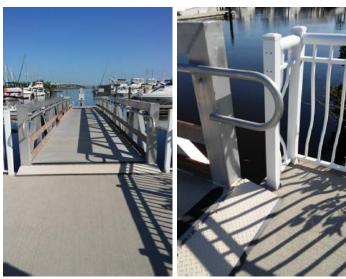
Figure 4-8 - Top of Gangway to Boat Slips

- As shown in Figure 4-7, the concrete ramp spurring off from the Harborwalk, leading to the gate, has handrails for the last 8 feet closest to the gate, however, is missing handrails for the first 16 feet of the ramp, violating §505.2.
- The transition plate at the top of the gangway, shown in Figure 4-8, has a slope of 20% for a rise of about 2.5", exceeding the maximum allowable slope of 8.3%, violating §405.2.

- Install 16' of handrails, complying with §505, along the concrete ramp leading to the gate.
- Replace the transition plate at the top of the gangway with a longer plate so that the slope is no greater than 8.3%.

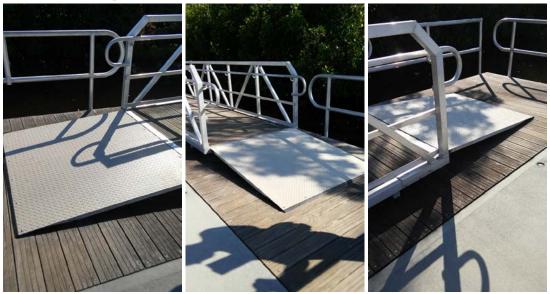
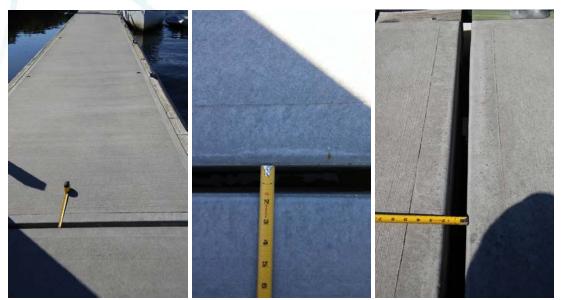
Figure 4-9 - Gangway and Transition Plates at Ends of Floating Dock along Harborwalk

Figure 4-10 - Floating Dock along Harborwalk

- Both the transition plates leading to the pier extend approximately 5' long and over 6" high, with no handrails or edge protection on the outside of the transition plate, allowing the potential for a person using a wheelchair to fall off the plate, violating §405.8 and §405.9.
- The expansion joints between the concrete platforms on the floating dock have a 1.5" to 2" gap, violating §302.3.

- Install handrails, complying with §505, and edge protection, complying with §405.9, onto the two transition plates leading from the gangways on either side of the floating platform.
- Fill the 7 joints along the floating dock with concrete expansion joint fill material.

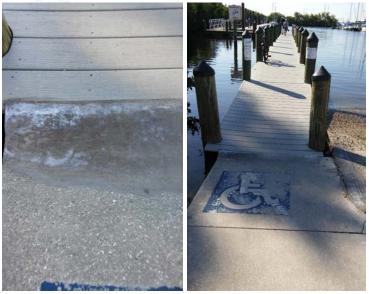
Figure 4-11 - Entrance to Boat Launch - Marked with ISA

- The concrete lip connecting the sidewalk to the pier has a max running slope of 14% and a cross slope of 4%, violating §403.3.
- The dock is sloped at 10% for 10', exceeding the max running slope for a ramp, violating §405.2.

Reconstruct this sloped portion of the dock so that it extends at least an additional 2' over the concrete sidewalk, achieving a max running slope of 8.33%.

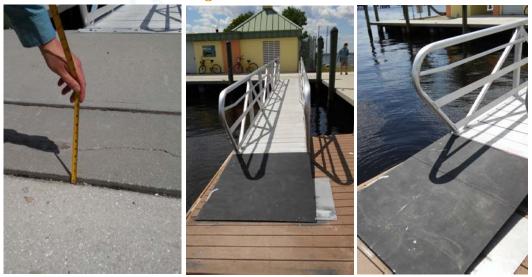
Figure 4-12 - Gangway and Transition Plate Leading to Single Floating Boat Slips

- The concrete dock at the top of the floating dock's gangway has a joint with a vertical change in level of 1", violating §303.4.
- The cross slope of the gangway is 4%, violating §403.3.
- The transition plate extends over 5' long and over 6" high, with no handrails or edge protection the outside of the transition plate, allowing the potential for a person using a wheelchair to fall off the plate, violating §405.8 and §405.9.

- Correct the joint along the dock by installing a ramped transition that will allow the 1" change in level to be sloped to 8.33% or less.
- Inspect the gangway and the floating dock for the reason the cross slope is at 4% and look to correct it.
 - This may involve resetting or adjusting the gangway, or it could involve correcting the floating dock.
- Add handrails, complying with §505, and adequate edge protection, compliant with §405.9, to both sides of the transition plate.

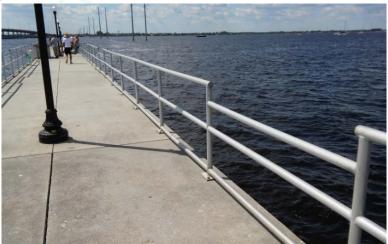
Figure 4-15 - Fishing Areas

• The regular railing height is 42", however, every 30' there are 34" high accessible railings for a width of 6'. This means that about 20% of the railings that are able to be fished from are accessible. The code requires 25% to be accessible, thus this violates §1005.2.1.

• The current arrangement is nicely dispersed, offers plenty of options and locations for fishing, however, it is not technically compliant due to the percentage of railing space that should be lowered. It's not likely to generate any complaints in its current arrangement, however, to become technically compliant at 25% the City must lower approximately an additional 25' of railing on each side of the pier to a maximum height of 34".

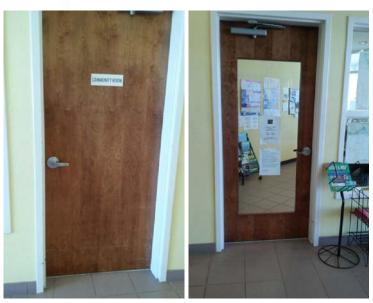
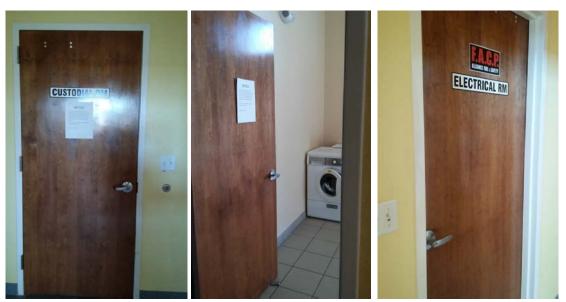
Figure 4-17 - Signage for Public Rooms - Community Room and Dock Master's Office

Figure 4-18 – Signage for Restricted Rooms - Custodial Room, Electrical Room and Laundry Room

All permanent rooms in the building, including the Community Room, Dock Master's Room, Custodial Room, Electrical Room, Laundry Room and others, are all missing appropriate tactile signage identifying the room, violating §216.2.

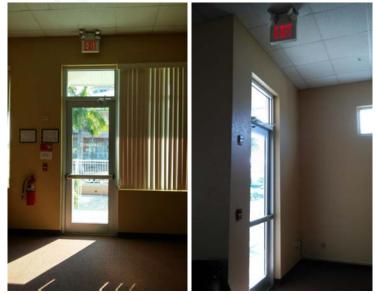
Figure 4-19 - Emergency Exits

The emergency exits from the building are not identified with tactile signage, violating §216.4.1.

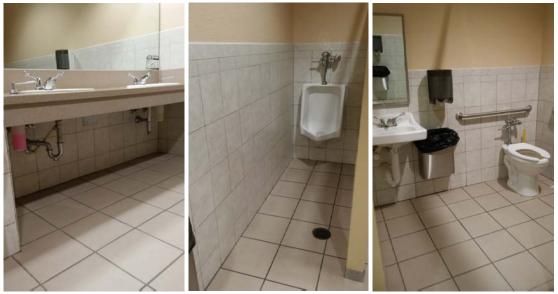
Figure 4-20 - Restrooms

Summary: There are two restrooms in the marina building, one public male restroom and one public female restroom. The Men's restroom was assessed and only minor issues were found that can be fixed with little effort. The woman's room is similar and also only has minor issues.
