CITY OF PUNTA GORDA ADA TRANSITION PLAN FINAL REPORT

Laishley Park

October 4, 2017

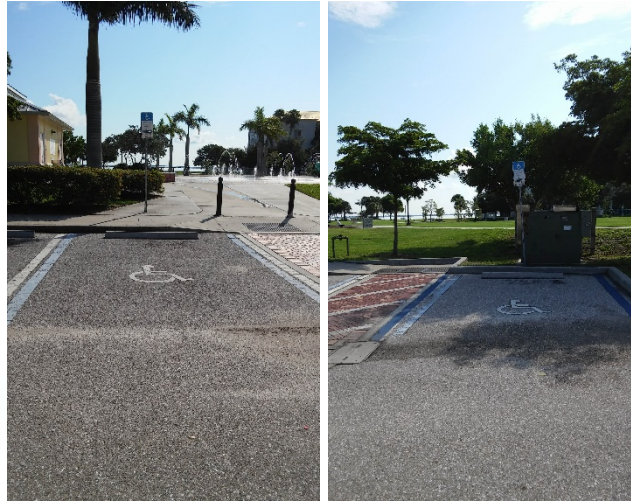
Figure 4-1: Accessible Parking Spaces

- The northern-most accessible parking space, located adjacent to the park's restrooms, has a running slope of 2.5% at the top of the access aisle, violating **ADAAG 502.4**, which states "Slopes not steeper than 2% shall be permitted within (Accessible) parking spaces and access aisles serving them."
- The southern-most accessible parking space, has a running slope of 2.5% at the bottom of the parking space, violating **ADAAG 502.4**, which states "Slopes not steeper than 2% shall be permitted within (Accessible) parking spaces and access aisles serving them."

- Resurface the access aisle and accessible parking space so that the running and cross slopes are no greater than 2%.

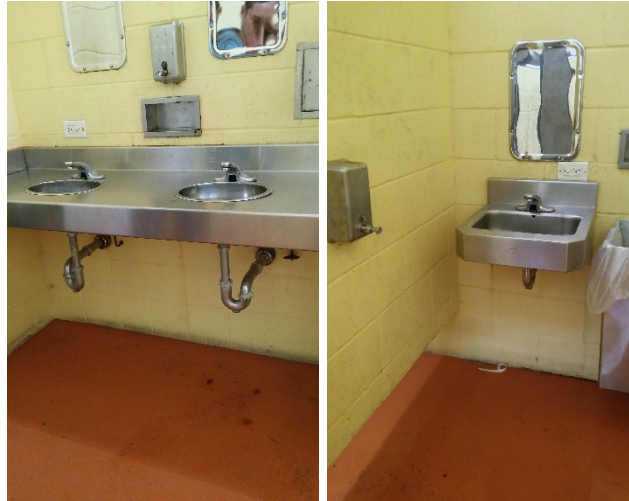
Figure 4-2: Pedestrian crossings

- The sinks in the main section of the restroom as well as the one in the accessible stall have exposed pipes, violating **ADAAG 606.5** which states “Water supply and drain pipes under lavatories and sinks shall be insulated or otherwise configured to protect against contact.”
- The soap dispenser located in the main section of the restroom is located 50” high, violating **ADAAG 308.2.1** which states “The high forward reach shall be 48” maximum ... above the ground.”
- The toilet in the accessible stall is located 18.5” from the side wall and 19.5” from the ground, violating **ADAAG 604.2** which states “The centerline of the water closet shall be 16” minimum to 18” maximum from the sidewall.” **ADAAG 604.4** states that “The seat height of a water closet above the finish floor shall be 17” minimum and 19” maximum.”

- Cover the pipe to all the sinks to protect people in wheelchairs from scraping their legs on the sharp edges.
- Lower the soap dispenser to a height of 48” maximum above the floor.
- Relocate the toilet so that it is centered between 16” and 18” from the sidewall and that the seat is no more than 19” high above the floor.
 - American Standard has a patented toilet design, called Access Pro, that allows the toilet to be shifted up to 3.5” in either direction without relocating the drain or flange.

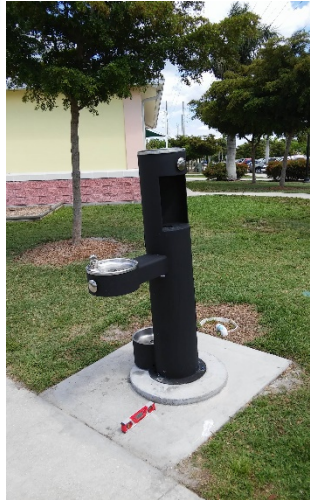
Figure 4-3 – Waterfountains

This water fountain has a ground level fountain for pets, a mid-level fountain with a spout height of 36" and a bottle refill station with a button located 51" high. In addition, the slope of the pavement adjacent to the water fountain has an 11% slope.

ADAAG 211.2 states that "No fewer than two drinking fountains shall be provided. One drinking fountain shall comply with **ADAAG 602.1** through **ADAAG 602.6** and one drinking fountain shall comply with **ADAAG 602.7**."

ADAAG 305.2 and **305.3** generally state that "The clear floor space shall be a minimum of 30" by 48" with slopes no greater than 2%."

ADAAG 308.2.1 states that "The high forward reach shall be 48" maximum ... above the ground."

ADAAG 602.4 states that "Spout outlets shall be 36" maximum above the finished floor."

ADAAG 602.7 states that "Spout outlets of drinking fountains for standing persons shall be 38" minimum and 43" maximum above the finished floor."

- Adjust the slope of the adjacent pavement so that a clear and level floor space is available to patrons using the fountains.
- Add a second drinking fountain nearby that has a spout outlet 38" to 43" above the floor.

- Either adjust the height of the water bottle refill station or add a secondary water bottle refill station that has a button located a maximum of 48" above the ground.

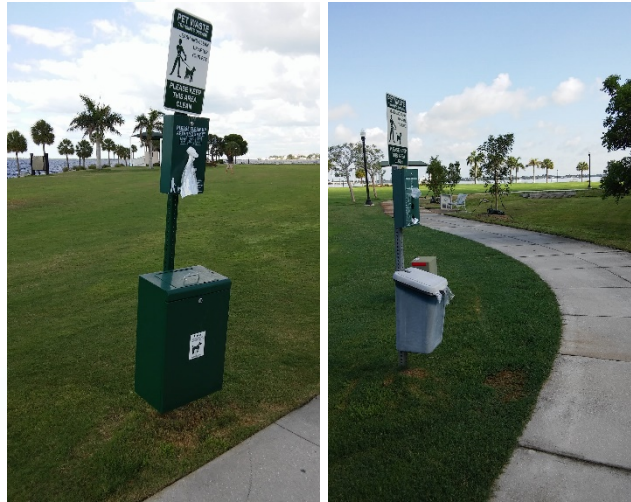
Figure 4-4 – Dog Stations

Two dog stations were found to have barriers to accessibility. One was located too far from the paved trail to be accessible. The other had its doggy bags located 56" high from the ground, too high and far to be reached by a person in a wheelchair.

ADAAG 308.3 states that, “Where a clear floor space allows a parallel approach to an element, the high side reach shall be 48” maximum above the ground... An obstruction shall be permitted between the clear floor space and the element where the depth of the obstruction is 10” maximum.”

- Relocate the dog stations/doggy bags to be no more than 48” above the ground and no more than 10” from the edge of the sidewalk.

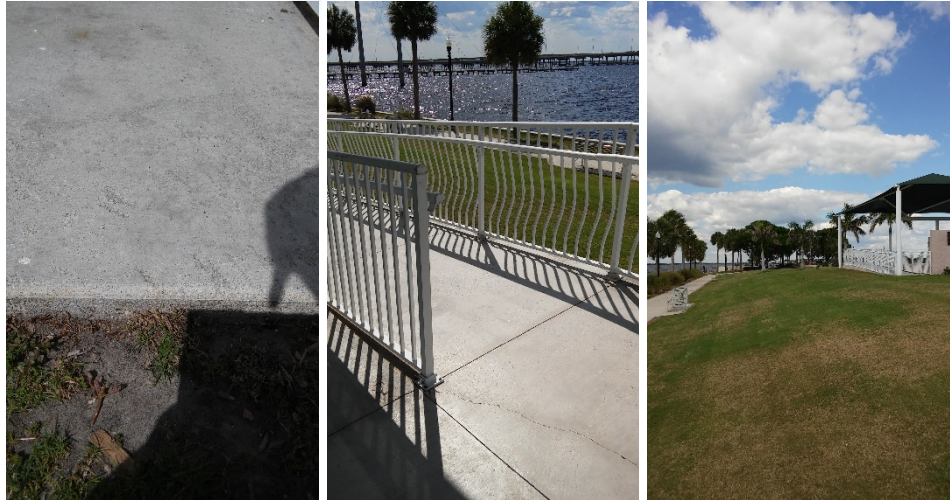
Figure 4-5 – Ramp to Stage

- There is no accessible connection to the stage **ADAAG 302.1**.
 - To access the stage, a visitor needs to either traverse approximately 125' of the Laishley Park great lawn, violating or, make their way over 40' of grass and an embankment that has a running slope of approximately 30%.
 - In addition, there is a 1.5" lip between the cement ramp and the adjacent grass/dirt.
- The south handrail, at the top of the ramp, does not have a handrail extension, violating **ADAAG 505.10**.

ADAAG 302.1 states that, "Floor and ground surfaces shall be stable, firm, and slope resistant."

ADAAG 505.10 states that, "Tamp handrails shall extend horizontally above the landing for 12 inches minimum beyond the top and bottom of the ramp runs."

- Connect the stage's ramp to an accessible route that in turn connects to the accessible parking. This can either be accomplished by paving a route from the southwest for a distance of approximately 125' or by paving a series of switchback ramps from the north.
- Extend the handrail at the top of the stage's ramp to include a 12" minimum handrail extension.

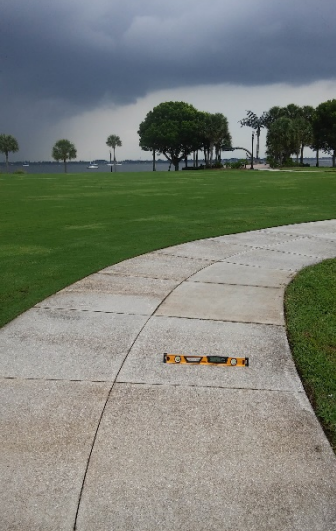
Map Item	Description & Recommendation	Photo(s)
<p>C1</p>	<p>3.3% cross slope – Resurface so the cross slope is no greater than 2%</p>

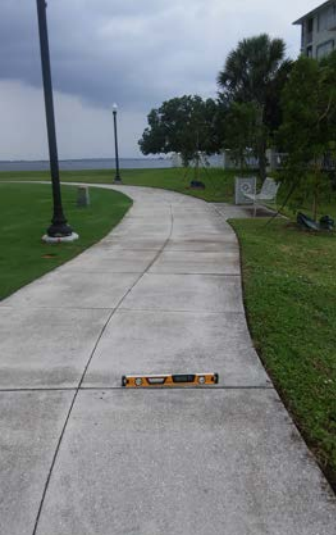
<p>C2</p>	<p>3.5% cross slope – Resurface so the cross slope is no greater than 2%</p>

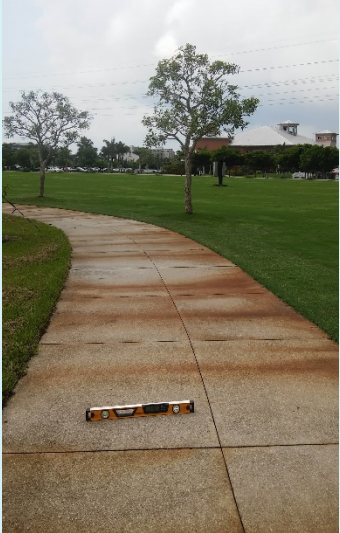
Map Item	Description & Recommendation	Photo(s)
<p>C3</p>	<p>2.6% cross slope – Resurface so the cross slope is no greater than 2%</p>

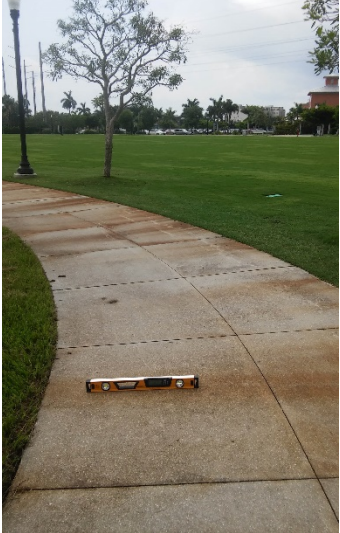
<p>C4</p>	<p>2.1% cross slope – Resurface so the cross slope is no greater than 2%</p>

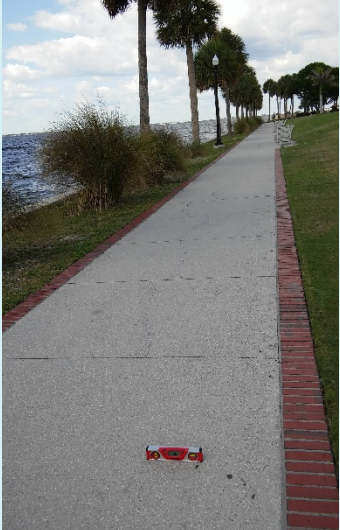
<p>C5</p>	<p>3.0% cross slope – Resurface so the cross slope is no greater than 2%</p>

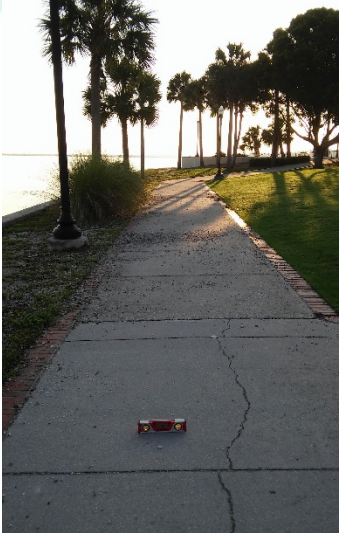
Map Item	Description & Recommendation	Photo(s)
C6	4.0% cross slope – Resurface so the cross slope is no greater than 2%

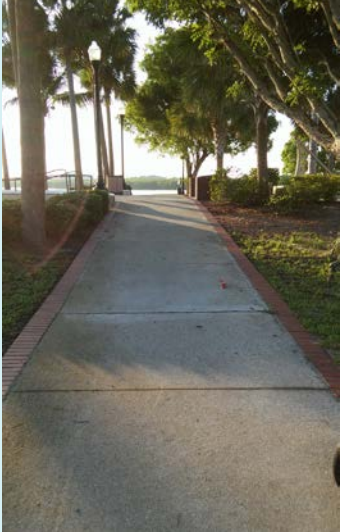
R1	8.5% running slope –Resurface the walkway to have a slope no greater than 8.3% and reconstruct it as a ramp with handrails and landings, per ADAAG 405.

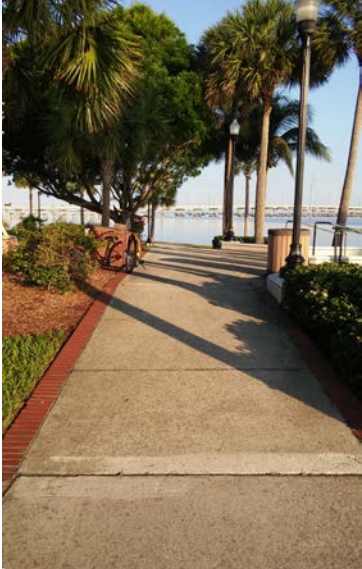
Map Item	Description & Recommendation	Photo(s)
<p>R2</p>	<p>6.5% to 8.4% running slope –Resurface the walkway to have a slope no greater than 8.3% and re-construct it as a ramp with handrails and landings, per ADAAG 405.</p>

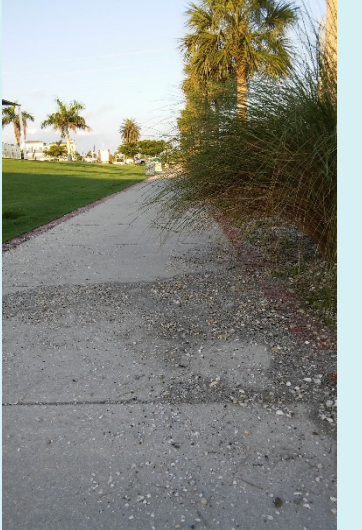
<p>M1</p>	<p>Unstable surface with lots of crushed shells on the path – Maintain the pathway so there is not a buildup of debris, possibly caused by a drainage issue. This debris causes the surface of the pathway to not be firm, stable, and slip resistant.</p>

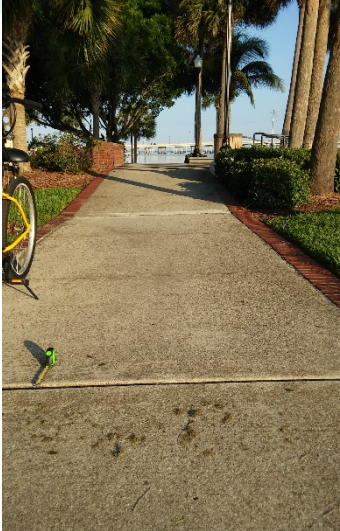
Map Item	Description & Recommendation	Photo(s)
<p>M2</p>	<p>1" gap in cement slabs – Fill in the gap so that the clearance is no greater than 0.5”.</p>
