Punta Gorda

CITY OF PUNTA GORDA ADA TRANSITION PLAN FINAL REPORT US 41 MULTI-USE RECREATION TRAIL

October 5, 2017

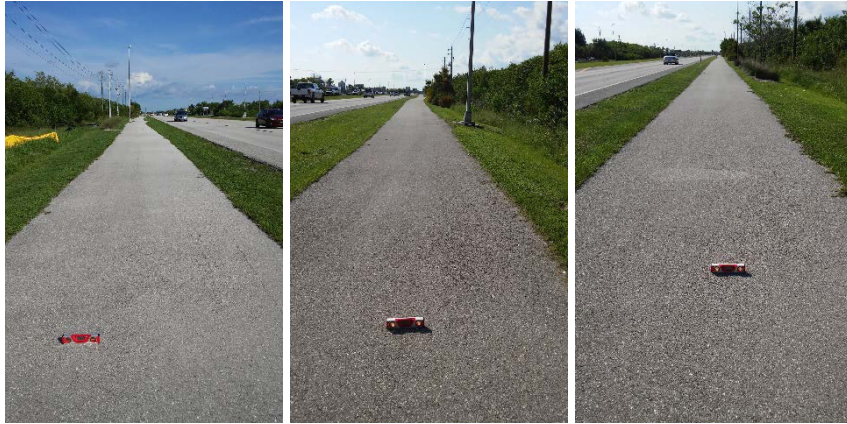
Figure 4-1 – Select locations with non-compliant cross slopes.

Per **ADAAG 403.3**, the cross (perpendicular) slope of a walking surface shall not be steeper than 2%. As such, 3 segments of the US 41 multiuse trail were found to have slopes in excess of this requirement, as shown in the photos below and detailed in Appendix A for a combined linear distance of approximately 2,150 feet.

The locations that have non-compliant cross slope must be resurfaced so that the cross slope does not exceed 2%, as specified in **ADAAG 403.3**.

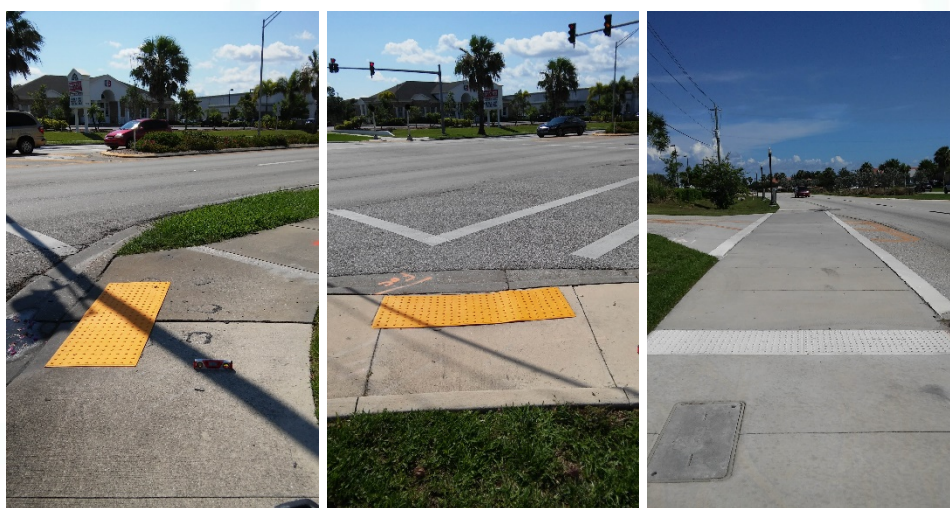
Figure 4-2 - Curb ramps and detectable warning surfaces along the multi-use trail.

Shown below, in Figure 4-2, are three curb ramps that are not ADA compliant. Issues include non-compliant slopes, detectable warnings not securely fastened, and detectable warnings that are not high contrast, respectively. A map detailing the locations of these barriers to accessibility is shown in Appendix A.

ADAAG 405.2 states that, “(Curb) ramp runs shall have a running slope not steeper than 8.33%”.

ADAAG 406.4 and **ADAAG 405.7.1** states that “Landings shall be provided at the top of curb ramps.” and “Slopes shall not be steeper than 2%.”

ADAAG 705.1.3 states that, “Detectable warning surfaces shall contrast visually with adjacent walking surfaces either light-on-dark, or dark-on-light.”

- Resurface the curb ramp so that the slope is not steeper than 8.33%. In addition, the landing at the top of the ramp shall be no steeper than 2% in any direction.
- Replace detectable warning surface that is coming unglued, and secure properly.
- Replace white detectable warning surface with a high contrast color.

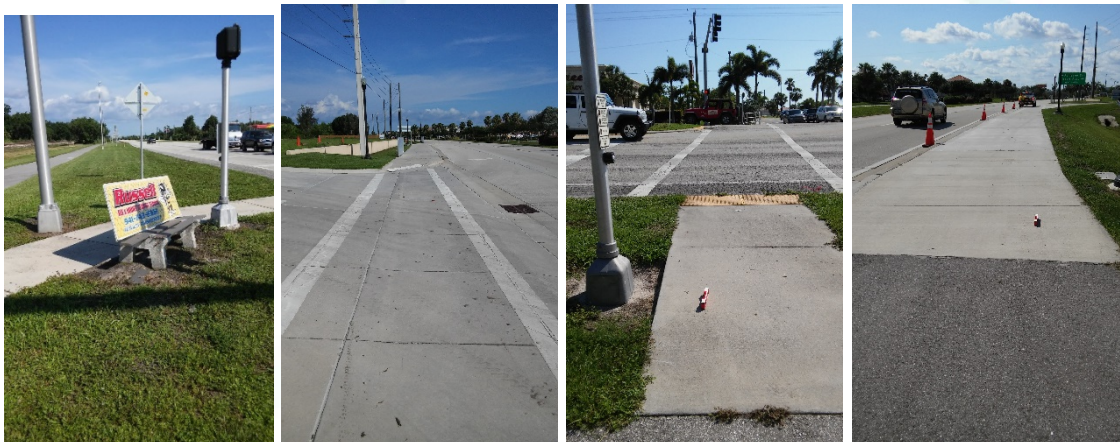
Figure 4-3 – Miscellaneous Barriers to Accessibility along the US-41 Trail

- The bench, which is part of Charlotte County’s ad bench program, does not have a clear floor space adjacent to it or an accessible route connecting to it thereby making it not accessible.

- **ADAAG 302.1** states that, “Floor and ground surfaces shall be stable, firm, and slip resistant.”
 - **ADAAG 305.3** states that, “The clear floor or ground space shall be 30 inches minimum by 48 inches minimum.”

- The Crosswalk has cross slopes in excess of 10%, violating **ADAAG 403.3**, which states “The cross slope of a walking surface shall not be steeper than 2%.”

- The slope at the pedestrian push button is 6.5%, violating **ADAAG 305.2**, which states “Slopes not steeper than 2% shall be permitted.”
- The pavement connecting the asphalt portion of the trail to the cement portion of the trail has a running slope of 7%, violating **ADAAG 403.3**, which states “The running slope of a walking surface shall not be steeper than 5%.”

- Remove the non-accessible bench or pave a clear and level accessible route to it so it is accessible to all users of the multi-use trail.
 - The accessible route to the bench shall be a minimum width of 36”, not have a cross slope of more than 2%, not have a running slope of more than 5%, and have a clear and level turning space at end point.
 - Since this bench is part of the County’s ad bench program, City action regarding this bench is subject to County approval.
- Regrade the crosswalk so that the cross slopes do not exceed 2%.
- Regrade the clear floor space adjacent to the pedestrian push button so the slope is not steeper than 2% in any direction.
- Regrade this portion of the trail so the running slope is not steeper than 5%.

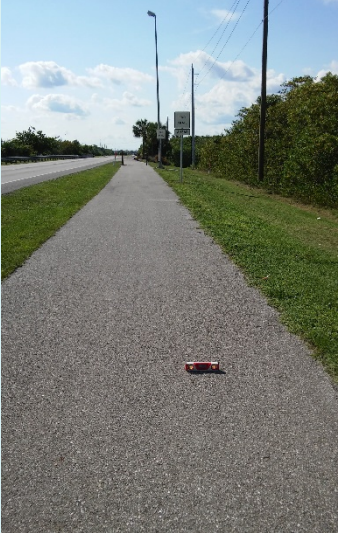
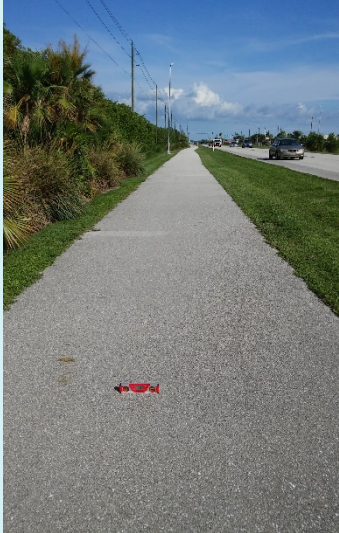
Map Item	Description & Recommendation	Photo(s)	
<p>C1</p>	<p>A cross slope exceeding 2% and up to 4.5% was measured at this section of multi-use trail.</p> <p>Resurface the multi-use trail so that the cross slope does not exceed 2%, per ADAAG 403.3.</p>

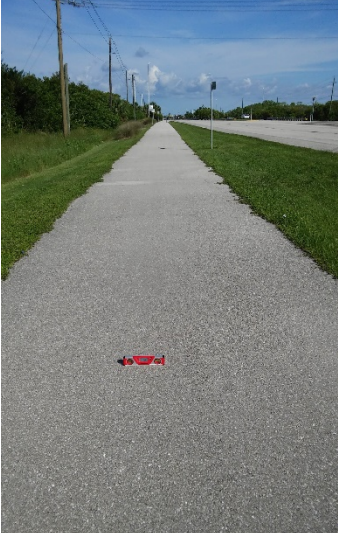
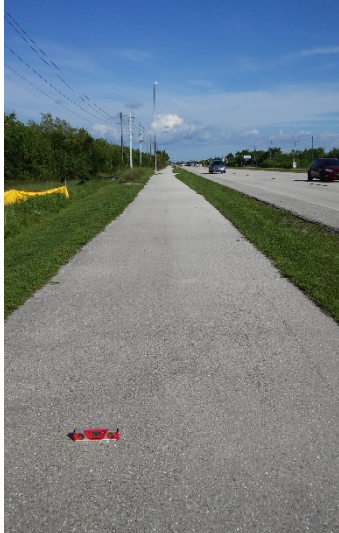
<p>C2</p>	<p>A cross slope exceeding 2% and up to 4.6% was measured at this section of multi-use trail.</p> <p>Resurface the multi-use trail so that the cross slope does not exceed 2%, per ADAAG 403.3.</p>

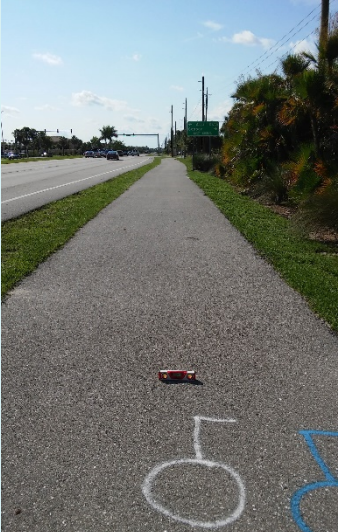
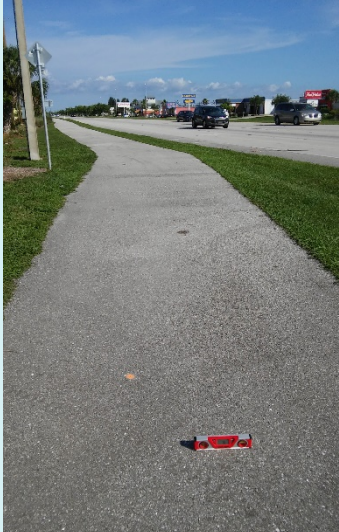
<p>C3</p>	<p>A cross slope exceeding 2% and up to 2.4% was measured at this section of multi-use trail.</p> <p>Resurface the multi-use trail so that the cross slope does not exceed 2%, per ADAAG 403.3.</p>

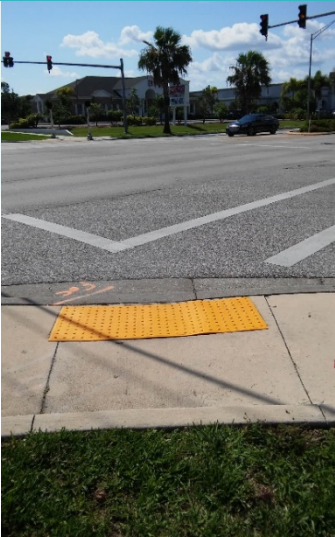
Map Item	Description & Recommendation	Photo(s)
<p>D1</p>	<p>The detectable warning is not securely fastened to the curb ramp and therefore may present a tripping hazard.</p> <p>Securely fasten the detectable warning.</p>

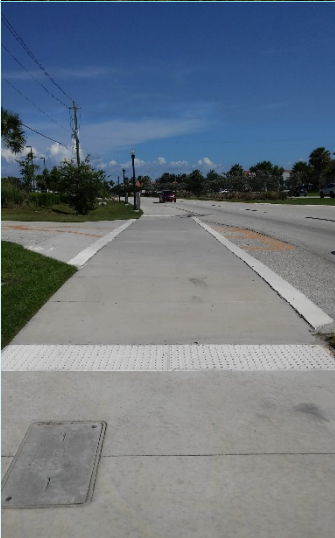
<p>D2</p>	<p>The white detectable warning is not high contrast when placed on cement.</p> <p>Replace the existing white detectable warning with a yellow or red detectable warning.</p>

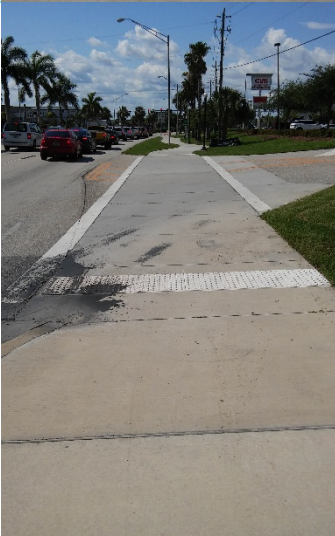
<p>D3</p>	<p>The white detectable warning is not high contrast when placed on cement. In addition, a portion of the detectable warning is located within the vehicular driveway.</p> <p>Replace the existing white detectable warning with a yellow or red detectable warning. Relocate the detectable warning so that it is not within the driveway's vehicular right-of-way.</p>

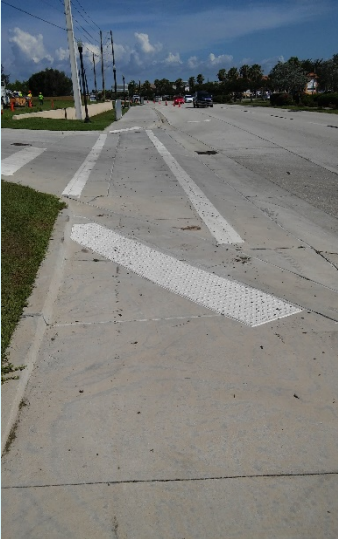
Map Item	Description & Recommendation	Photo(s)
<p>D4</p>	<p>The white detectable warning is not high contrast when placed on cement.</p> <p>Replace the existing white detectable warning with a yellow or red detectable warning.</p>

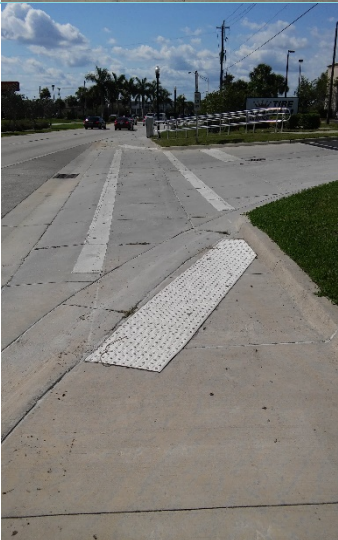
<p>D5</p>	<p>The white detectable warning is not high contrast when placed on cement.</p> <p>Replace the existing white detectable warning with a yellow or red detectable warning.</p>

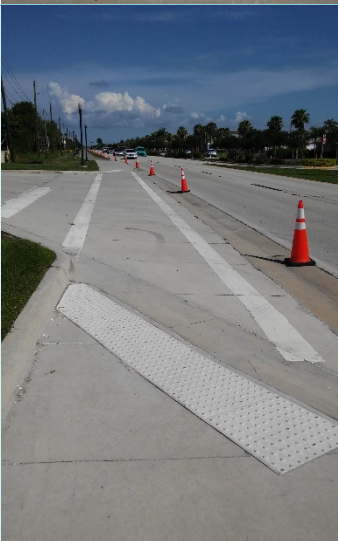
<p>D6</p>	<p>The white detectable warning is not high contrast when placed on cement.</p> <p>Replace the existing white detectable warning with a yellow or red detectable warning.</p>

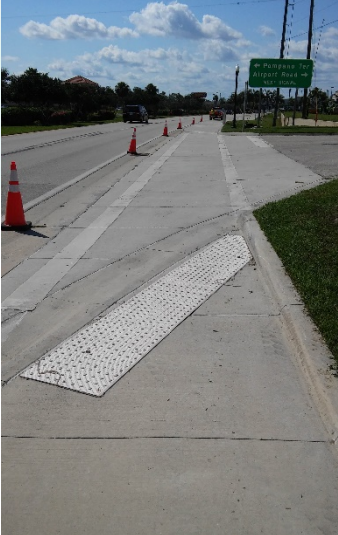
Map Item	Description & Recommendation	Photo(s)
<p>D7</p>	<p>The white detectable warning is not high contrast when placed on cement.</p> <p>Replace the existing white detectable warning with a yellow or red detectable warning.</p>

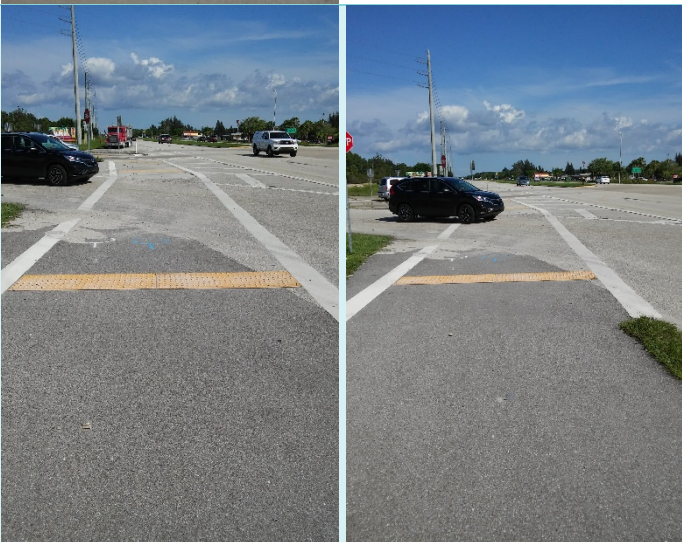
<p>D8</p>	<p>A portion of the detectable warning is located with the cross-street.</p> <p>Relocate the detectable warning further back so that it is not within the street.</p>

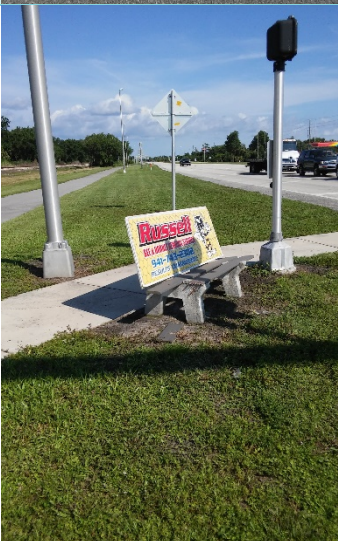
<p>M1</p>	<p>The 3rd party bench is not accessible.</p> <p>Remove or relocate the bench.</p>

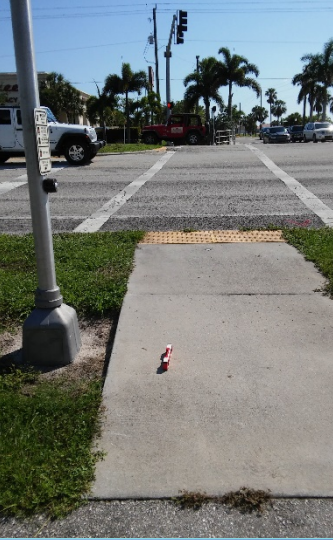
Map Item	Description & Recommendation	Photo(s)
<p>M2</p>	<p>There is a 6.5% running slope at pedestrian push button.</p> <p>Either relocate the pedestrian push button to a location with a clear and level floor space or resurface a 30"x48" section of pavement adjacent to the pedestrian button to be level in all directions. Lastly, repave the 6.5% ramp to have a slope no greater than 5%.</p>

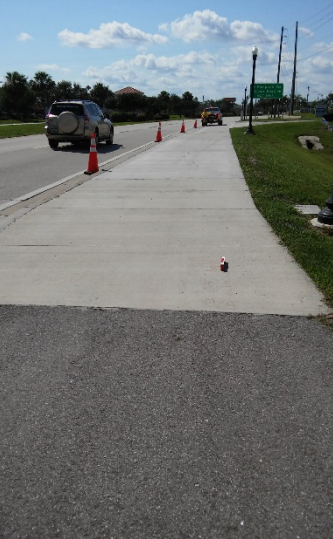
<p>M3</p>	<p>There is a 7% running slope at the section where the cement transitions to asphalt.</p> <p>Extend the transition so that the running slope is no greater than 5%.</p>

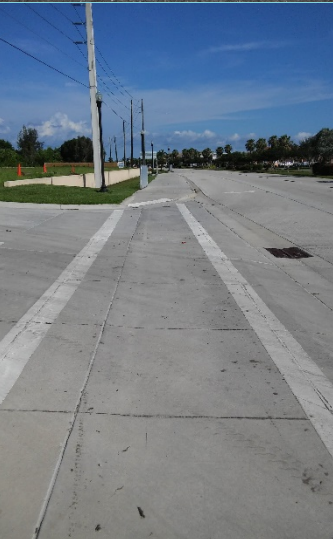
<p>M4</p>	<p>The crosswalk has a cross slope of up to 10%, violating ADAAG 403.3.</p> <p>The accessible route must have a cross slope no greater than 2% for a minimum width of 36". Either repave the driveway or relocate the crosswalk to a level location.</p>
