# **CITY OF PUNTA GORDA**

## **ADA TRANSITION PLAN FINAL REPORT**

### **Hounds on Henry Dog Park**

October 4, 2017

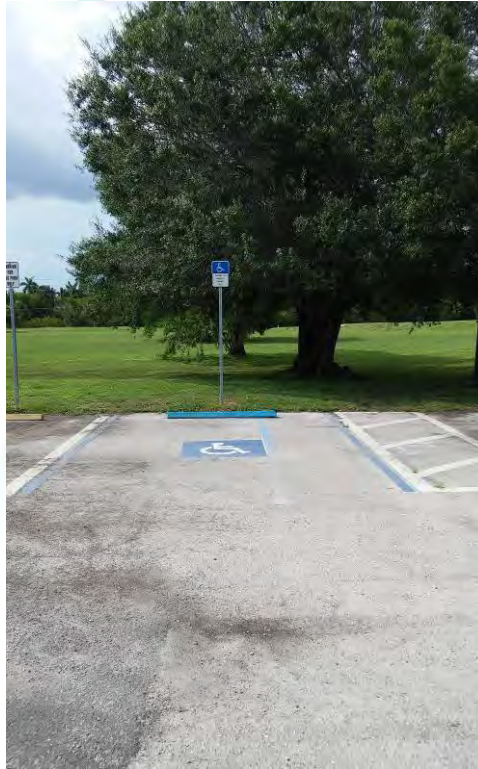
**Figure 4-1 – Accessible Parking Space**

One (1) accessible parking space is provided among the 49 total parking spaces. As such, several deficiencies exist in terms of requirements for accessible parking.

**ADA 208.2** states that, for between 26 to 50 total parking spaces, a minimum of 2 are required to be an accessible parking space.

**ADAAG 208.2.4** states that, "For every six or fraction of six (accessible) parking spaces required... at least one shall be a van parking."

**ADAAG 502.6** states that, parking space identification shall include the International Symbol of Accessibility. Signs identifying van parking spaces shall contain the designation "van accessible". The sign must also have the caption "Parking by Disabled Permit Only" and include the penalty for illegal use.

It is recommended to re-stripe a non-accessible parking space to create an additional accessible parking space with an adjacent aisle. The parking space and aisle must be marked and have appropriate signage to be in full compliance with the ADA and FAC. The parking space and level must have a slope no greater than 2% in any direction. At least one of the two accessible parking spaces shall have a sign designating it as being van accessible. Both accessible parking spaces must have signage indicating the penalty for illegal use.

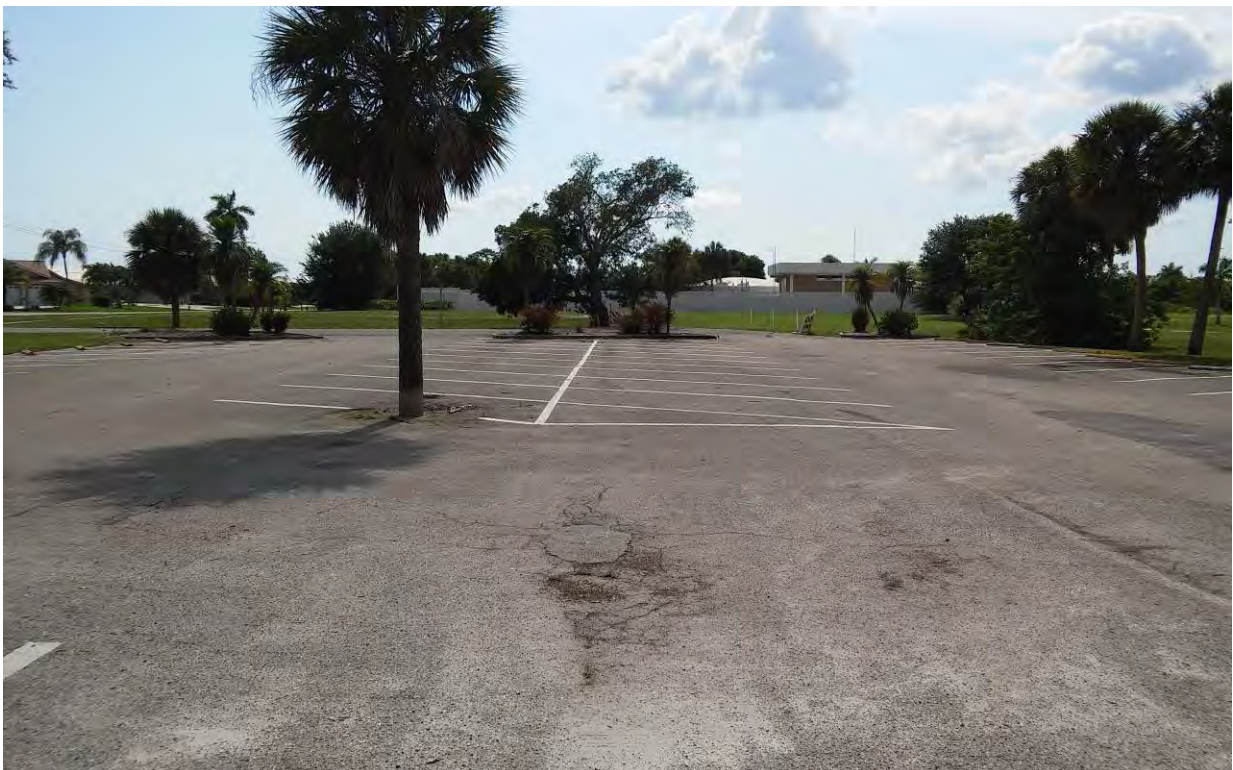
**Figure 4-2 - Parking Area**

Parking spaces are provided for use by patrons of the Hounds on Henry dog park. The surface parking lot is located on the west side of the park, and is accessed via a driveway from West Henry Street.

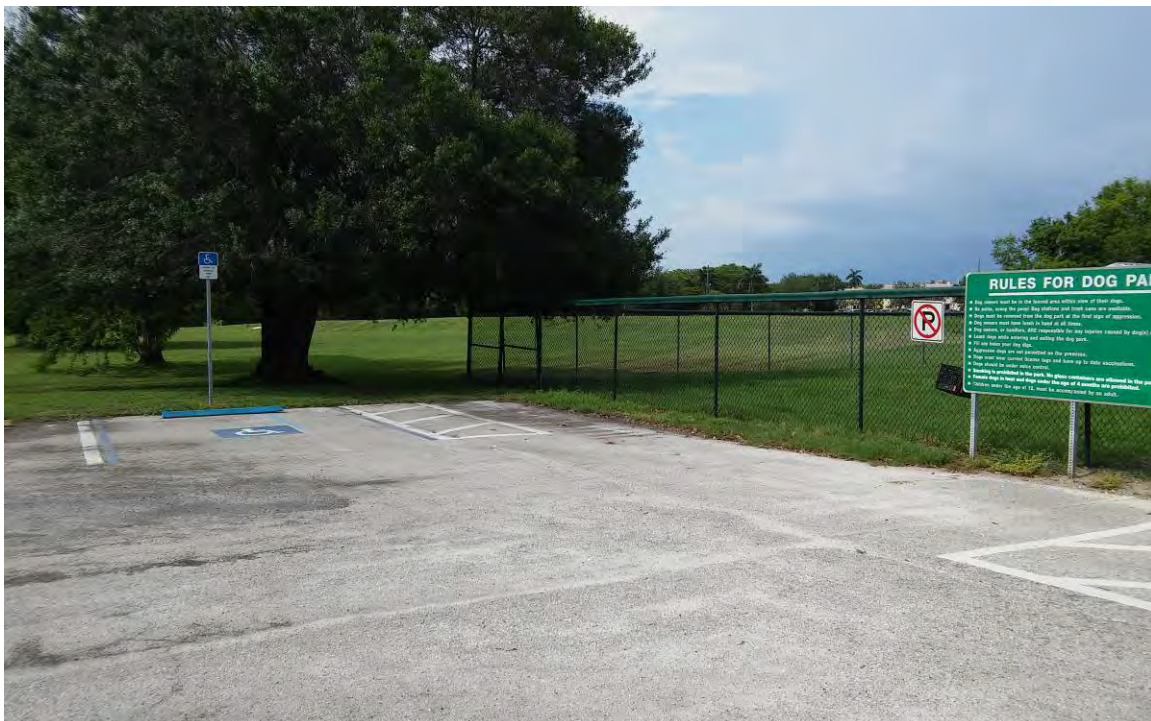
Figure 4-3 – Access aisle and accessible route

The access aisle, adjacent to the existing accessible parking space, shown in Figure 4-3, ends and does not connect to the accessible route leading to the park's entrance. In addition, a portion of the asphalt adjacent to the park's gate, shown in Figure 4-4, is a tripping hazard.

**FAC 502.3** states that, "Accessible routes must connect parking spaces to accessible entrances. In parking facilities where the accessible route must cross vehicular traffic, marked crossing enhance pedestrian safety."

It is recommended that the existing access aisle as well as the access aisle for the additional proposed accessible parking space be striped in such a way as to have them connect to the park's entrance. In addition, the access aisle should be striped so it does not compel users to walk or wheel behind parked vehicles that are not their own. The section of pavement adjacent to the park's gate shall be resurfaced or beveled to remove the non-compliant changes in level.

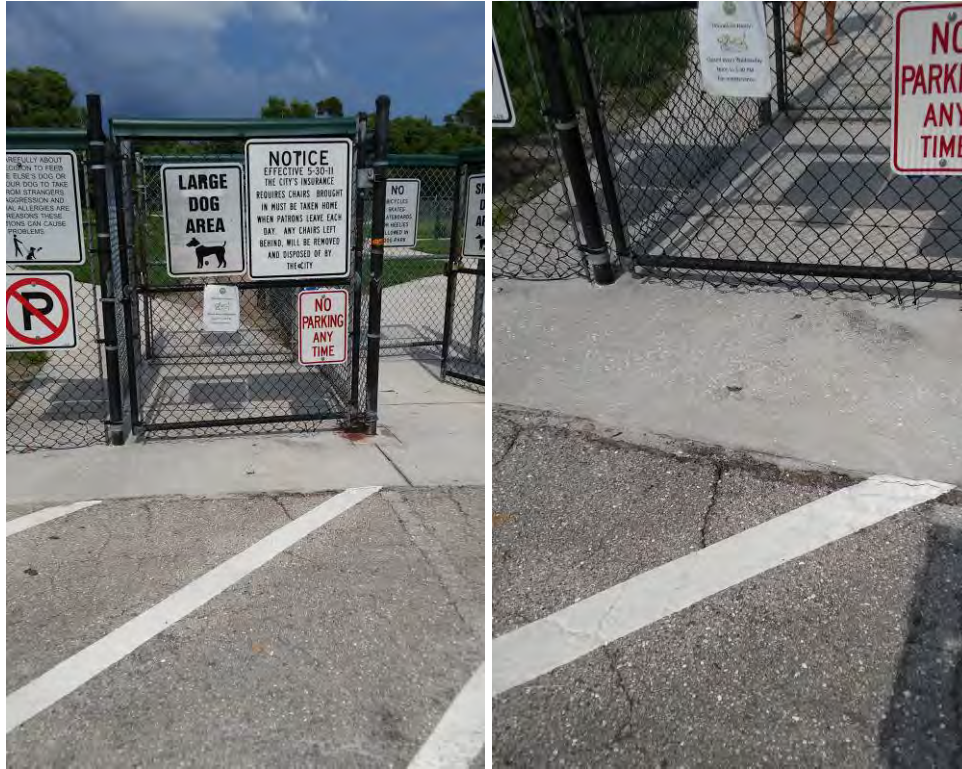
Figure 4-4 - Entrance gate

**ADAAG 303.2** states that, "Changes in level of  $\frac{1}{4}$ " high maximum shall be permitted to be vertical."

**ADAAG 303.3** states that, "Changes in level of  $\frac{1}{4}$ " high minimum and  $\frac{1}{2}$ " high maximum shall be beveled with a slope not steeper than 1:2."

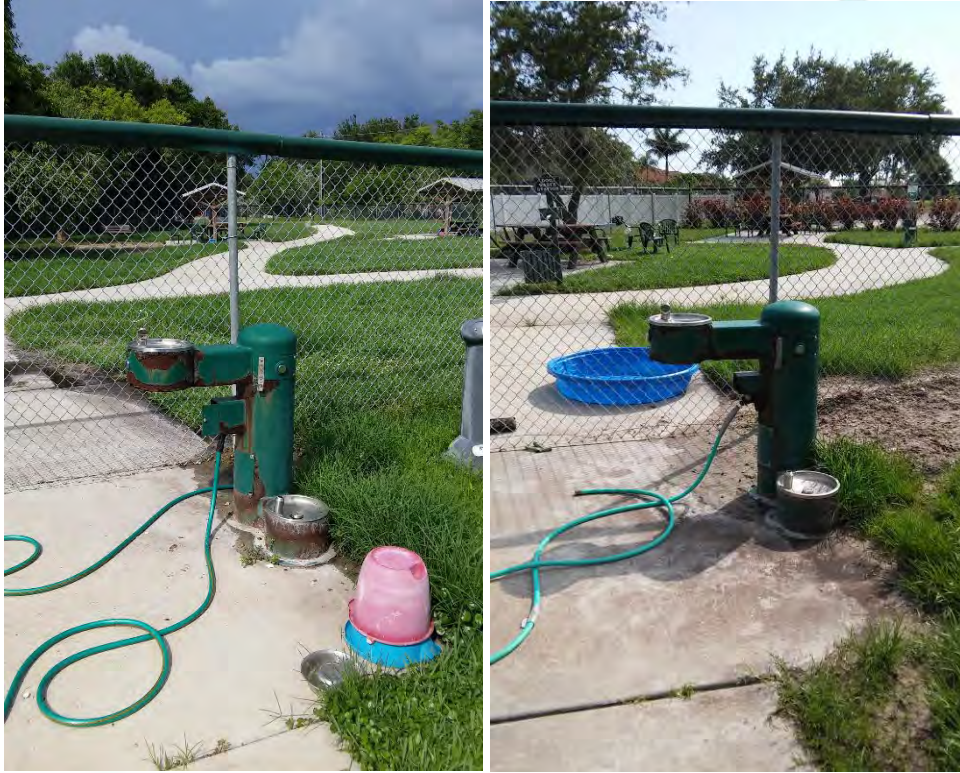
Figure 4-5 – Drinking Fountains.

In two instances within the park, only one drinking fountain was provided. In addition, the existing drinking fountains are extremely rusted.

**ADAAG 211.2** states that, no fewer than two drinking fountains shall be provided at each location.

**ADAAG 602.4** states that, one drinking fountain shall have a spout height of 36" maximum above the finished floor.

**ADAAG 602.7** states that, one drinking fountain shall have a spout height of 38" minimum and 43" maximum above the finished floor.

Install additional drinking fountains of appropriate height adjacent to the existing drinking fountains. In addition, consider replacing/refurbishing the existing, rusted drinking fountains.

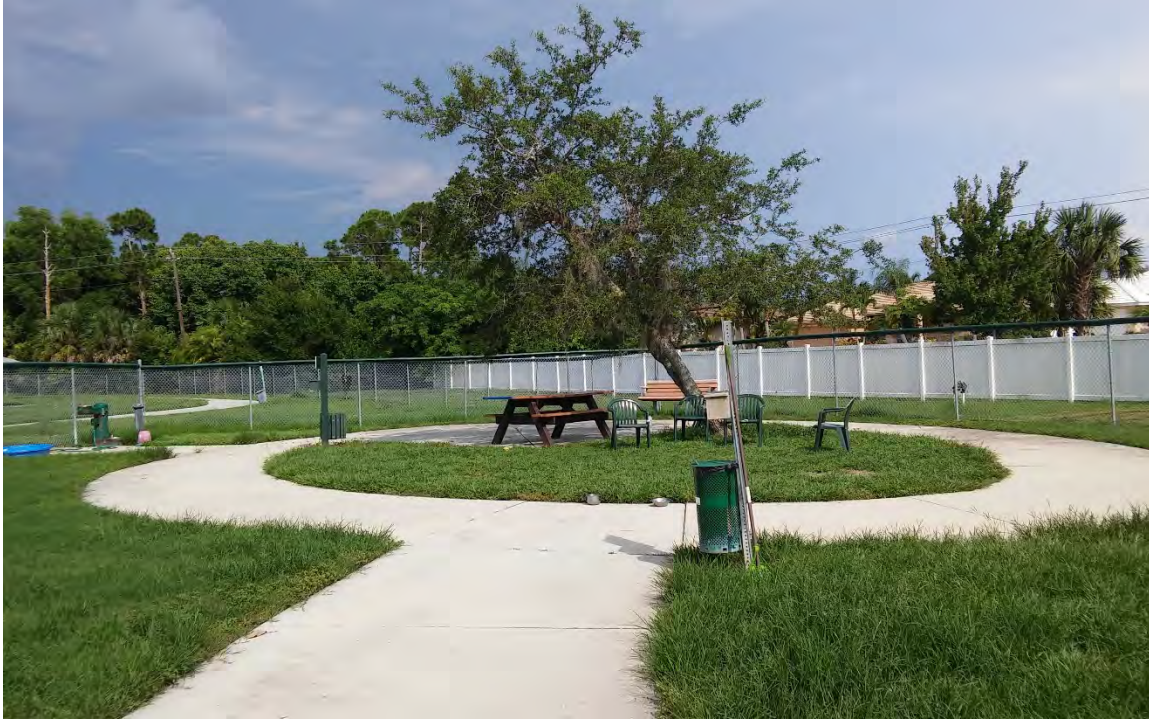
Figure 4-6 – Drinking Fountains.

The tree's branches act as protruding objects.

**ADAAG 307.2** states that, "Objects with leading edges more than 27" and not more than 80" above the finish floor or ground surface shall protrude 4" maximum horizontally into the circulation path."

Trim and maintain the tree's branches so that they do not protrude more than 4" into the circulation path. This will prevent visitors with visual impairments from not being able to detect and then make contact with the hazardous object.

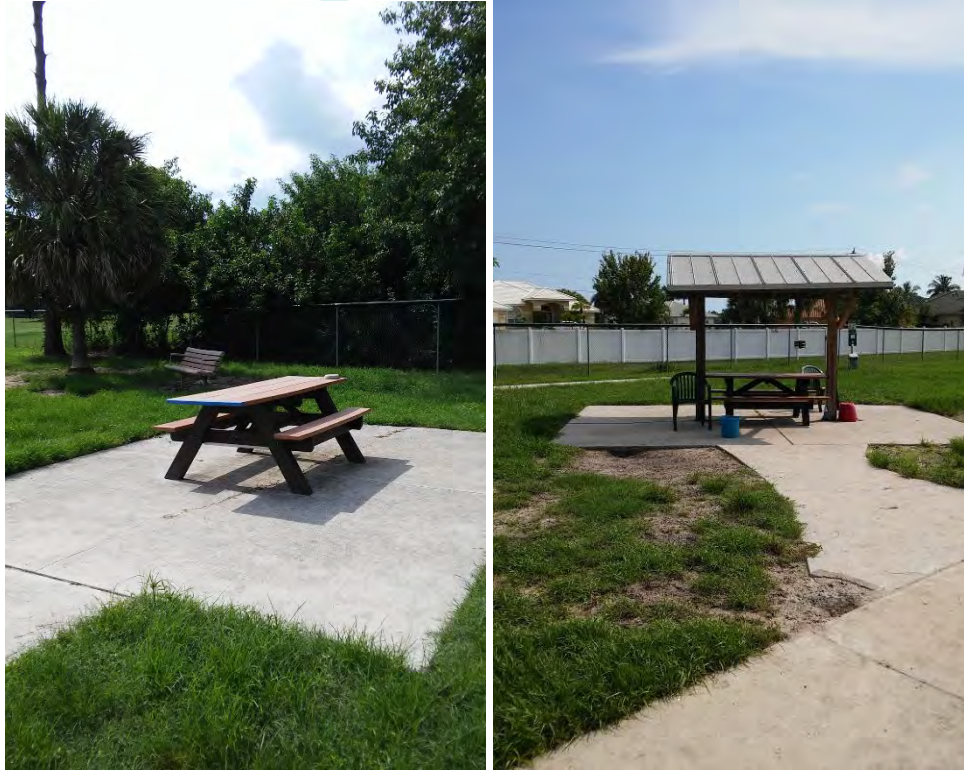
Figure 4-7 – Picnic Tables.

In the large dog park section, there is 1 picnic table with accessible features, which is located in an area exposed to the elements. There are 3 non accessible tables located under small pavilions.

Make sure at least one pavilion contains a picnic table with accessible elements so that visitors using the accessible tables have the option to use a sheltered table as well.
