# **CITY OF PUNTA GORDA**

## **ADA TRANSITION PLAN FINAL REPORT**

### **Marion Avenue Plaza**

October 4, 2017

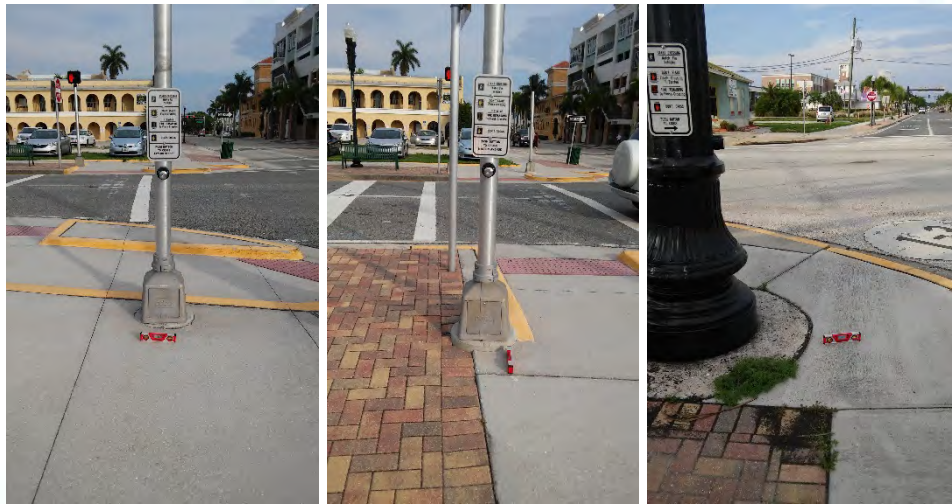
Figure 4-2 – Pedestrian Push Buttons

Shown in Figure 4-2, are three non-accessible pedestrian push buttons, located within Marion Avenue Plaza.

- The clear floor space adjacent to each of the pedestrian push buttons on the north corner of the Marion Avenue and Taylor Street intersection is approximately 3.5%.
- The clear floor space adjacent to the pedestrian push button on the west corner of the Marion Avenue and US 41 Northbound intersection is approximately 3%.

**ADAAG 302.1** states that, “Floor or ground surfaces shall be stable, firm, and slip resistant.”

**ADAAG 305.2** states that, “Floor and ground surfaces of a clear floor or ground space shall comply with 302. Slopes not steeper than 2% shall be permitted.”

**ADAAG 305.3/PROWAG R404** states that “The clear floor or ground space shall be 30 inches minimum by 48 inches minimum.”

- Resurface the pavement adjacent to the two pedestrian push buttons on the north corner of Marion Avenue and Taylor Street so that the maximum slope of the adjacent clear floor space is 2%.
- Resurface the pavement adjacent to the pedestrian push buttons on the west corner of Marion Avenue and US 41 Northbound so that the maximum slope of the adjacent clear floor space is 2%.
