# CITY OF PUNTA GORDA ADA TRANSITION PLAN FINAL REPORT Public Safety Building

October 4, 2017

**Prepared For:**  
City of Punta Gorda  
326 West Marion Avenue  
Punta Gorda, Florida, 33950

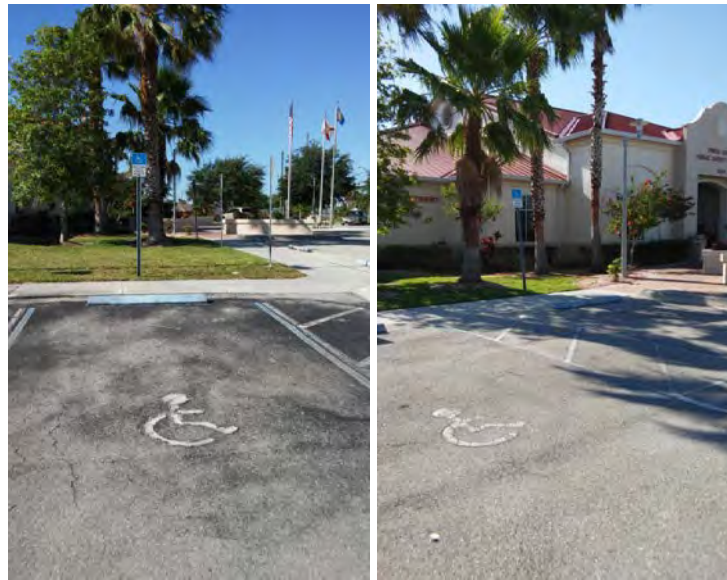
Figure 4-1 – Accessible Parking Spaces front of Building

- The striping and ISA symbols are fading and not easily visible.

- Restripe and repaint the faded parking spaces and ISA symbols.

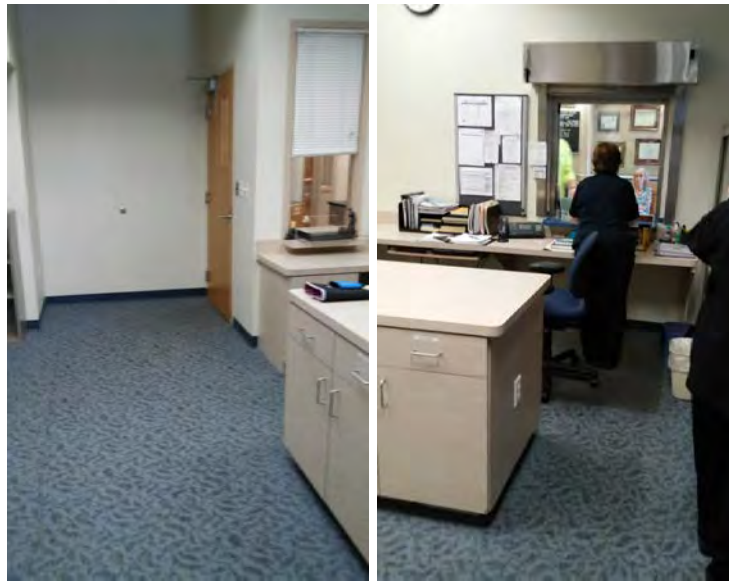
Figure 4-5 – Door from Hallway to Records Room

- The door to access the Records Room from the main hallway requires a force of about 11 pounds to open, violating §404.2.9.

- Adjust the strength of the door closer so the force required to open the door is a maximum of 5 pounds. Ensure the speed of the door closing on its own complies with §404.2.8.1, and takes 5 seconds or more to close from 90 degrees open to 12 degrees open.

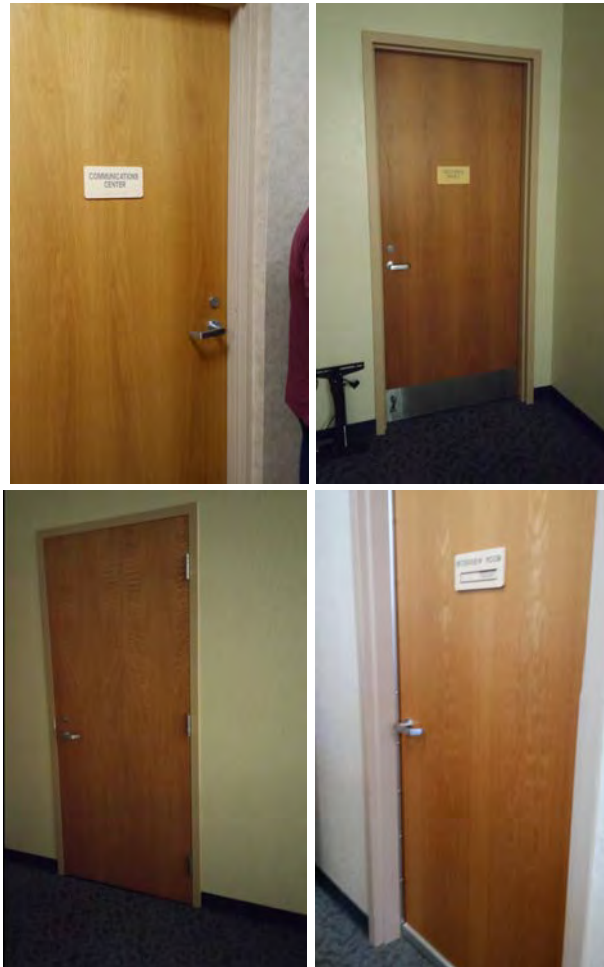
Figure 4-6 – Doors to Permanent Rooms

- Several office doors have tactile signs located on the center of the door, violating §703.4.2.
- Several utility rooms are not identified with tactile signage, violating §216.2.
- The Interview Room has a variable occupancy sign that is located 58" high, too high to be reachable for an employee in a wheelchair, violating §308.2.1.

- Add/replace the signage on all doors with tactile signs, located on the latch side of the door, complying with **ADAAG 703**.
  - Signs should designate the room by its name or a room number.
  - Signs should be braille with raised lettering.
  - The height of the sign should be placed between 48" and 60" high from the floor, measured to the baseline of the lowest and highest line of raised characters.
  - The sign should be placed in the center of an 18" clear space adjacent to the latch side of the door.
    - For double doors, the sign should be placed in the center of the two doors since no wall space exists to the right of the right hand doorway.

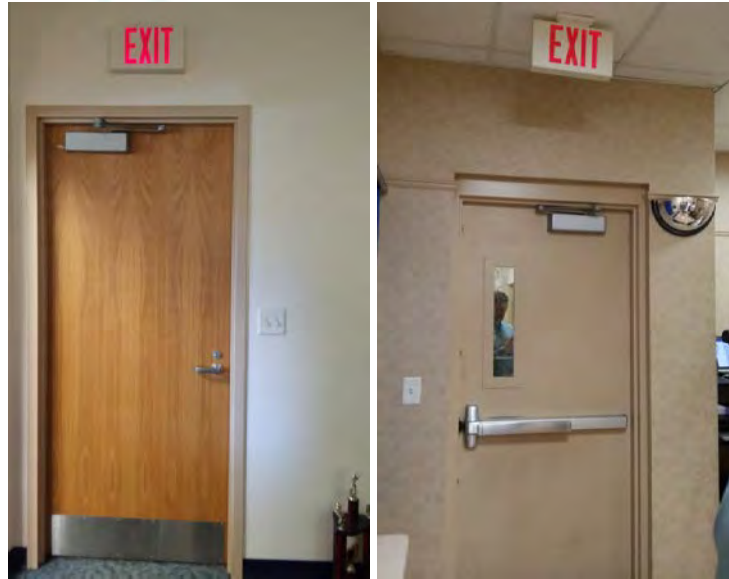
Figure 4-7 – Emergency Exit Doors

- There are 5 emergency exits in the office building portion of the public safety complex, none of which are identified with tactile signage, violating §216.4.1.

- Place tactile exit signs on the wall, on the latch side of door to comply with **ADAAG 703.1, ADAAG 703.2, ADAAG 703.4.2, and ADAAG 703.5**, identifying the exterior exit doors.

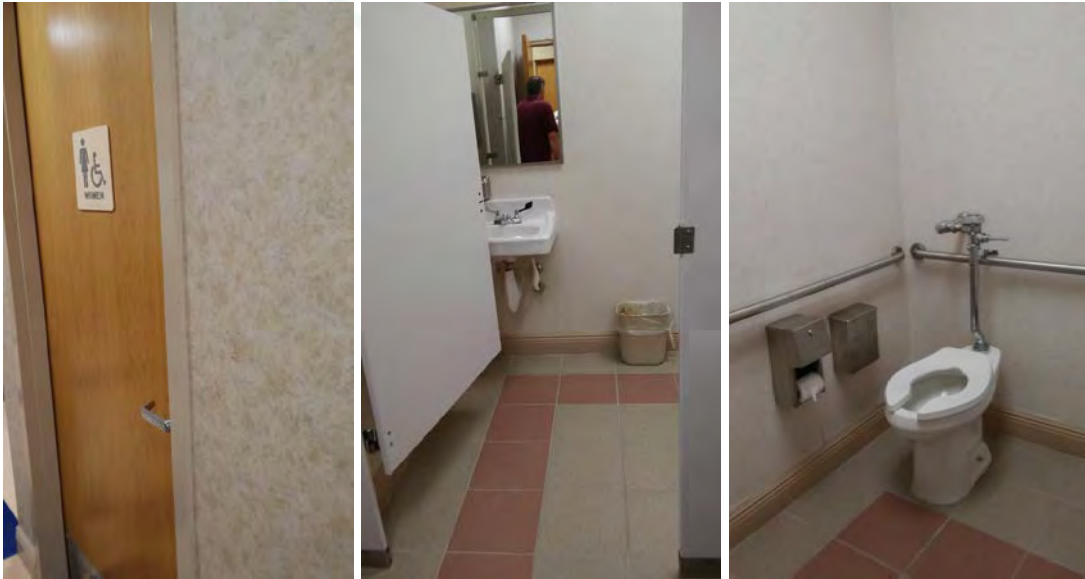
Figure 4-9 – Women's Hallway Restroom

- The signage identifying the bathroom is located on the door, not next to the door on the latch side, violating §703.4.
- The toilet is located 18.75" from the side wall, too far from the wall, violating §604.2.

- Relocate the signage to be adjacent to the door, complying with §703.4
- Relocate the toilet 0.75" to 2.75" closer to the side wall.
  - American Standard has a patented toilet design, called Access Pro, that allows the toilet to be shifted up to 3.5" in either direction without relocating the drain or flange.

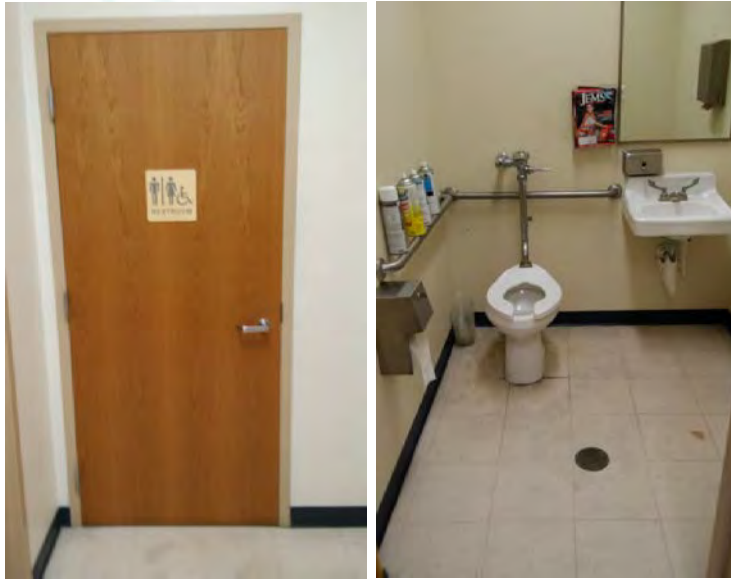
Figure 4-10 – Unisex Restroom

- The signage identifying the bathroom is located on the door, not next to the door on the latch side, violating §703.4.
- The mirror is 48" above the floor, violating §606.3.

- Relocate the signage to be adjacent to the door, complying with §703.4
- Lower the mirror on the wall by 8". This will require relocating the soap dispenser to the side wall.

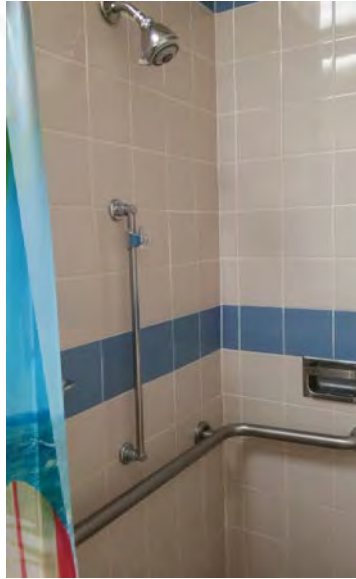
Figure 4-12 – Women's Locker Room Shower

- The Woman's Locker Room has a shower, however, it does not have accessible hardware, violating §608.6.
- The entrance to the shower is 33" wide, too narrow to be accessible, violating §608.2.1

- Install shower hardware that is compliant with §608.6, with a hose of 59" and the option to use it as a shower head or a hand-held unit.
- Replace or modify the shower so that it has an entry opening of at least 36" wide.

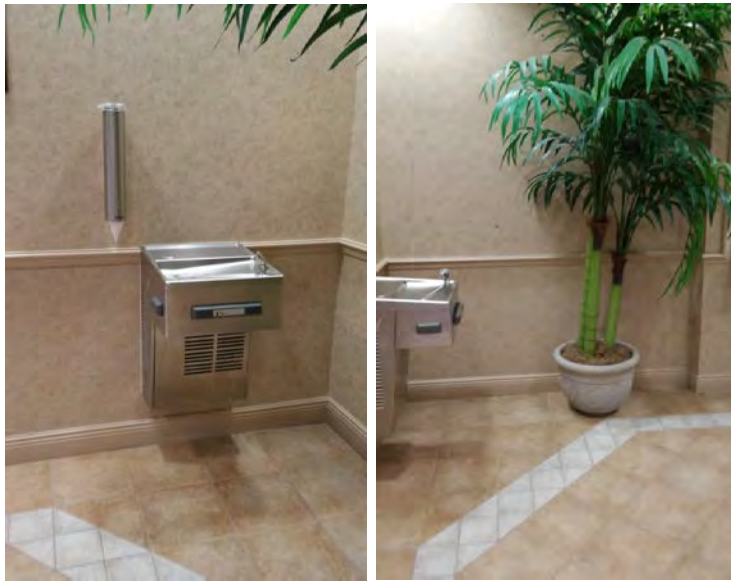
Figure 4-13 – Lobby Water Fountain

The single drinking fountain has spout height of 36", which is compliant per **ADAAG 602.4**. However, per **ADAAG 211.2** no fewer than two water fountains shall be provided, complying with 602.4 and 602.7. **ADAAG 602.7** states that a secondary water fountain for standing persons must have a spout height between 38" and 43" above the floor.

- Install a secondary water fountain with a spout height between 38" and 43", per **ADAAG 602.7**

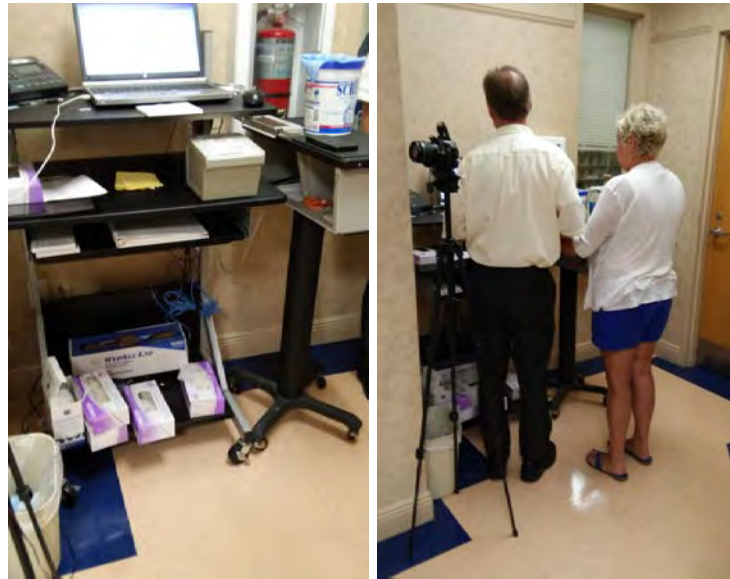
Figure 4-15 – Finger Print Station

- The finger printing area counter is 42" tall, however, should be no higher than the maximum height for a service counter of 36", violating §904.4.1.
