CITY OF PUNTA GORDA ADA TRANSITION PLAN FINAL REPORT Public Works Complex

October 4, 2017

Prepared For:
City of Punta Gorda
326 West Marion Avenue
Punta Gorda, Florida, 33950

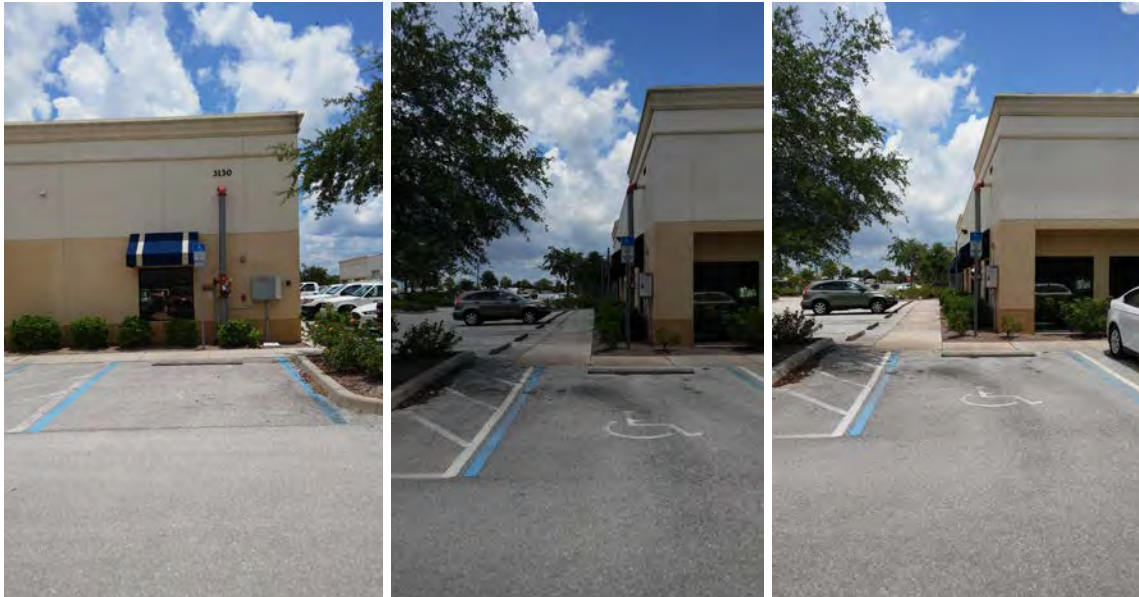
Figure 4-1 - Parking Area

A total of 6 accessible parking space are provided, 4 adjacent to the Public Utilities building and 2 by the Public Works building among the 261 total parking spaces. Some deficiencies exist in terms of requirements for accessible parking.

ADAAG 208.3 states that, accessible parking spaces that serve a particular building shall be located on the shortest accessible route from the parking to an accessible entrance.

ADAAG 208.2.4 states that, “For every six or fraction of six (accessible) parking spaces required at least one shall be a van parking.”

ADAAG 502.4 states that, “Parking spaces and access aisles shall not have slopes steeper than 2%.”

FAC 502.6.1 states that, “Each (accessible) parking space must be striped in a manner that is consistent with the standards of the controlling jurisdiction for other spaces and prominently outlined with blue paint, and must be repainted when necessary, to be clearly distinguishable as a parking space designated for persons who have disabilities.”

- All of the accessible parking spaces should be relocated to be closer to the entrance of the two facilities.
- The accessible parking space on the side of the public works building has a running slope of 4%. Accessible parking spaces must not have a slope greater than 2%. The slope must either be regraded or the accessible parking space relocated to a level area.

- A sign must be mounted that identifies one of the accessible parking space as being “van accessible”.
- It is recommended to restripe the faded markings designating the accessible parking and aisles.

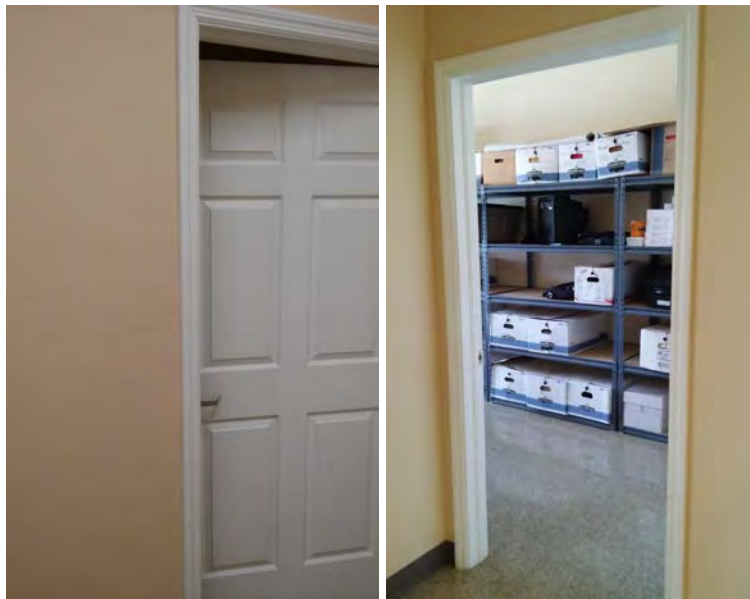
Figure 4-2 – Example of a doorway without ADA compliant signage.

Not all doors in the interior and exterior of the facility have ADA compliant signage. The ADA also requires that wherever exit signage directs emergency egress from a facility, a raised lettering and Braille (tactile) sign, compliant with ADA standards, must also be provided to assist individuals with vision impairments in finding exits.

ADAAG 703.1, 703.2, and 703.5 state that, permanent rooms shall have signage with visual characters, raised characters, and braille.

ADAAG 703.4.2 states that, at doors, the sign shall be located alongside the door at the latch side.

At all exit doors, provide a tactile exit sign with raised characters and braille. At all permeant rooms, make sure the room's signage has visual characters, raised characters, and Braille.

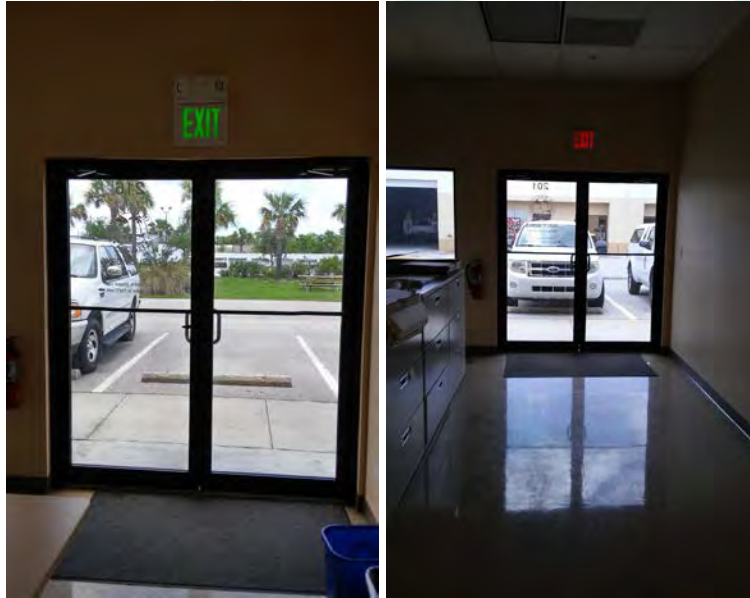
Figure 4-3 – Examples of exit doorways without ADA compliant signage.

ADAAG 216.4.1, 703.2, 703.3, 703.5 states that, exit doors are required to have tactile signs with visual characters, raised characters, and Braille.
