CITY OF PUNTA GORDA ADA TRANSITION PLAN FINAL REPORT Sculpture Park

October 4, 2017

Prepared For:
City of Punta Gorda
326 West Marion Avenue
Punta Gorda, Florida, 33950

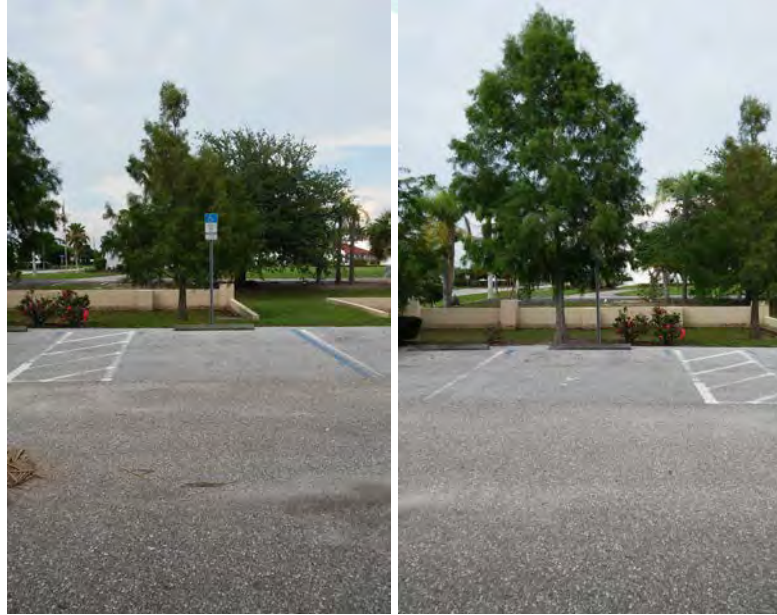
Figure 4-1 – Existing accessible parking spaces

The parking lot adjacent to Sculpture Park is owned by the City. This lot has 62 paved parking spaces, 2 of which are marked as being accessible. However, there are a handful of issues with the parking, as detailed below.

1. For a parking facility with 51 to 75 parking spaces, a minimum of 3 are required to be accessible, per **ADAAG 208.2**.
2. The lines and ISA marking for the two accessible parking spaces are fading, violating **FAC 502.6**. states that, "Each (accessible) parking space must be striped in a manner that is consistent with the standards of the controlling jurisdiction for other spaces and prominently outlined with blue paint, and must be repainted when necessary, to be clearly distinguishable as a parking space designated for persons who have disabilities."

3. Tree branches are blocking the visibility of the northern-most accessible parking sign.
4. The access aisle, adjacent to the existing accessible parking space, shown in Figure 4-1, does not connect to the accessible route leading to the park's entrance. The nearby sidewalk has a raised curb. This violates **ADAAG 502.3** which states that, "Access aisles shall adjoin an accessible route." **ADAAG 303.2** states that, "Changes in level of ¼" high maximum shall be permitted to be vertical."

5. The accessible parking spaces serving this park are not located on the shortest route to the park. This violates **ADA 208.3**, which states "(Accessible) parking spaces that serve a particular facility shall be located on the shortest accessible route from the parking to an (accessible) entrance."

A minimum of three accessible parking spaces are required in this parking lot, based on the current number of parking spaces. Therefore, a third accessible parking space must be added to this lot. In addition, the location of the two accessible parking spaces are not on the shortest accessible path to the adjacent park. As such, they shall be relocated to the southwest, as shown Figure 4-2. This location will allow for the accessible aisle to tie in directly to the paved path around the park as well as mitigate the other parking violations that are listed above.

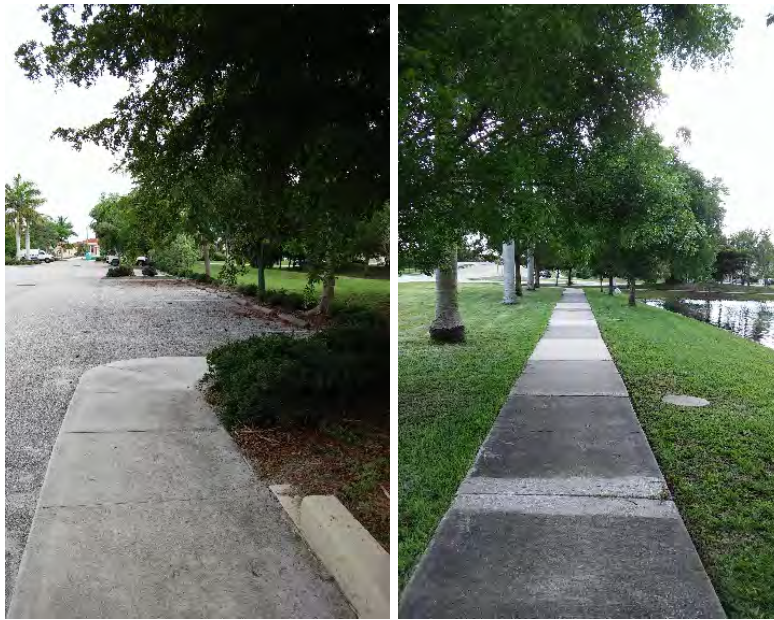
Figure 4-3 – Low hanging tree branches along path.

Vertical clearance is defined as the minimum unobstructed vertical passage space. Vertical clearance is often limited by obstacles such as building overhangs, tree branches, signs, and awning. As shown below in Figure 4-3, the path within and around Sculpture Park contains various low hanging tree branches, which do not meet the minimum standards set forth for protruding objects, as defined in **ADAAG 307.2**, which states that, “objects with leading edges more than 27 inches and not more than 80 inches above the finish floor or ground shall protrude 4 inches maximum horizontally into the circulation path.”

Trim and maintain the tree branches extending over the parks' paved trails to meet the minimum vertical clearance of 80 inches. This will prevent users with visual impairment from making contact with the branches.

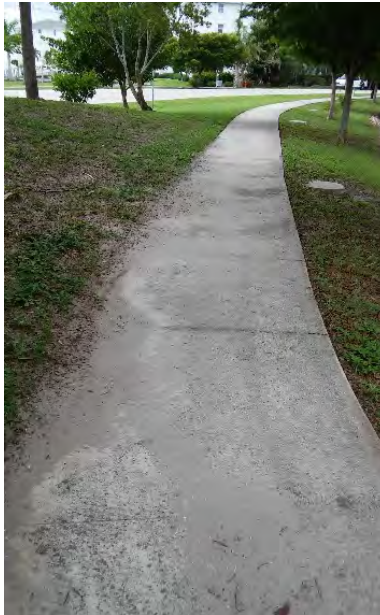
Figure 4-4 – Sediment accumulation along path

Figure 4-4 shows a segment of the path where sand and debris have accumulated, presumably from water runoff. The accumulation of sediment along with debris can pose as a tripping hazard as well as a surface that is not slip resistant.

ADAAG 302.1 states that, “Floor and ground surfaces shall be stable, firm, and slip resistant.”

The sand and debris should be cleared from the path. In addition, steps should be taken to control the drainage in this area to minimize this from occurring.
