Punta Gorda

ADA TRANSITION PLAN FINAL REPORT A.C. Freeman House

October 4, 2017

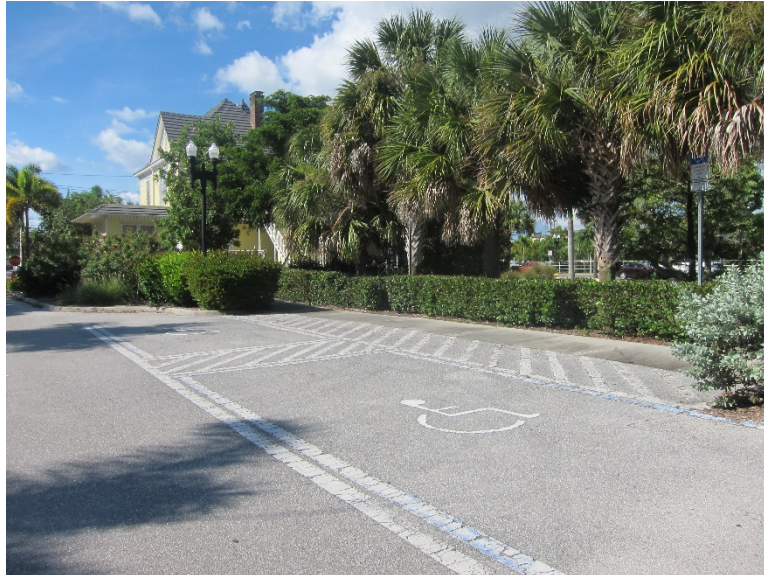
Figure 4-1 – Accessible Parking Spaces on West Side of Property

- The striping outlining the spaces, hash marks for the access aisle and ISA symbols are fading.
- The signs reserving the spaces are obscured by tree overgrowth and are set back from the spaces so that they are not readily visible.
- The access aisle serving one of the two spaces does not extend the full length of the vehicle space. Shrubbery is planted at the end of the aisle and obstructs intended use of the aisle for wheelchair deployment and maneuverability.

- Restripe and repaint the faded parking space and access aisle lines and the ISA symbols.
- Relocate the accessible spaces reserved signs so they clearly identify the spaces as reserved for individuals with disabilities.
 - Note that using one sign to identify both of the spaces is acceptable under ADAAG standards.
- Remove shrubbery to provide space to lengthen the access aisle to be the same length of the accessible space it serves and extend the aisle markings to be consistent with ADAAG specifications.

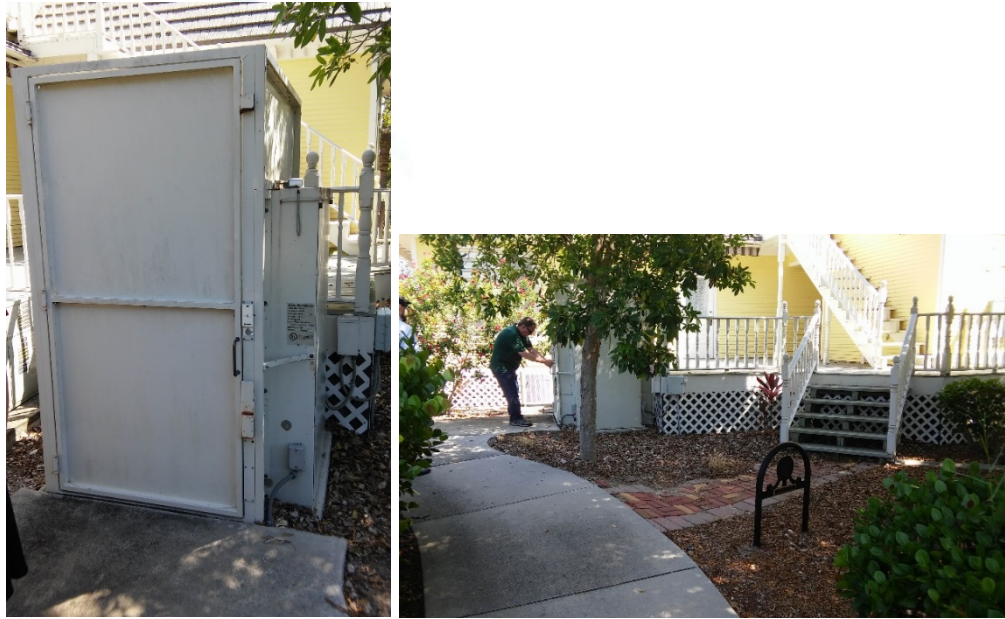
Figure 4-2 – Wheelchair Lift and Rear Entrance to Building

- The front door exit to the facility is not accessible due to stairs, a door width less than 32”, and a door threshold that is approximately 2” high. This entrance does not have a sign displayed that provides directions to the accessible entrance at the rear of the facility. Additionally, the rear accessible entrance is not identified by the International Symbol of Accessibility.
- The wheelchair lift was not operational at the time of this assessment. It may need maintenance or the staff may need training on its operation.

- Install a visual sign at the front entrance (preferable on a post mounted at the walkway leading to the entrance so visitors are immediately aware of the accessible entrance location at the rear of the building.
- Maintain and/or train staff on the operation of the wheelchair lift.
