CITY OF PUNTA GORDA ADA TRANSITION PLAN FINAL REPORT City Hall Annex

October 4, 2017

Prepared For:
City of Punta Gorda
326 West Marion Avenue
Punta Gorda, Florida, 33950

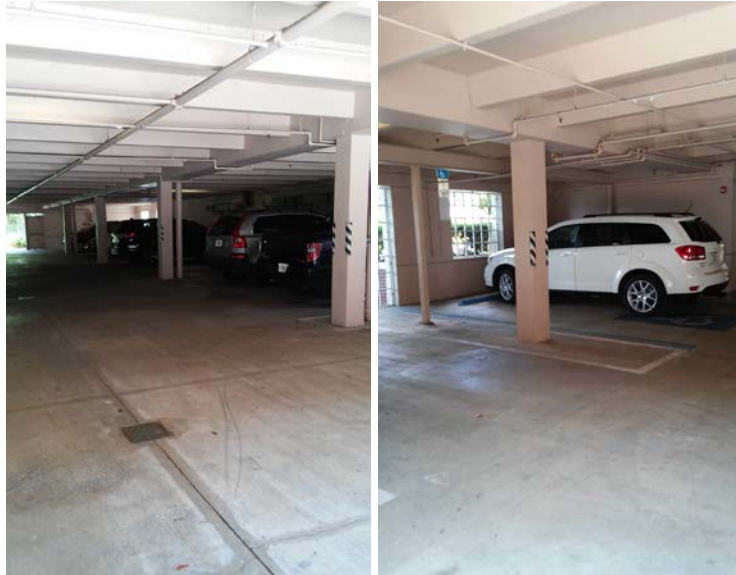
Figure 4-1 – Existing accessible parking spaces

1. The vertical clearance within the garage is 79", which is below the minimum height of 98" per, per **ADAAG 502.5**.

According to the ADA, accessible parking spaces must have a minimum vertical clearance of 98". Since this garage has insufficient vertical clearance, it is recommended to remove the signage at the accessible parking space and reclassify it as a "courtesy space for people with disabilities". In addition, a sign should be placed outside the garage directing vehicles needing high clearance and accessible parking to the adjacent surface parking lot.

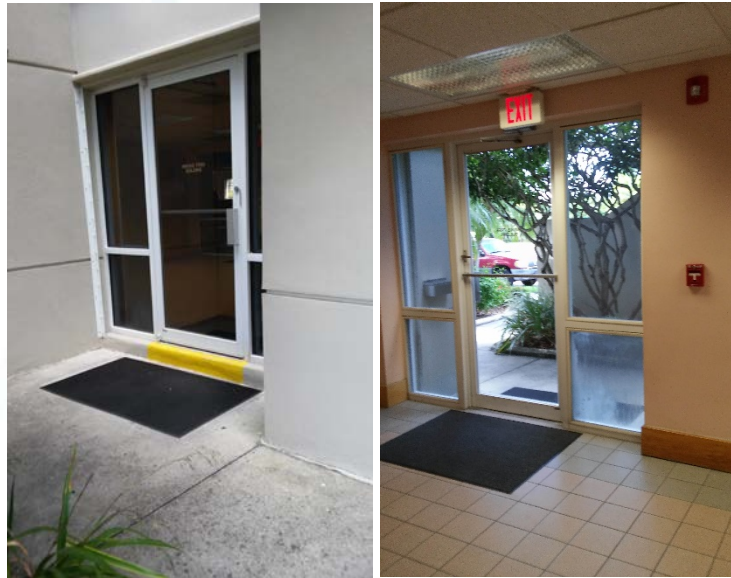
Figure 4-2 – Harvey Street Entrance/Exit

1. There is a step at the entrance/exit to the parking garage. This entrance/exit connects the adjacent sidewalk to the elevator. Per **ADAAG 3003.2**, a vertical change greater than $\frac{1}{4}$ " is not accessible.

1. Pave a ramp at the exterior of the door thereby making the accessible route to/from the sidewalk ADA compliant.

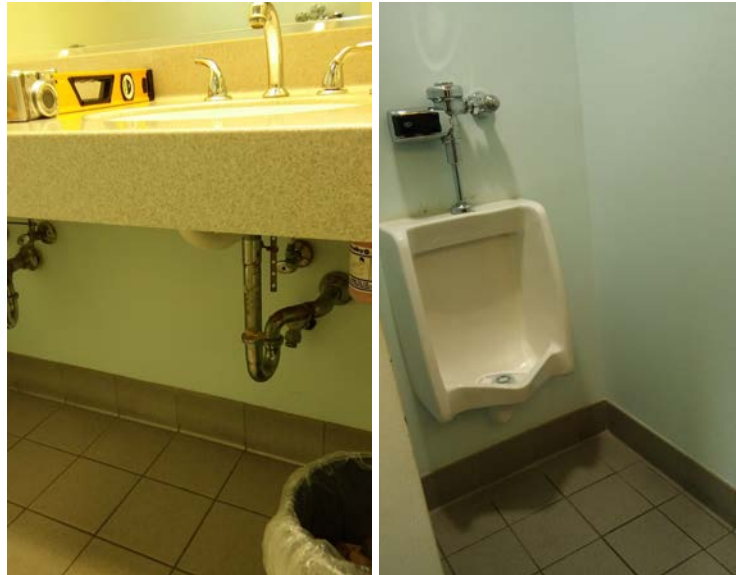
Figure 4-4 – Men's Restrooms

1. The paper towels are located at a height of 58" from the ground, violating **ADAAG 308**.
2. The bathroom's main sink's pipes are exposed, violating **ADAAG 606.5**.
3. There is no rear grab bar behind the toilet, violating **ADAAG 604.8.1.5**.
4. The urinal is 20" from the rim to the floor, violating **ADAAG 605.2**.

1. Lower the paper towel dispensers to a maximum height of 48".
2. Insulate all exposed sink pipes to prevent contact with the legs of users in wheelchairs.
3. Install rear grab bars on the accessible toilets.
4. Lower the urinal so the rim is a maximum height of 17" from the floor.

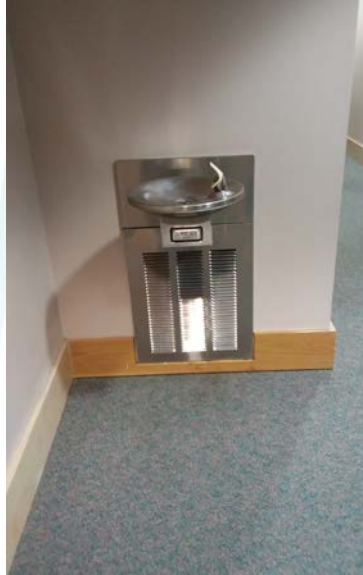
Figure 4-5 – Single Drinking Fountain.

The single drinking fountain has spout height of 36", which is compliant per **ADAAG 602.4**. However, per **ADAAG 211.2** no fewer than two water fountains shall be provided, complying with 602.4 and 602.7. **ADAAG 602.7** states that a secondary water fountain for standing persons must have a spout height between 38" and 43" above the floor.

Install a secondary water fountain with a spout height between 38” and 43”, per **ADAAG 602.7**

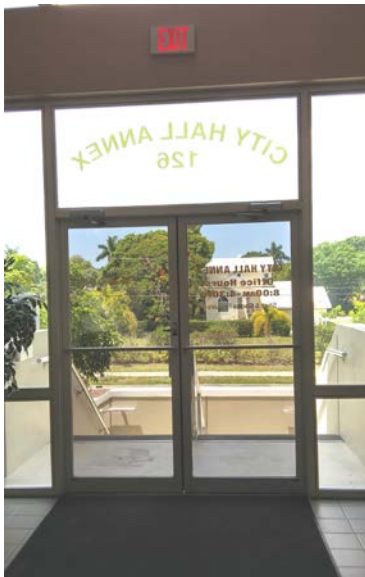
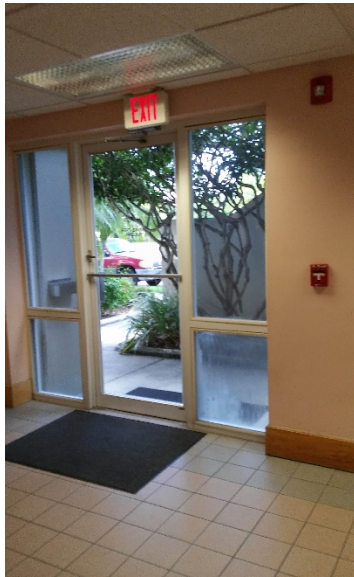
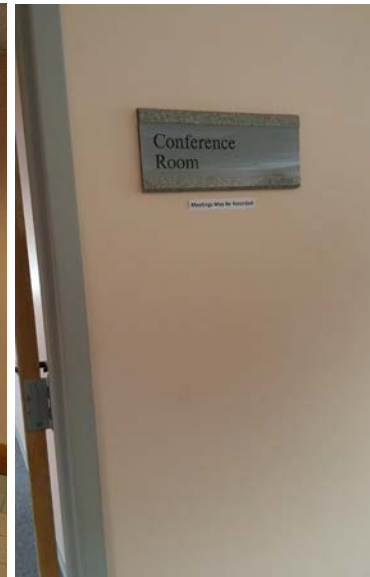
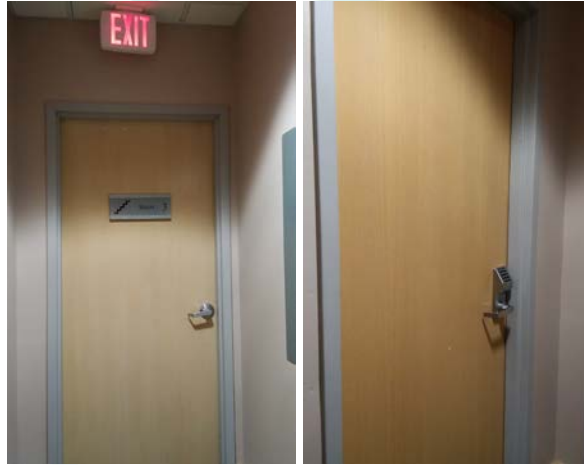
Figure 4-6 – Signage.

1. Exit doors do not have tactile exit signs, violating **ADAAG 216.4.1**.
2. Some doorways/rooms are lacking tactile signage or have them mounted in a non-compliant position.

1. Place tactile exit signs on the wall, on the latch side of door to comply with **ADAAG 703.1, ADAAG 703.2, ADAAG 703.4.2, and ADAAG 703.5**, identifying the exterior exit doors.
2. Add/replace the signage on all doors with tactile signs, located on the latch side of the door, complying with **ADAAG 703**.
 - a. Signs should designate the room by its name or a room number.
 - b. Signs should be braille with raised lettering.
 - c. The height of the sign should be placed between 48” and 60” high from the floor, measured to the baseline of the lowest and highest line of raised characters per **ADAAG 703.4.1**.
 - d. The sign should be placed in the center of an 18” clear space adjacent to the latch side of the door.
 - i. For double doors, the sign should be placed in the center of the two doors since no wall space exists to the right of the right hand doorway.

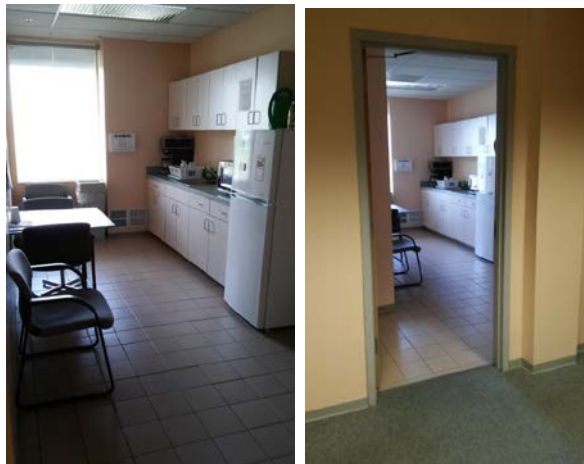
Figure 4-7 – Employee Break Area Kitchen

1. The sink in the employee kitchen is 36" high, 2" too high to be considered accessible, violating **ADAAG 804.4**.

1. Ensure the sink complies with **ADAAG 606.3** and **ADAAG 606.4**, where the height of the sink is 34" max and the faucet controls comply with **ADAAG 309**.

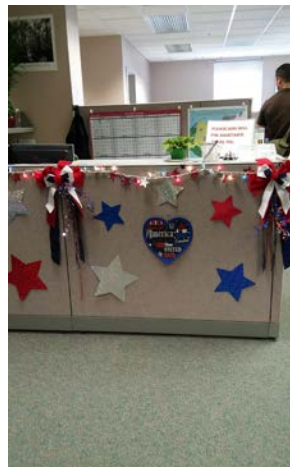
Figure 4-8 – Miscellaneous.

1. Some of the receptionist desks, which have forms for the public to fill out, have a counter height of 42.5" with no auxiliary writing surface, violating **ADAAG 904.4**.

1. Either lower a section of the existing desk to a maximum height of 36" or place a foldable table, with a maximum height of 36", adjacent to the desk that can be set up as a writing surface on an as-needed basis.
