# Punta Gorda

## CITY OF PUNTA GORDA ADA TRANSITION PLAN FINAL REPORT Cooper Street Rec Center

October 4, 2017

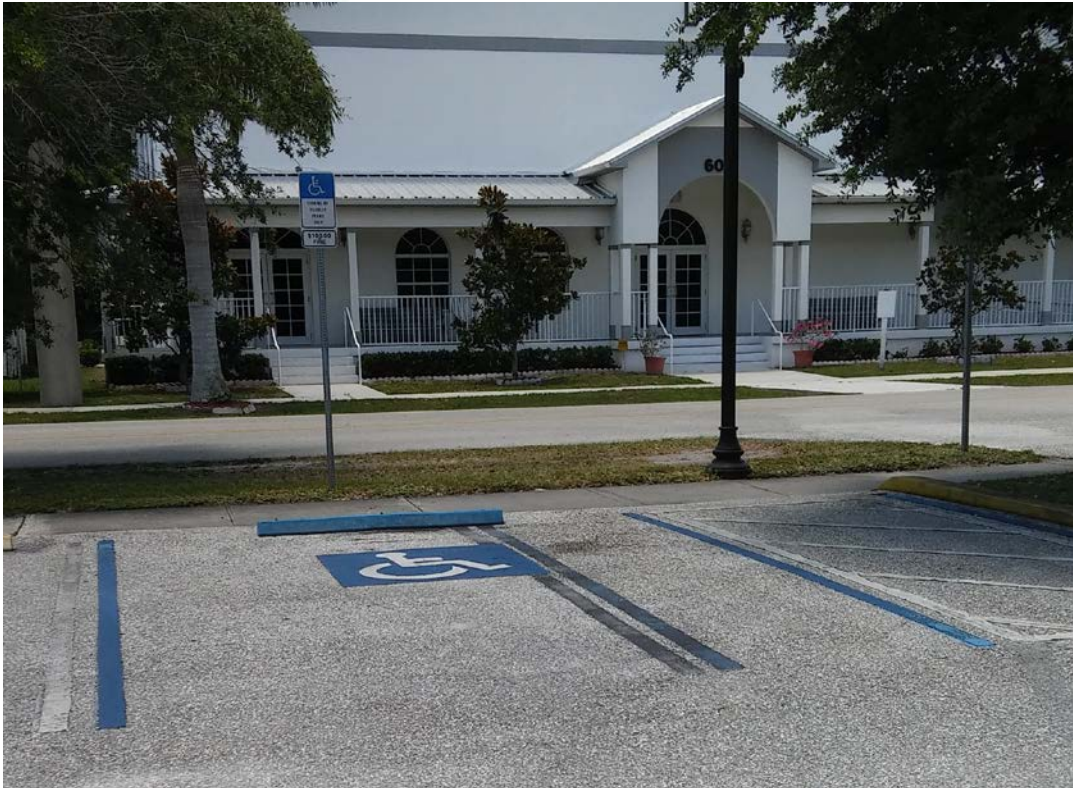
**Figure 4-1 - Parking Area**

One accessible parking space is provided among the 18 total parking spaces. Some deficiencies exist in terms of requirements for accessible parking.

**ADAAG 208.2.4** states that, “For every six or fraction of six (accessible) parking spaces required at least one shall be a van parking.”

**FAC 502.6.1** states that, “Each (accessible) parking space must be striped in a manner that is consistent with the standards of the controlling jurisdiction for other spaces and prominently outlined with blue paint, and must be repainted when necessary, to be clearly distinguishable as a parking space designated for persons who have disabilities.”

A sign must be mounted that identifies this parking space as being “van accessible”. It is recommended to remove the faded stripes located within the accessible parking space.

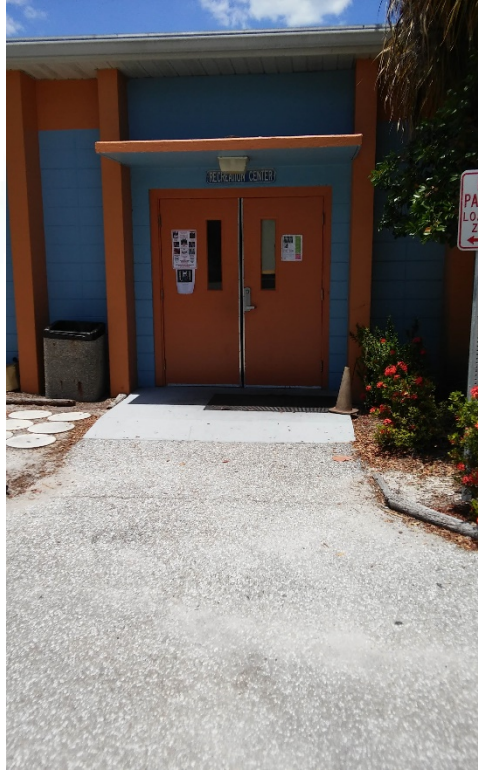
Figure 4-2 – Accessible route leading to the at-grade public entrance.

From the parking lot, there are two entrances to the facility; a set of double doors that are approximately at street level, shown in Figure 4-2; and a ramp leading up to a raised entrance, shown in Figure 4-3.

The street level entrance has a non-compliant slope leading to it. The asphalt section is sloped at 6% for approximately 4 feet and leads to a 2 foot concrete slab with a 10.5% slope.

**ADA 404.2.4** illustrates that, a clear floor space must be provided at the doorway.

**ADA 305.2** states that, floor or ground surfaces of a clear floor space must not have a slope steeper than 2%.

**ADA 403.3** states that, the running slope of walking surfaces shall not be steeper than 5%.

**ADA 405.2** states that, ramp runs shall have a running slope not steeper than 8.33%.

- For the at-grade entrance, a clear & level floor space must be created in front of the doorway, per **ADA 404**. The slope of the pavement leading to the doorway must be ramped, per **ADA 405** and include landings, and have handrails and edge protection per **ADA 505**.
- For the ramped entrance, modify the handrail on the ramp to have 12 inch extensions located at the top and bottom of the ramp. Regrade the ramp to have a running slope no greater than 8.33%.

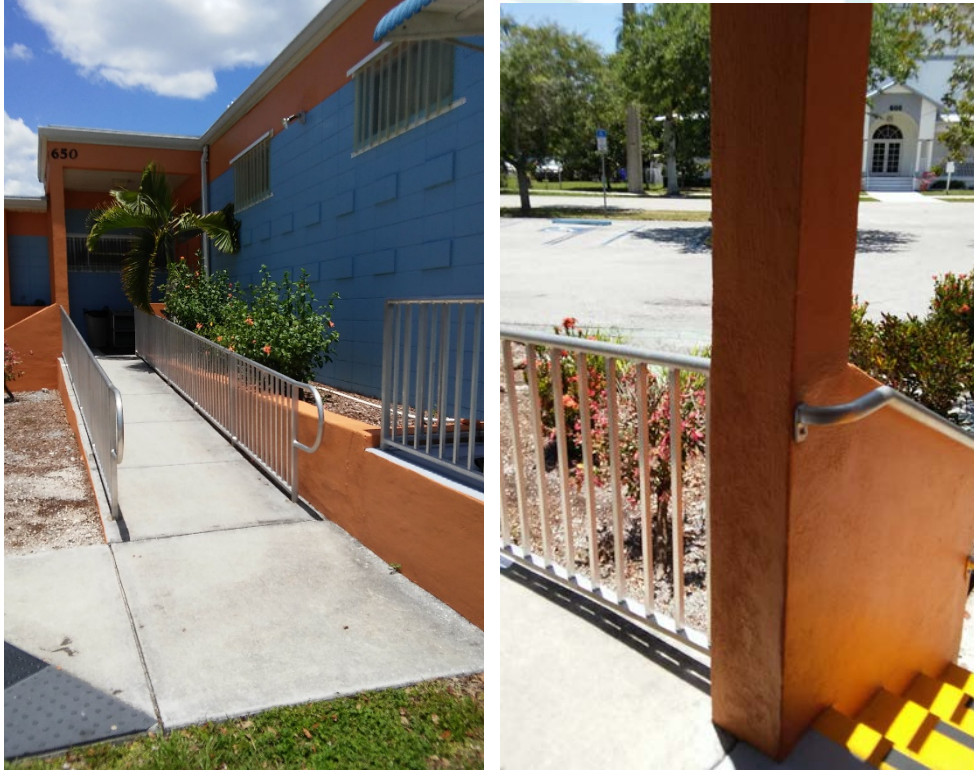
Figure 4-3 – Ramp leading to the raised public entrance.

The ramped entrance has handrails that don't extend far enough at the top or bottom of the ramp as well as a ramp that has a 9% slope in some sections.

**ADA 505.10.1** states that, ramp handrails shall extend horizontally above the landing for 12 inches minimum beyond the top and bottom of ramp runs.

**ADA 405.2** states that, ramp runs shall have a running slope not steeper than 8.33%.

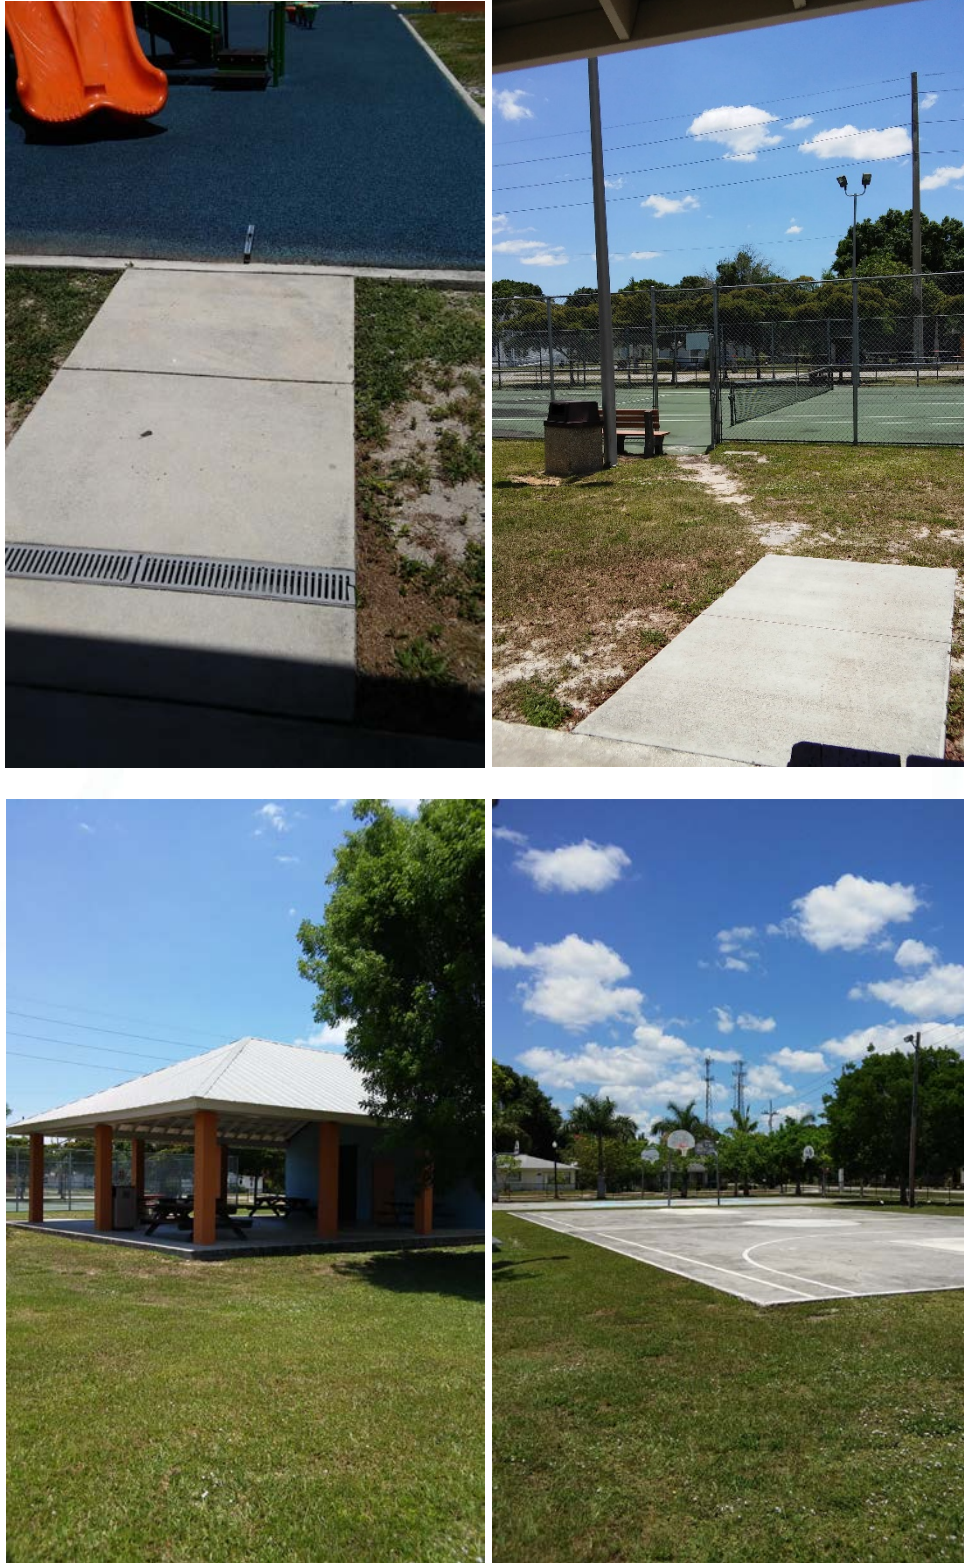
Figure 4-4 – Non accessible outdoor elements

- The rear door of the facility, leading to the outdoor play area, has an excessive slope, in excess of 25% at the transition on the rubber play area.
- There is no accessible route to the basketball court or tennis court
  - The bleachers are not accessible.
- There is no accessible routes to the pavilion.
  - Within the pavilion there are 6 non-accessible picnic tables
  - There are non-accessible grills adjacent to the pavilion

**ADAAG 403.3** states that, running slopes of walking surfaces shall not be steeper than 5% with cross slopes not steeper than 2%.

**ADAAG 206.12** states that, at least one accessible route shall directly connect both sides of the court.

**ADAAG 206.2.4** states that, at least one accessible route shall connect accessible buildings with all elements within the facility which are otherwise connected by a circulation path.

**ABA F245.2.2** states that, where picnic facilities contain more than two picnic units, at least 20 percent of the picnic units shall provide mobility features.

- Regrade the areas with running slopes greater than 5% or cross slopes greater than 2%.
- Pave an accessible route to the basketball and tennis courts.
- Pave an accessible route to the pavilion.
- Either pave an accessible route to at least one of the grills or add a new grill in an accessible location.
- Make sure at least 20% of the picnic tables within the shelter have accessible features.
- Pave an accessible route to the bleachers, making sure that there is a clear floor space for wheelchair users.

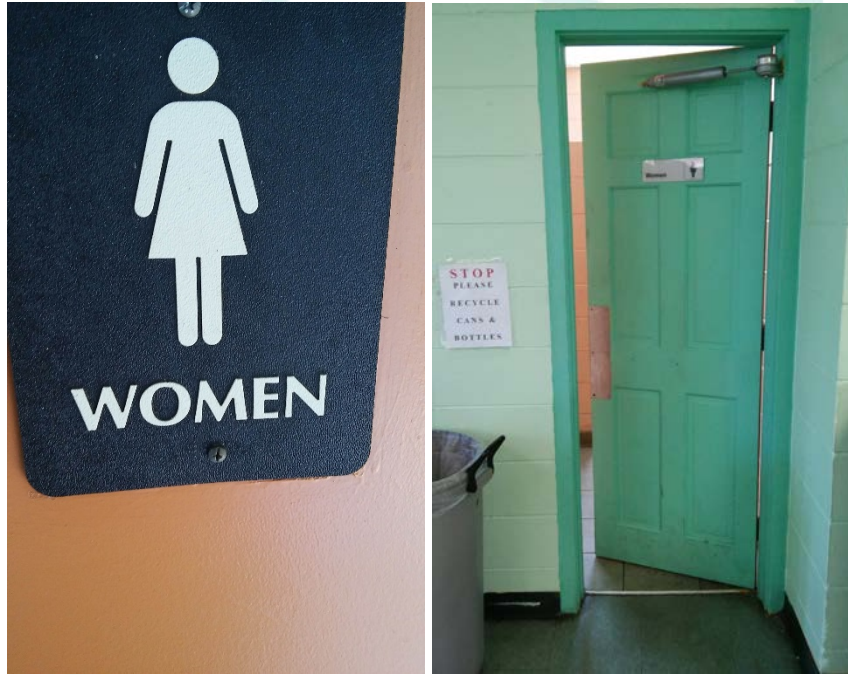
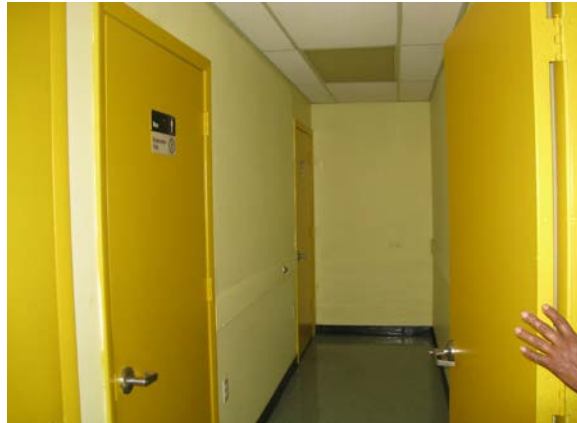
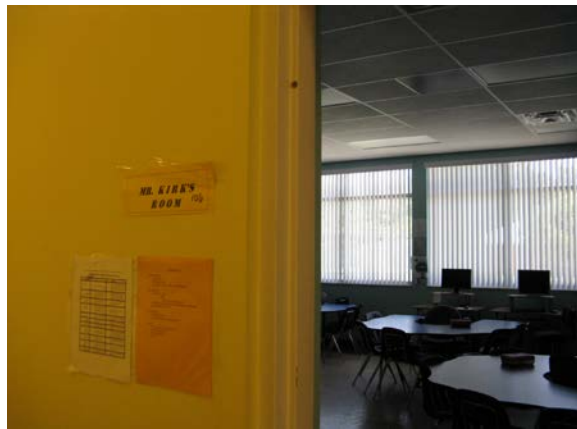
Figure 4-6 - Doorways without ADA compliant signage.

Not all doors in the interior and exterior of the facility have ADA compliant signage. The ADA also requires that wherever exit signage directs emergency egress from a facility, a raised lettering and Braille (tactile) sign, compliant with ADA standards, must also be provided to assist individuals with vision impairments in finding exits. Lastly, the exterior bathroom sign has a screw in the Braille portion of the sign

**ADAAG 703.1, 703.2, and 703.5** state that, permanent rooms shall have signage with visual characters, raised characters, and braille.

**ADAAG 703.4.1** states that, tactile characters on signs shall be located 48 inches minimum and 60 inches maximum above the finished floor.

**ADAAG 703.4.2** states that, at doors, the sign shall be located alongside the door at the latch side.

At all exit doors, provide a tactile exit sign with raised characters and braille. At all permeant rooms, make sure the room's signage has visual characters, raised characters, and Braille. Remount the bathroom signage adjacent to the door, making sure the Braille characters are not being obstructed. Lastly, at all doors, make sure the signage is located between 48 and 60 inches from the floor and mounted on the wall on the latch side of the door (*see ADA 703.4.2 for exceptions to the location of the signage*).

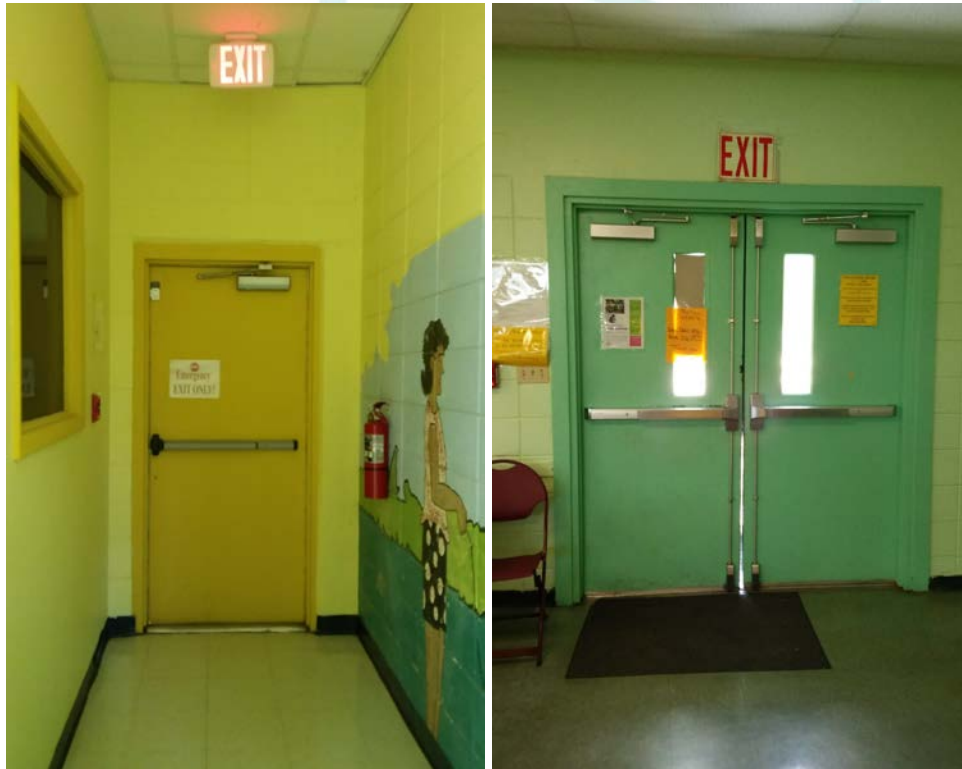
Figure 4-7 – Exit doorways without signage.

**ADAAG 216.4.1, 703.2, 703.3, 703.5** states that, exit doors are required to have tactile signs with visual characters, raised characters, and Braille.

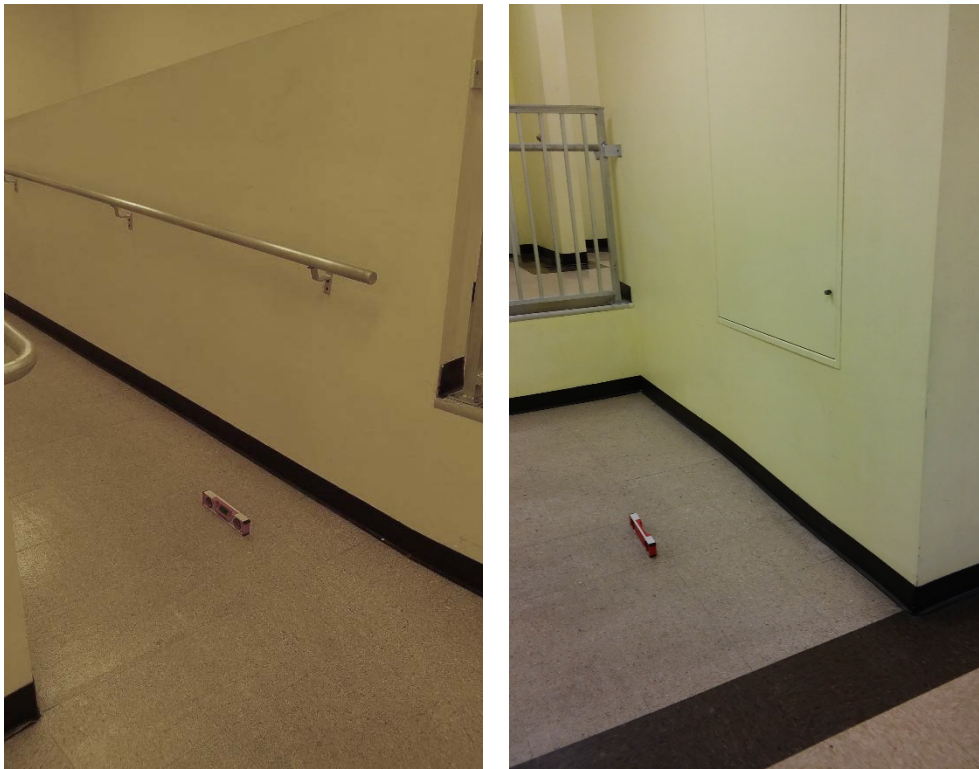
Figure 4-10 – Interior Ramp and Handrails

- The ramp in the newer wing of the facility has sections where the slope is in excess of 9%, in violation of **ADAAG 405.2**.
- The handrails do not extend a minimum of 12" beyond the ramp, in violation of **ADAAG 505.10**.
- Sections of the ramp do not have handrails, per **ADAAG 505.2**.

**ADA 405.2** states that, ramp runs shall have a running slope not steeper than 8.33%.

**ADA 505.10** states that, ramp handrails shall extend horizontally above the landing for 12 inches minimum beyond the top and bottom of ramp runs.

**ADA 505.2** states that, Handrails shall be provided on both sides of stairs and ramps.

Resurface the sections of the ramp where the running slope exceeds 8.33%, per **ADAAG 405.2**. Construct additional handrails and handrail extensions adjacent to the sections of the ramp where they are missing, per **ADAAG 505.2** and **ADAAG 505.10**.
