CITY OF PUNTA GORDA ADA TRANSITION PLAN FINAL REPORT Fire Station #2

October 4, 2017

Prepared For:
City of Punta Gorda
326 West Marion Avenue
Punta Gorda, Florida, 33950

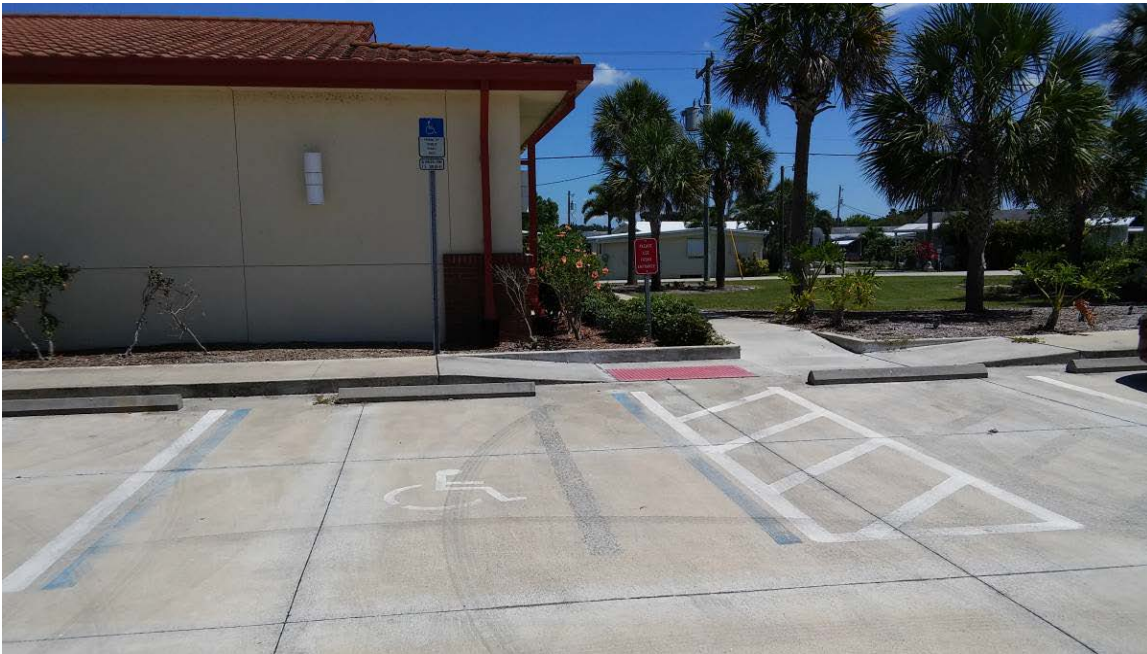
Figure 4-1 - Parking Area

The requisite numbers of accessible parking spaces (1) are provided among the 10 total parking spaces. However, several deficiencies exist in terms of requirements for accessible parking.

FAC 502.6.1 states that, “Each such parking space must be striped in a manner that is consistent with the standards of the controlling jurisdiction for other spaces and prominently outlined with blue paint, and must be repainted when necessary, to be clearly distinguishable as a parking space designated for persons who have disabilities.”

ADAAG 208.2.4 states that, “For every six or fraction of six (accessible) parking spaces required... at least one shall be a van parking.”

ADAAG 502.6 states that, “Signs identifying van parking spaces shall contain the designation ‘van accessible’.”

It is recommended to re-stripe the accessible parking space and adjacent accessible aisle to make it more prominent and be in full compliance with the ADA and FAC. A sign must be added to the existing accessible parking sign with the words “van accessible” on it.

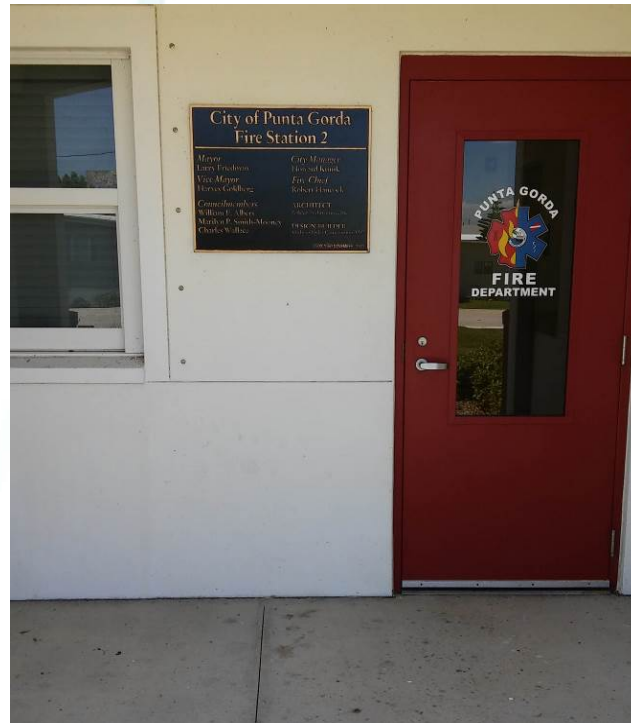
Figure 4-2 - Accessible Route & Entrance

An accessible route from the existing parking area to the facility's only public entrance is provided, as shown below.

There are no recommendations for this section of the facility.

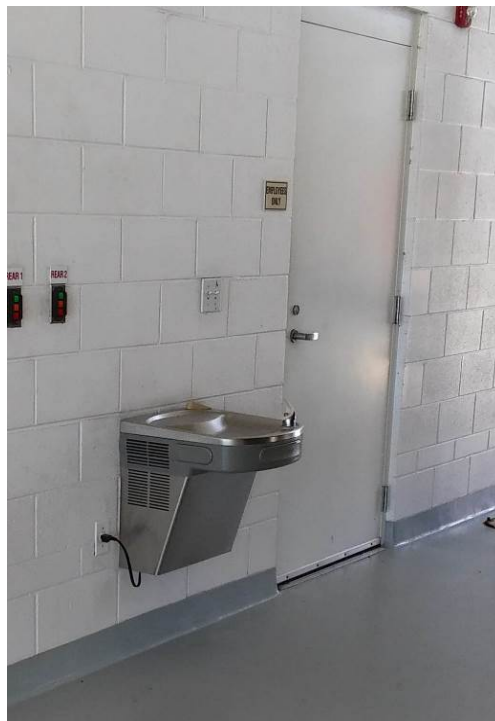
Figure 4-5 - Single Drinking Fountain

There is only one drinking fountain provided at this location.

ADAAG 211.2 states that, no fewer than two drinking fountains shall be provided at each location.

ADAAG 602.4 states that, one drinking fountain shall have a spout height of 36" maximum above the finished floor.

ADAAG 602.7 states that, one drinking fountain shall have a spout height of 38" minimum and 43" maximum above the finished floor.

Install an additional drinking fountain of appropriate height adjacent to the existing drinking fountain. Two drinking fountains are required so that a person in a wheelchair can access the lower fountain while a person with difficulty bending over can access the higher one.

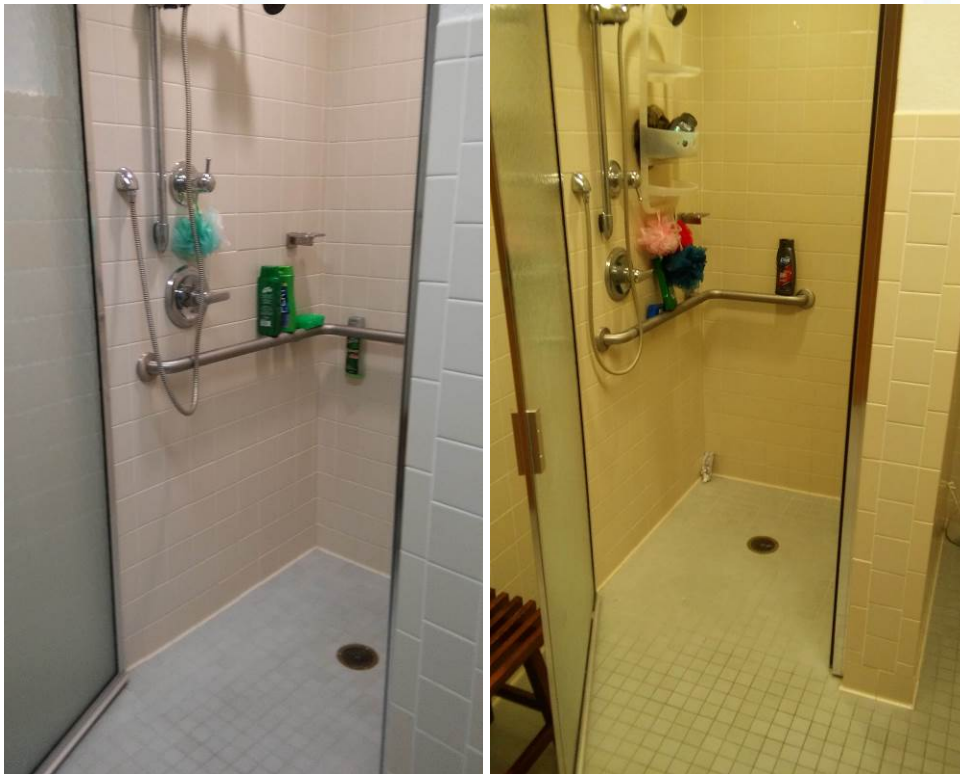
Figure 4-6 - Shower Opening

The locker room shower has a door opening that is 32" in width.

ADAAG 608.2.1 states that, transfer type showers shall have a 36" wide minimum entry.

The shower opening shall be widened to be 36" minimum.
