CITY OF PUNTA GORDA ADA TRANSITION PLAN FINAL REPORT Fire Station #3

October 4, 2017

Prepared For:
City of Punta Gorda
326 West Marion Avenue
Punta Gorda, Florida, 33950

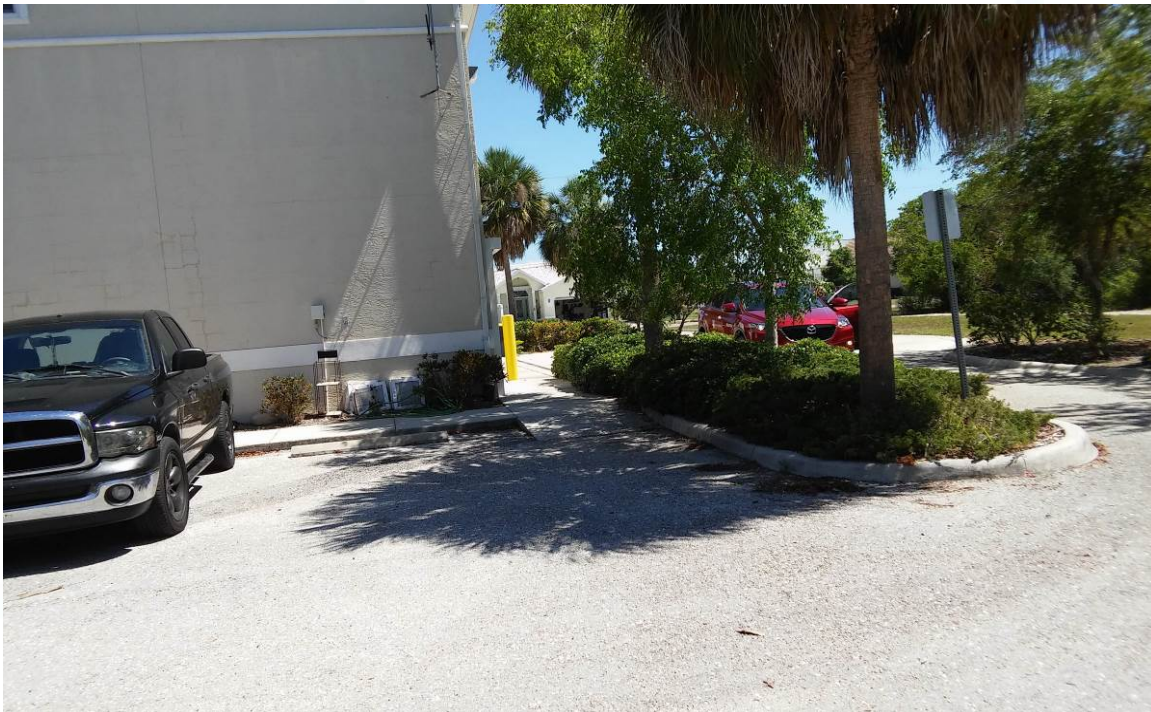
Figure 4-1 - Parking Area

No accessible parking spaces are provided among the 15 total parking spaces. As such, several deficiencies exist in terms of requirements for accessible parking. It was also pointed out that the fire trucks have difficulty maneuvering through the tight turns at the south end of the driveway.

ADA 208.2 states that, for between 1 to 25 total parking spaces, a minimum of 1 is required to be an accessible parking space.

ADAAG 208.2.4 states that, “For every six or fraction of six (accessible) parking spaces required... at least one shall be a van parking.”

FAC 502.2 states that, each accessible parking space must be at least 12 feet wide and shall have an adjacent aisle.

FAC 502.3 states that, access aisles must be 60” wide minimum and extend the full length of the parking space. The Access aisle must connect to an accessible route.

FAC 502.6.1 states that, “Each (accessible) parking space must be striped in a manner that is consistent with the standards of the controlling jurisdiction for other spaces and

prominently outlined with blue paint, and must be repainted when necessary, to be clearly distinguishable as a parking space designated for persons who have disabilities.”

ADAAG 502.6 states that, parking space identification shall include the International Symbol of Accessibility. Signs identifying van parking spaces shall contain the designation “van accessible”. The sign must also have the caption “Parking by Disabled Permit Only” and include the penalty for illegal use.

It is recommended to re-stripe the existing parking space closest to the curb ramp as an accessible parking space with an adjacent aisle – perhaps by removing some the bushes to the east. The parking space and aisle must be marked and have appropriate signage to be in full compliance with the ADA and FAC. The parking space must be level with no slope no greater than 2% in any direction.

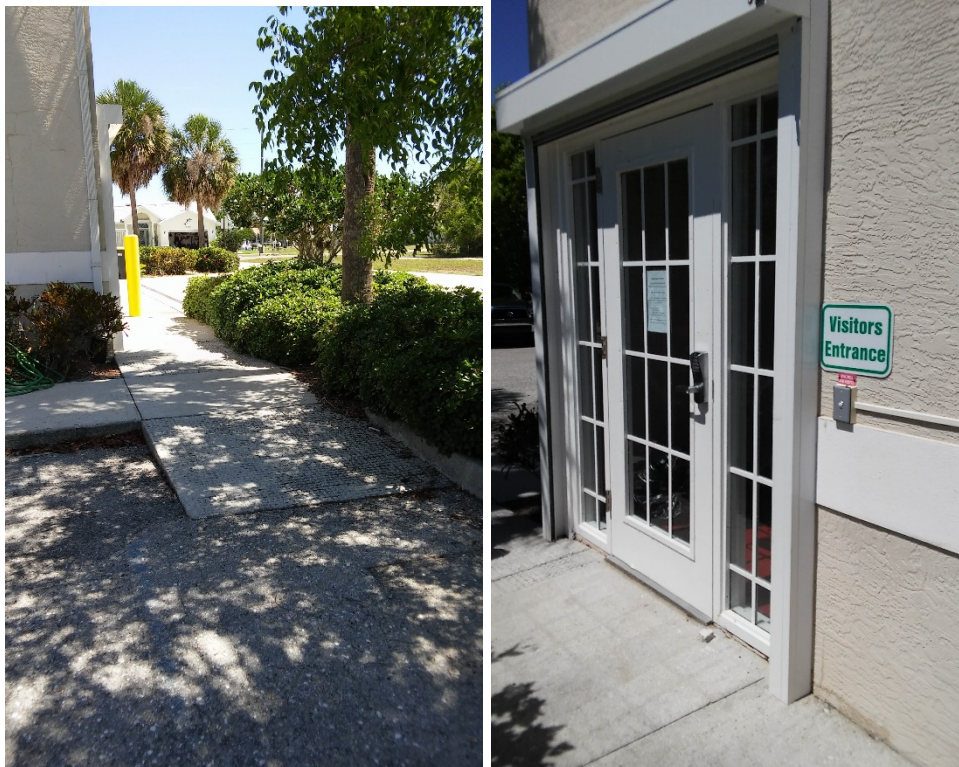
Figure 4-2 – Curb Ramp and Public Entrance

The curb ramp, shown in Figure 4-1 and Figure 4-2, does not have edge protection and is potentially located within the aisle of the future accessible parking space. There is a 7.9% slope at the public entrance’s doorway. The interior lift is not currently operable.

ADA 405.9 states that, “Edge protection... shall be provided on each side of ramp runs.”

ADA 502.4 states that, “Access aisles shall be the same level as the parking space they serve. Changes in level are not permitted.”

ADA 404.2.4 illustrates that, a clear floor space must be provided at the doorway.

ADA 305.2 states that, floor or ground surfaces of a clear floor space must not have a slope steeper than 2%.

Remove the existing curb ramp and adjust the slope of the accessible path to the north and west to compensate for the change in level. Resurface the clear floor space adjacent to the entrance to have a slope no greater than 2% for a distance as specified in ADA 404.2.4. The lift must be maintained so it is functioning correctly.

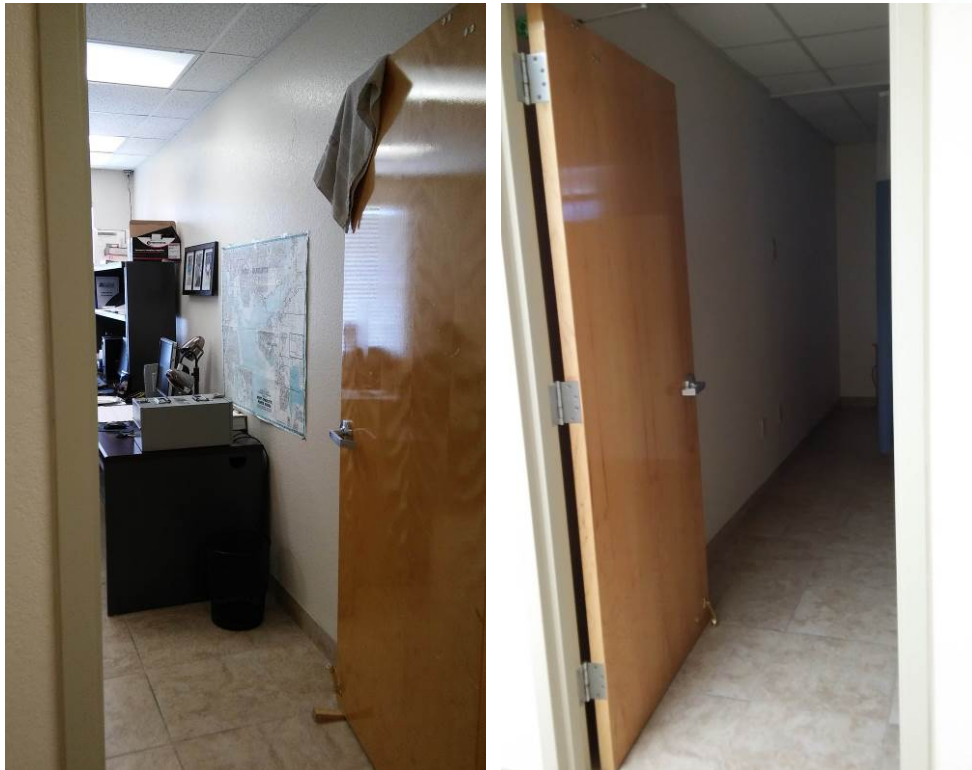
Not all doors in the interior of the facility have ADA compliant signage. The ADA requires that wherever exit signage directs emergency egress from a facility, a raised lettering and Braille (tactile) sign compliant with ADA standards must also be provided to assist individuals with vision impairments in finding exits.

ADAAG 216.4.1 states that, exit doors are required to have tactile signs.

ADAAG 703.3 states that, exit doors are required to have signage with raised characters and braille.

ADAAG 703.5 states that, exit doors are required to have signage with visual characters.

ADAAG 703.1, 703.2, and 703.5 state that, permanent rooms shall have signage with visual characters, raised characters, and braille.

Figure 4-4 - Doorways without signage.=

At exit doors, provide a tactile exit sign with raised characters and braille. At all permanent rooms, make sure the room's signage has visual characters, raised characters, and braille.

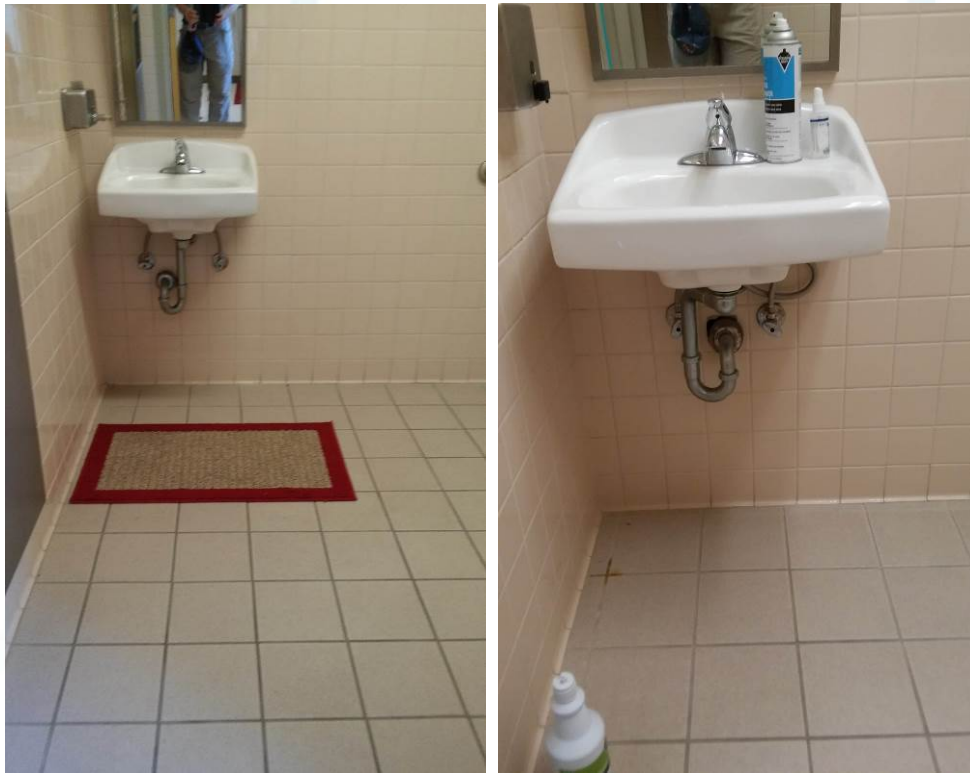
Figure 4-5 – Restroom Sinks

The pipes for the men's and women's restroom sinks are not covered.

ADAAG 606.5 states that, "Water supply and drain pipes under lavatories and sinks shall be insulated to protect against contact."

Cover the pipes under all of the restroom sinks.
