CITY OF PUNTA GORDA ADA TRANSITION PLAN FINAL REPORT Hector House Plaza

October 4, 2017

Prepared For:
City of Punta Gorda
326 West Marion Avenue
Punta Gorda, Florida, 33950

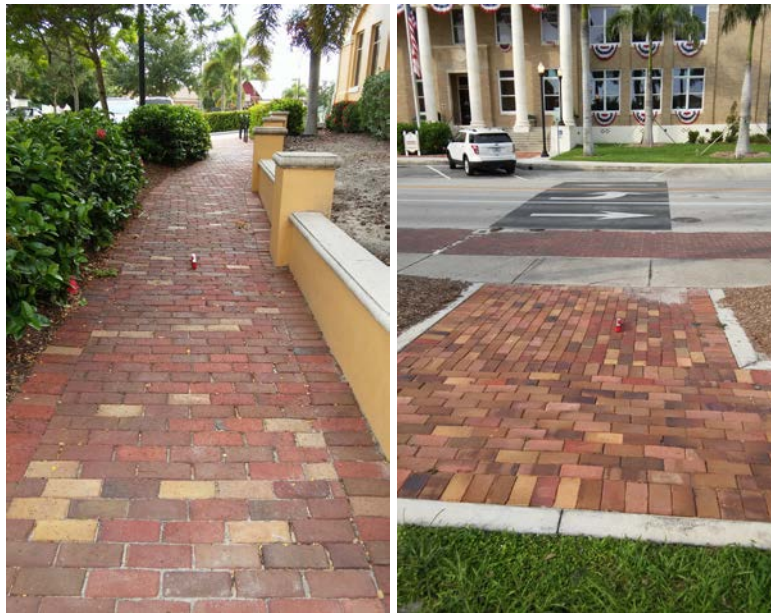
Figure 4-1: Non-Accessible Running Slopes

Sections of the accessible route leading to and from the two accessible parking spaces have non-accessible cross and running slopes. Figure 4-1 shows locations with running slopes of approximately 6%. Figure 4-2 shows locations with cross slopes of approximately 3%.

ADAAG 403.3 states, “The running (perpendicular) slope of a walking surfaces shall not be steeper than 5%. The cross (perpendicular) slope of a walking surface shall not be steeper than 2%.”

- The locations that have non-compliant running slope must be either resurfaced so that the cross slope does not exceed 5%, as specified in **ADAAG 403.3**, or
 - The section of the accessible route with a running slope greater than 5% must be retrofitted into an ADA compliant ramp, per **ADAAG 405**.
- The locations that have non-compliant cross slope must be resurfaced so that the cross slope does not exceed 2%, as specified in **ADAAG 403.3**.
