# Punta Gorda

## CITY OF PUNTA GORDA ADA TRANSITION PLAN FINAL REPORT Herald Court Alley

October 4, 2017

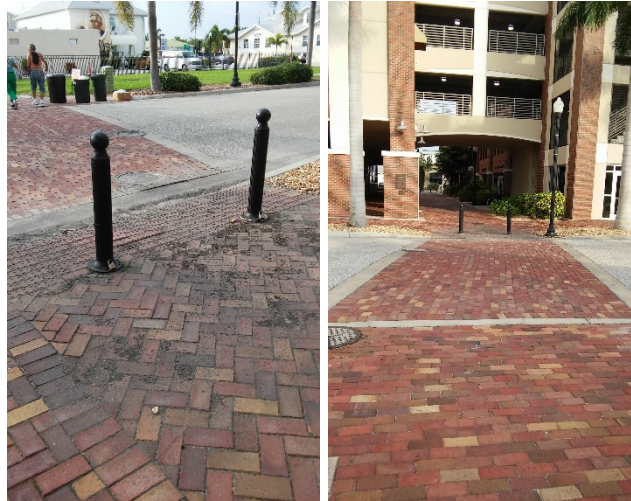
**Figure 4-1: Pedestrian crossings**

Shown below are two views of the Herald Court crosswalk, leading to/from the Herald Court Alley. The south side has detectable warnings, but they are not high contrast and there appears to be debris gathered at the crossing, perhaps from a drainage issue. The north side curb ramp is missing detectable warnings.

**ADAAG 302.1** states that, “Floor or ground surfaces shall be stable, firm, and slip resistant.”

**ADAAG 705.1.3** states that, “Detectable warning surfaces shall contrast visually with adjacent walking surfaces either light-on-dark, or dark-on-light.”

- Replace the brick detectable warning on the south end of the crosswalk so that it is high contrast.
- Maintain the area where debris accumulates due to inadequate drainage.
- Install a detectable warning on the north side of the crosswalk.

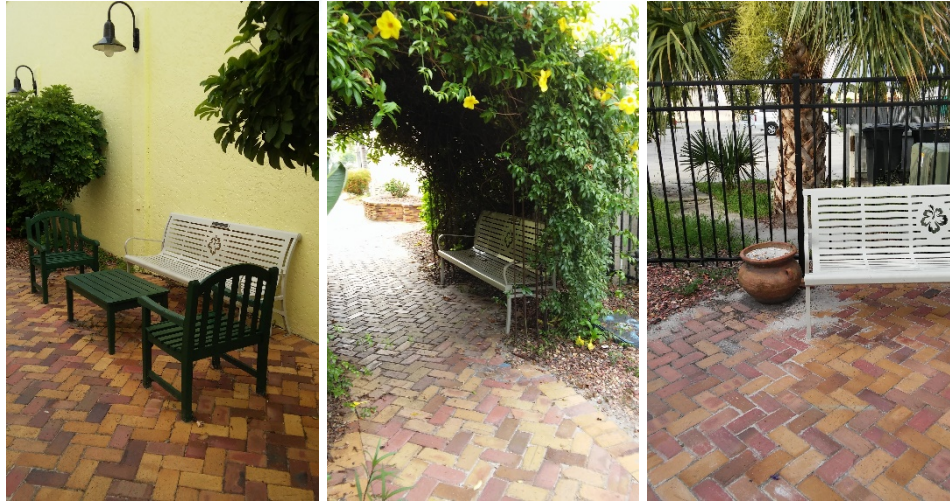
Figure 4-2

Shown in Figure 4-2, are three non-accessible benches located within Herald Court Alley.

**ADAAG 903.2** states that “Clear floor or ground space shall be positioned at the end of the bench seat and parallel to the short axis of the bench.”

**PROWAG R212.6** states that “At least 50 percent, but no less than one, of benches at each location shall provide clear space adjacent to the bench. The clear space shall be located either at one end of the bench.”

**ADAAG 305.3/PROWAG R404** states that “The clear floor or ground space shall be 30 inches minimum by 48 inches minimum.”

- Either remove the non-accessible benches or relocate the benches/obstruction to make at least one side of the benches accessible.

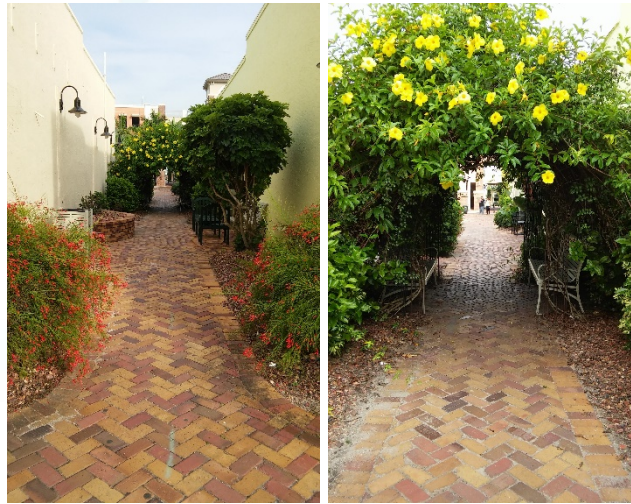
Figure 4-3

Vertical clearance is defined as the minimum unobstructed vertical passage space. Vertical clearance is often limited by obstacles such as building overhangs, tree branches, signs, and awnings. Shown below in Figure 4-3, the path contains low hanging shrubbery protrudes and obstructs Herald Court Alley.

**ADAAG 307.2** states that, “objects with leading edges more than 27 inches and not more than 80 inches above the finish floor or ground shall protrude 4 inches maximum horizontally into the circulation path.

- While the trellis itself is an acceptable height, the flower vines hanging down from it shall be trimmed or raised so that its height is a minimum of 80”. This will prevent visitors with visual impairments from making contact with the low hanging foliage.
