Punta Gorda

**CITY OF PUNTA GORDA
ADA TRANSITION PLAN FINAL REPORT
Hounds on Henry Dog Park**

October 4, 2017

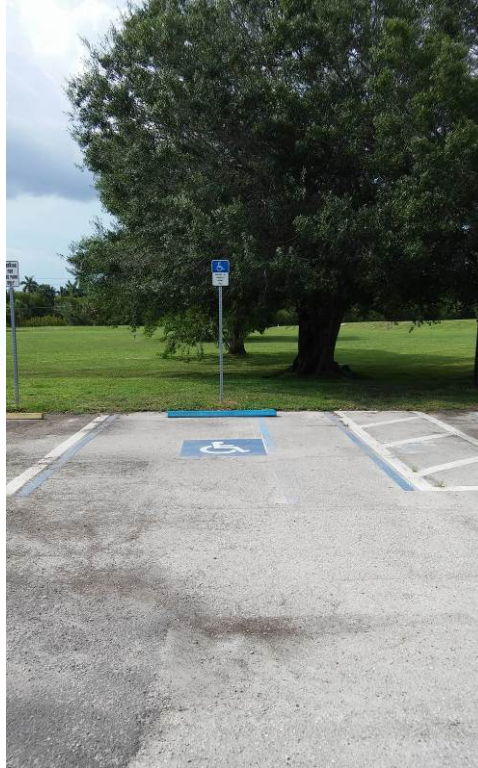
Figure 4-1 – Accessible Parking Space

One (1) accessible parking space is provided among the 49 total parking spaces. As such, several deficiencies exist in terms of requirements for accessible parking.

ADA 208.2 states that, for between 26 to 50 total parking spaces, a minimum of 2 are required to be an accessible parking space.

ADAAG 208.2.4 states that, “For every six or fraction of six (accessible) parking spaces required... at least one shall be a van parking.”

ADAAG 502.6 states that, parking space identification shall include the International Symbol of Accessibility. Signs identifying van parking spaces shall contain the designation “van accessible”. The sign must also have the caption “Parking by Disabled Permit Only” and include the penalty for illegal use.

It is recommended to re-stripe a non-accessible parking space to create an additional accessible parking space with an adjacent aisle. The parking space and aisle must be marked and have appropriate signage to be in full compliance with the ADA and FAC.

The parking space and level must have a slope no greater than 2% in any direction. At least one of the two accessible parking spaces shall have a sign designating it as being van accessible. Both accessible parking spaces must have signage indicating the penalty for illegal use.

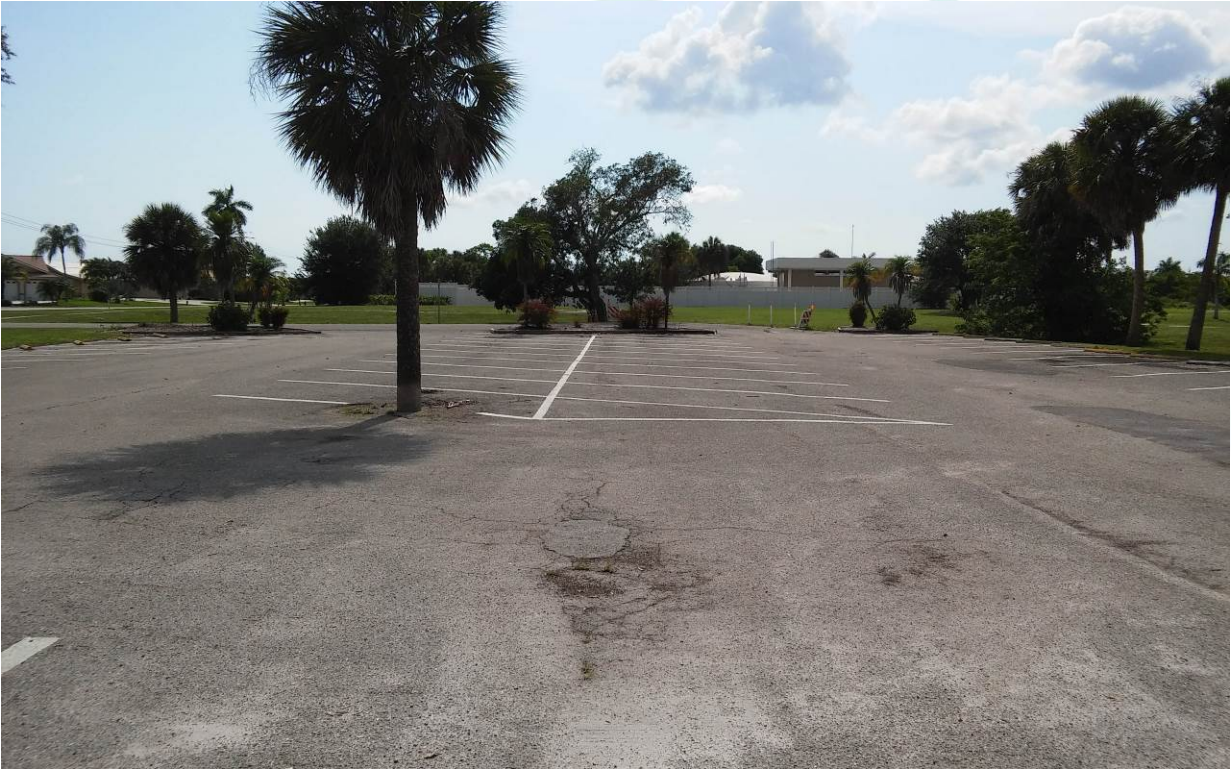
Figure 4-2 - Parking Area

Parking spaces are provided for use by patrons of the Hounds on Henry dog park. The surface parking lot is located on the west side of the park, and is accessed via a driveway from West Henry Street.

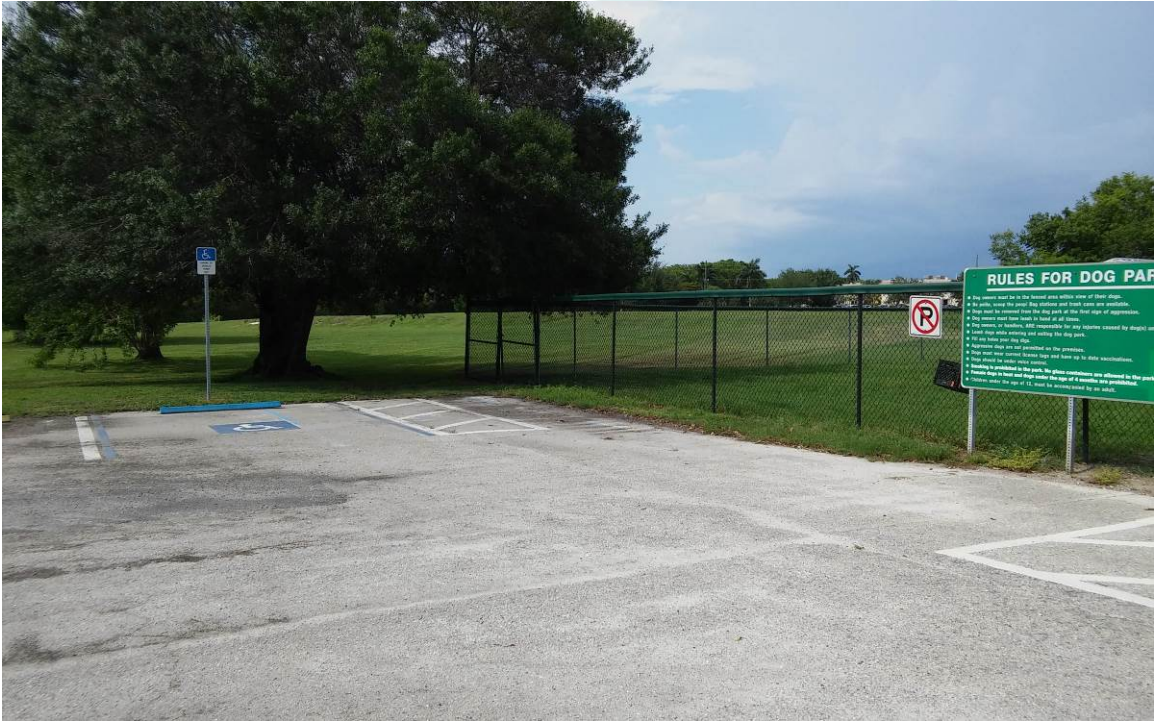
Figure 4-3 – Access aisle and accessible route

The access aisle, adjacent to the existing accessible parking space, shown in Figure 4-3, ends and does not connect to the accessible route leading to the park's entrance. In addition, a portion of the asphalt adjacent to the park's gate, shown in Figure 4-4, is a tripping hazard.

FAC 502.3 states that, "Accessible routes must connect parking spaces to accessible entrances. In parking facilities where the accessible route must cross vehicular traffic, marked crossing enhance pedestrian safety."

It is recommended that the existing access aisle as well as the access aisle for the additional proposed accessible parking space be striped in such a way as to have them connect to the park's entrance. In addition, the access aisle should be striped so it does not compel users to walk or wheel behind parked vehicles that are not their own. The section of pavement adjacent to the park's gate shall be resurfaced or beveled to remove the non-compliant changes in level.

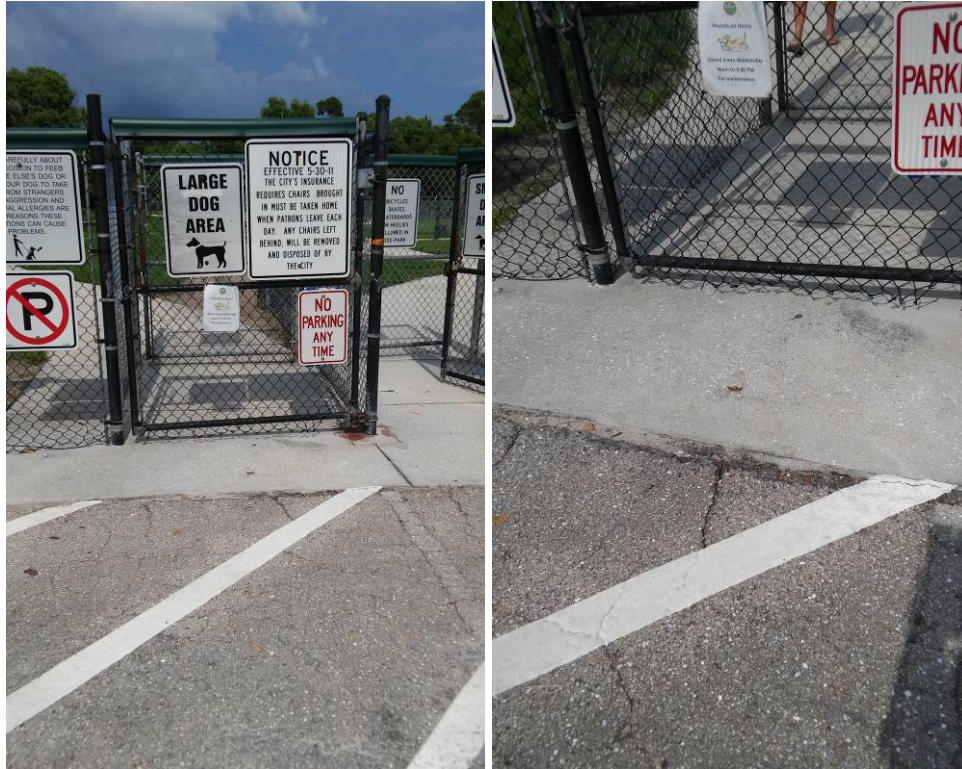
Figure 4-4 - Entrance gate

ADAAG 303.2 states that, "Changes in level of ¼" high maximum shall be permitted to be vertical."

ADAAG 303.3 states that, "Changes in level of ¼" high minimum and ½" high maximum shall be beveled with a slope not steeper than 1:2."

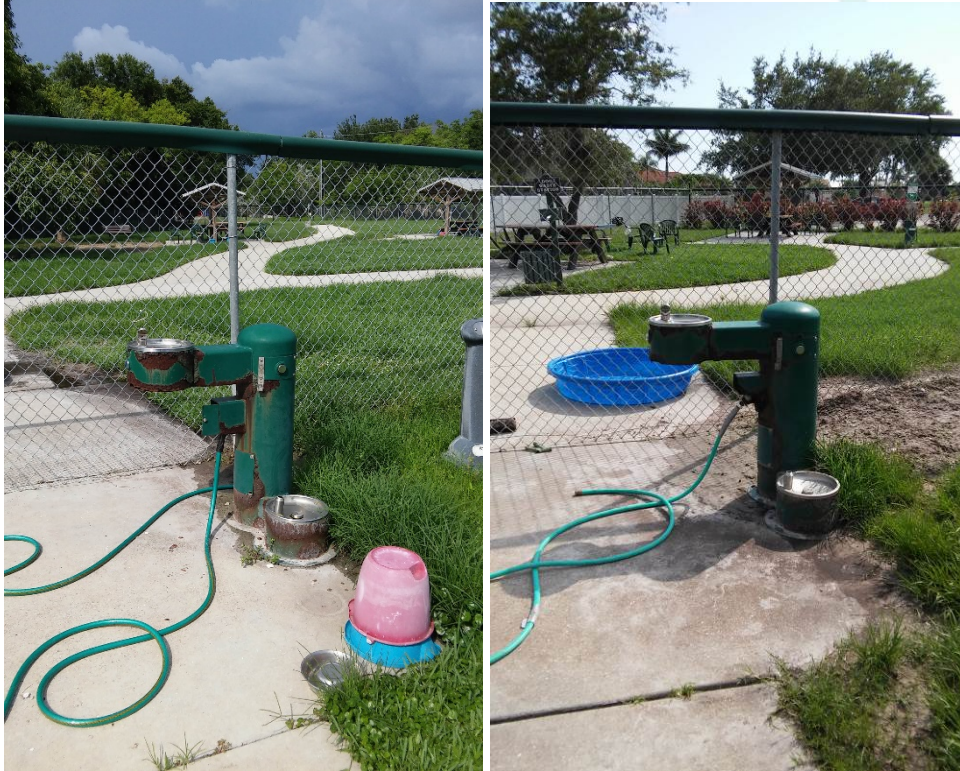
Figure 4-5 – Drinking Fountains.

In two instances within the park, only one drinking fountain was provided. In addition, the existing drinking fountains are extremely rusted.

ADAAG 211.2 states that, no fewer than two drinking fountains shall be provided at each location.

ADAAG 602.4 states that, one drinking fountain shall have a spout height of 36" maximum above the finished floor.

ADAAG 602.7 states that, one drinking fountain shall have a spout height of 38" minimum and 43" maximum above the finished floor.

Install additional drinking fountains of appropriate height adjacent to the existing drinking fountains. In addition, consider replacing/refurbishing the existing, rusted drinking fountains.

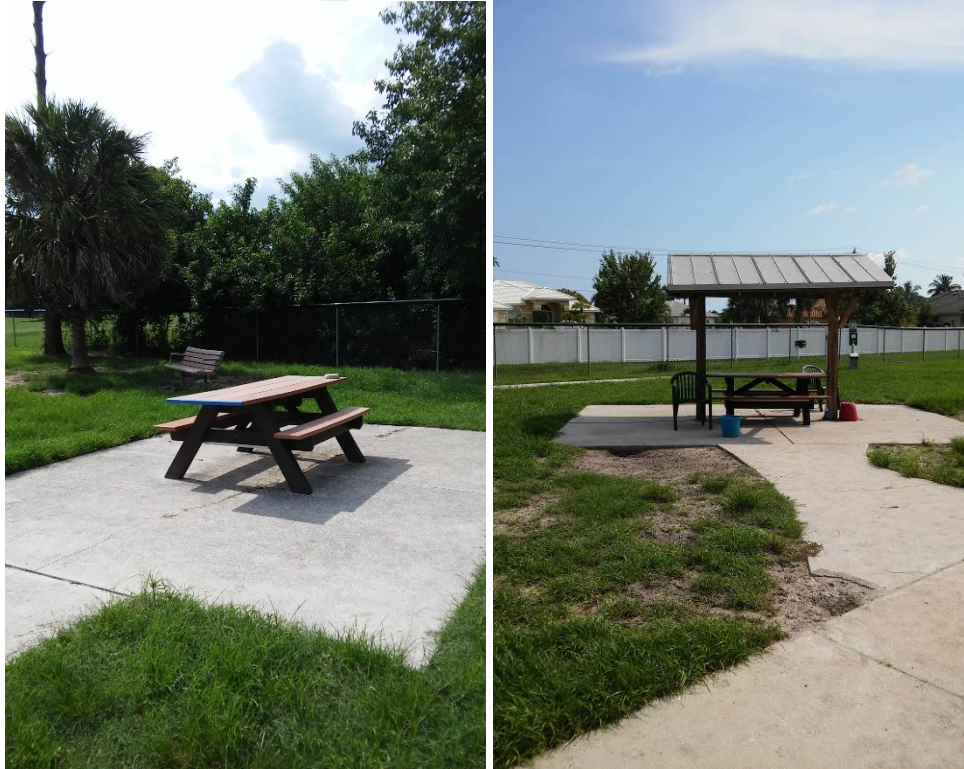
Figure 4-7 – Picnic Tables.

In the large dog park section, there is 1 picnic table with accessible features, which is located in an area exposed to the elements. There are 3 non accessible tables located under small pavilions.

Make sure at least one pavilion contains a picnic table with accessible elements so that visitors using the accessible tables have the option to use a sheltered table as well.
