# Punta Gorda

## CITY OF PUNTA GORDA ADA TRANSITION PLAN FINAL REPORT Linear Park

October 4, 2017

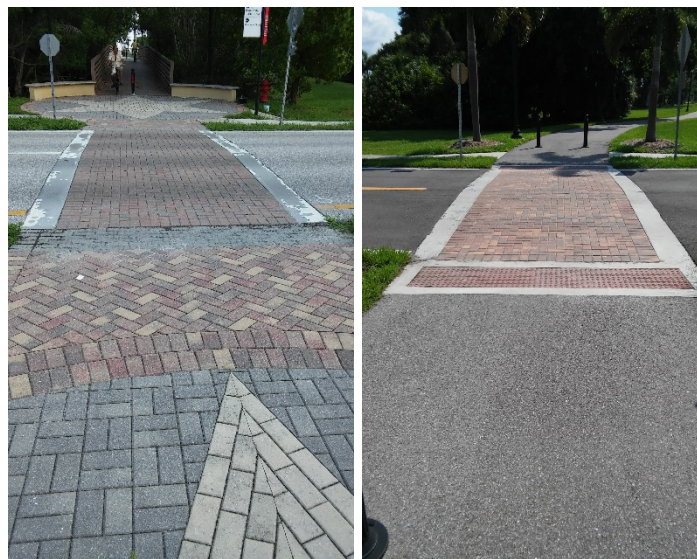
Figure 4-1 - Detectable warning surfaces along the multi-use trail.

Shown below, in Figure 4-1, are two curb ramps that are not ADA compliant. Issues include having the detectable warning not be high contrast and not extending the full length of the curb ramp. A map detailing the locations of these barriers to accessibility is shown in Appendix A.

**ADAAG 705.1.3** states that, “Detectable warning surfaces shall contrast visually with adjacent walking surfaces either light-on-dark, or dark-on-light.”

**FDOT Design Standards 304** states that, “Detectable warnings shall extend the full width of the ramp and to a depth of 2’.”

- Replace the dark brick detectable warning surface with a high contrast color.
- The detectable warning does not extend the full width of the curb ramp. Add additional detectable warnings to the sides of these ramps.

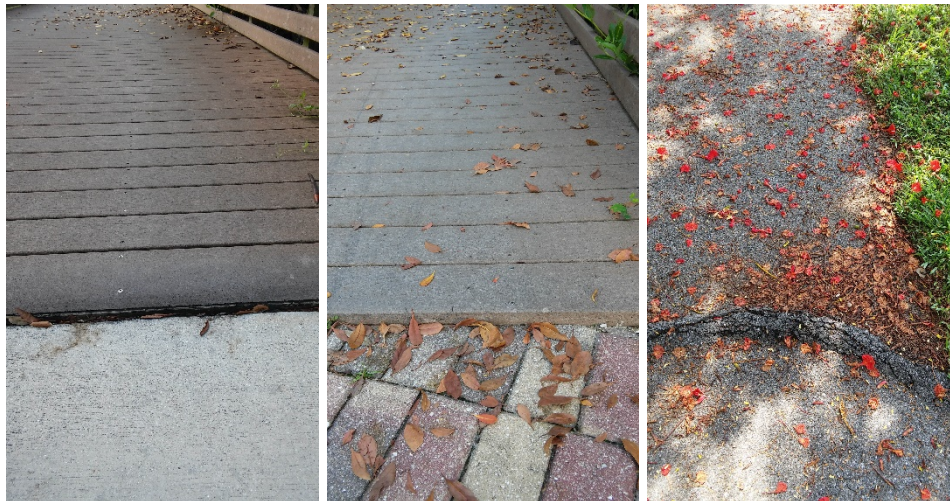
Figure 4-2: Tripping hazards located along pathway.

Figure 4-2 illustrates some of the deficiencies along the shared path that have been impacted by changes in level, which can pose as a tripping hazards. Figure 4-3 illustrates some of the tripping hazards found at the artificial turf exercise area, such as exposed edges and tree roots growing under the artificial turf. Additional photos of other tripping hazards can be found in Appendix A.

**ADAAG 303.2** states that, “Changes in level of  $\frac{1}{4}$ ” high maximum shall be permitted to be vertical.”

**ADAAG 303.3** states that, “Changes in level of  $\frac{1}{4}$ ” high minimum and  $\frac{1}{2}$ ” high maximum shall be beveled with a slope not steeper than 1:2.”

- Add additional pavement to both ends of the pedestrian bridge to eliminate or minimize the change in level.
- Resurface the section of trail where tree roots cause the pavement to buckle and create a tripping hazard.
  - Be aware that while not an ADA violation at this time, additional sections of the trail have tree roots that may potentially cause tripping hazards in the near future.
- Remove the tree roots growing under the artificial turf that are creating a tripping hazard.
- Securely fasten the edges of the artificial turf to the ground so the seams are no longer tripping hazards.

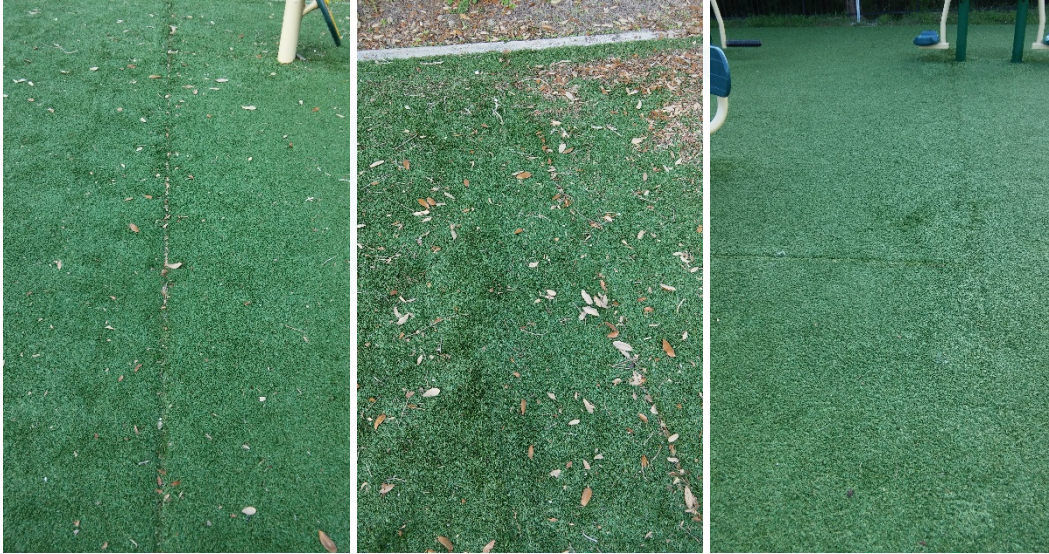
Figure 4-3 – Artificial Turf Tripping Hazards.

**ADAAG 302.2** states that, “Carpet shall be securely attached... Exposed edges of carpet shall be fastened to the floor surfaces...”

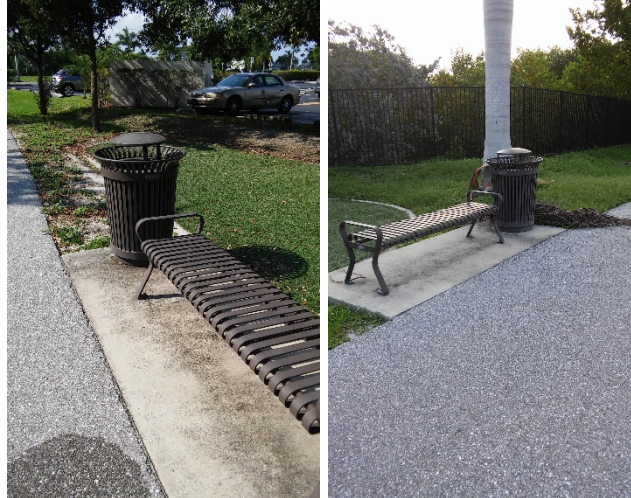
Figure 4-3: Benches.

The benches shown below, in Figure 4-3, are provided adjacent to the trail's exercise area. Adjacent to some of these benches is a garbage can that blocks access to the bench.

**ADAAG 903.2** states that "Clear floor or ground space shall be positioned at the end of the bench seat and parallel to the short axis of the bench."

**PROWAG R212.6** states that "At least 50 percent, but no less than one, of benches at each location shall provide clear space adjacent to the bench. The clear space shall be located either at one end of the bench."

**ADAAG 305.3/PROWAG R404** states that "The clear floor or ground space shall be 30 inches minimum by 48 inches minimum."

- Adjust the location of the garbage cans to create a 30"x48" clear and level floor space adjacent to the benches.
  - Make sure the garbage can is relocated so as to be within reach range from a level section of the trail.

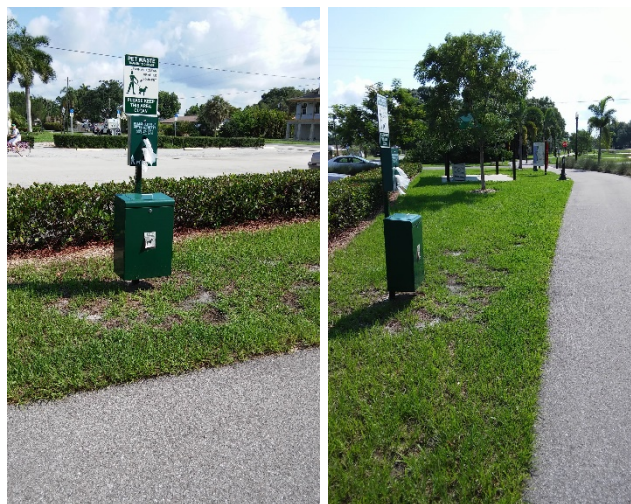
Figure 4-4 – Dog Station

A dog station was found to have barriers to accessibility, as it was located too far from the paved trail to be accessible.

**ADAAG 308.3** states that, "Where a clear floor space allows a parallel approach to an element, the high side reach shall be 48" maximum above the ground... An obstruction

shall be permitted between the clear floor space and the element where the depth of the obstruction is 10" maximum."

- Pave a level accessible route to the dog station so that visitors can access it via a connection from the trail.

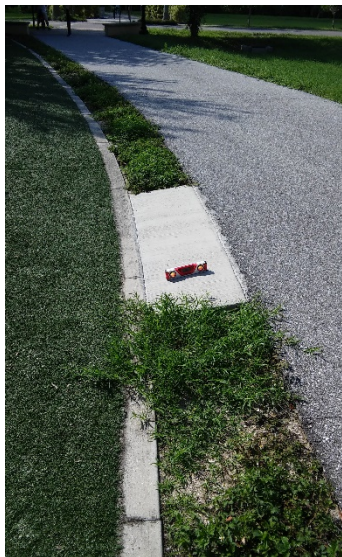
Figure 4-5 – Ramp Slope.

The running slope on one of the ramps from the trail to the exercise area is 16%, as shown in Figure 4-5.

**ADAAG 405.2** states that, "Ramp runs shall have a running slope no steeper than 8.33%."

- Repave the ramp to have a slope no steeper than 8.33%.

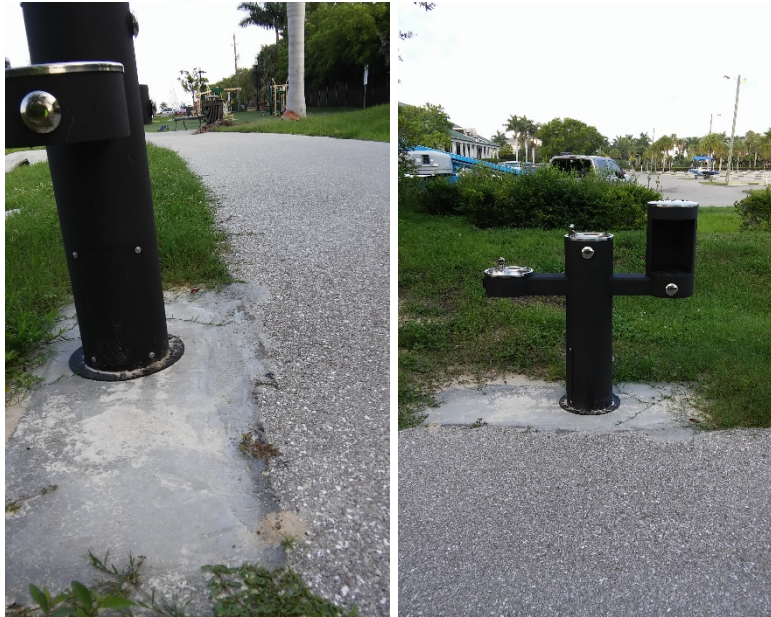
Figure 4-1 – Drinking Fountains.

One set of water fountains were found to have barriers to accessibility. The surface adjacent to the fountains was uneven and not a level clear floor space, as required for wheelchair users.

**ADAAG 305.2** and **305.3** generally state that “The clear floor space shall be a minimum of 30” by 48” with slopes no greater than 2%.”

Resurface the area adjacent to and underneath the drinking fountains so that there is a clear and level floor space with a slope no greater than 2% in any direction.

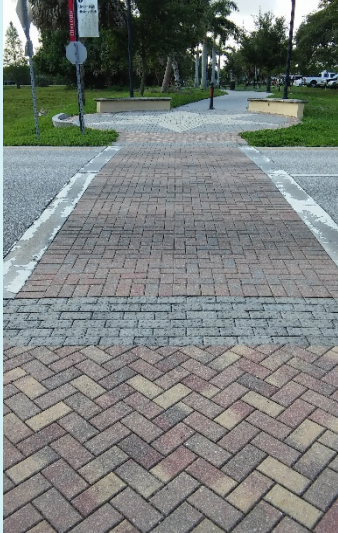
| Map Item | Description & Recommendation | Photo(s) |
|---|--|--|
| <p><b>D1</b></p> | <p>The detectable warning is not high contrast when placed adjacent to brick pavers.</p> <p>Replace the existing detectable warning with a yellow or red detectable warning.</p> | |

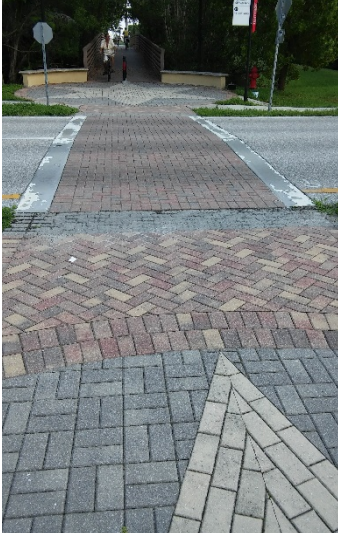
| Map Item | Description & Recommendation | Photo(s) |
|---|--|--|
| <p><b>D2</b></p> | <p>The detectable warning is not high contrast when placed adjacent to brick pavers.</p> <p>Replace the existing detectable warning with a yellow or red detectable warning.</p> | |

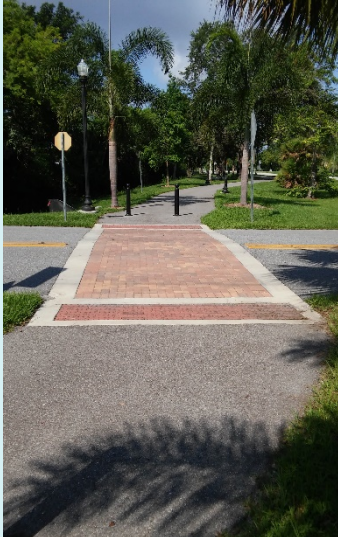
| Map Item | Description & Recommendation | Photo(s) |
|---|---|--|
| <p><b>D7</b></p> | <p>The detectable warning does not cover the full width of the curb ramp.</p> <p>Add additional detectable warning to the sides so that the entire width of the curb ramp has a detectable warning surface on it.</p> | |

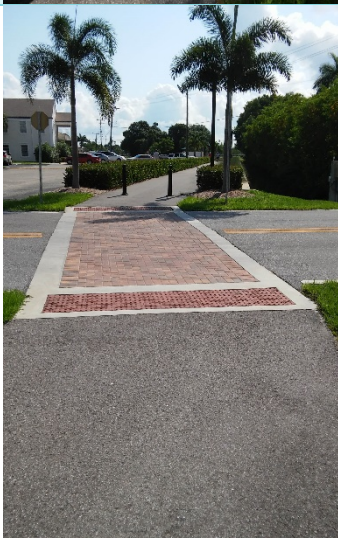
| Map Item | Description & Recommendation | Photo(s) |
|---|---|--|
| <p><b>D8</b></p> | <p>The detectable warning does not cover the full width of the curb ramp.</p> <p>Add additional detectable warning to the sides so that the entire width of the curb ramp has a detectable warning surface on it.</p> | |

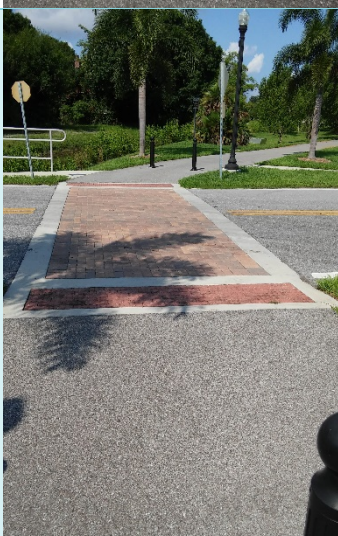
| Map Item | Description & Recommendation | Photo(s) |
|---|---|--|
| <p><b>D9</b></p> | <p>The detectable warning does not cover the full width of the curb ramp.</p> <p>Add additional detectable warning to the sides so that the entire width of the curb ramp has a detectable warning surface on it.</p> | |

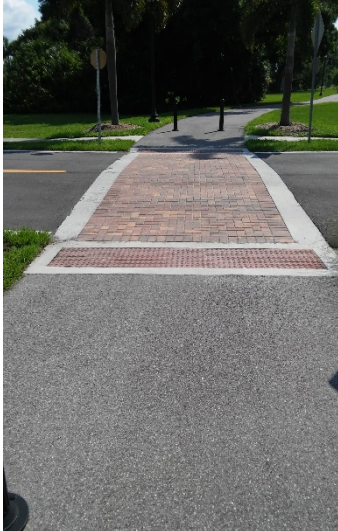
| Map Item | Description & Recommendation | Photo(s) |
|---|---|--|
| <p><b>D10</b></p> | <p>The detectable warning does not cover the full width of the curb ramp.</p> <p>Add additional detectable warning to the sides so that the entire width of the curb ramp has a detectable warning surface on it.</p> | |

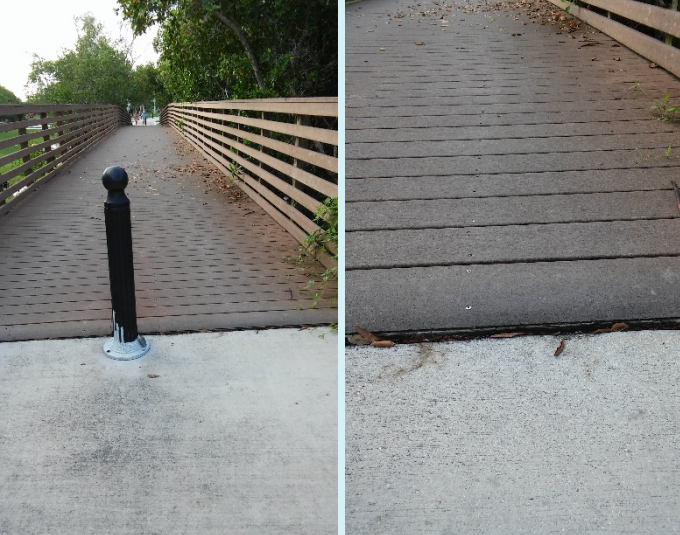
| Map Item | Description & Recommendation | Photo(s) |
|---|---|--|
| <p><b>T1</b></p> | <p>There is a 2" lip beveled to 1" at the end of the pedestrian bridge.</p> <p>Add additional pavement to the ends of the pedestrian bridge to eliminate or minimize the change in level.</p> | |

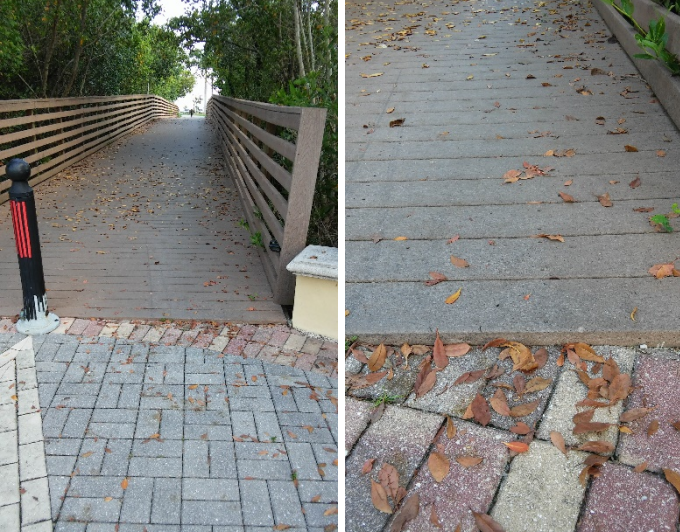
| Map Item | Description & Recommendation | Photo(s) |
|---|---|--|
| <p><b>T2</b></p> | <p>There is a 1" lip at the end of the pedestrian bridge.</p> <p>Add additional pavement or bevel the board at the end of the pedestrian bridge to eliminate or minimize the change in level.</p> | |
