CITY OF PUNTA GORDA ADA TRANSITION PLAN FINAL REPORT Marion Avenue Plaza

October 4, 2017

Prepared For:
City of Punta Gorda
326 West Marion Avenue
Punta Gorda, Florida, 33950

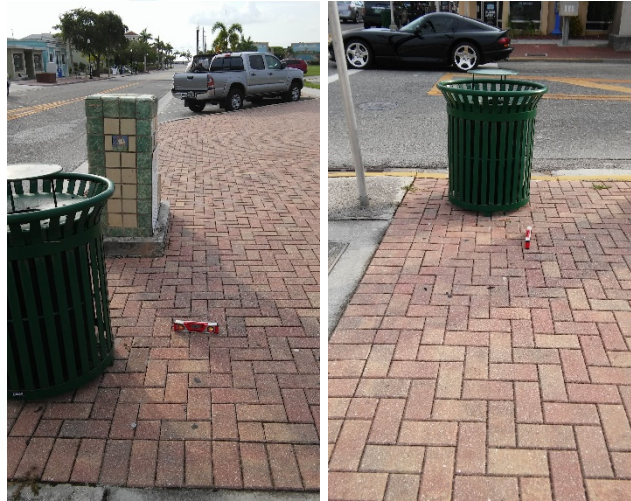
Figure 4-1: Garbage Can

There are a handful of amenities within Marion Avenue Plaza. The brick pavers adjacent to the garbage can, located on the north corner of Marion Avenue and Taylor Street, have a slope of approximately 4%.

ADAAG 302.1 states that, “Floor or ground surfaces shall be stable, firm, and slip resistant.”

ADAAG 305.2 states that, “Floor and ground surfaces of a clear floor or ground space shall comply with 302. Slopes not steeper than 2% shall be permitted.”

ADAAG 305.3/PROWAG R404 states that “The clear floor or ground space shall be 30 inches minimum by 48 inches minimum.”

- Relocate the garbage can to a location where the adjacent clear floor space has a 2% maximum slope in all directions.

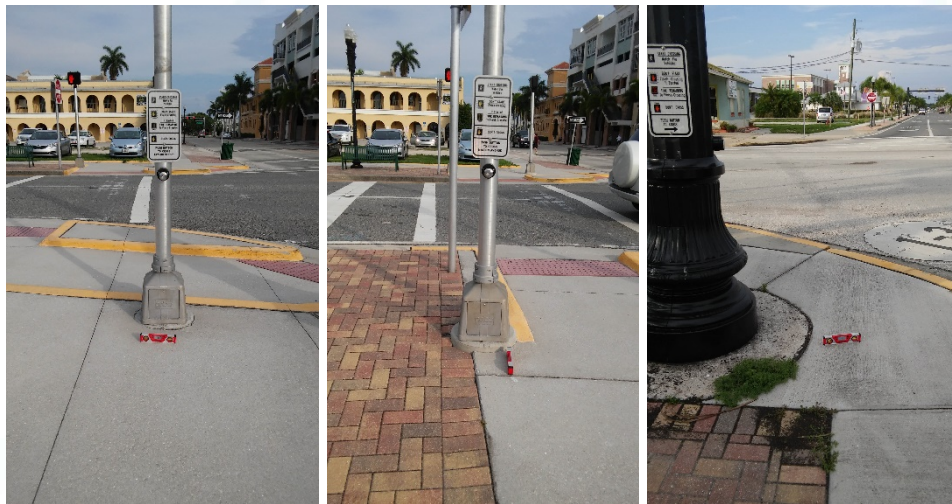
Figure 4-2 – Pedestrian Push Buttons

Shown in Figure 4-2, are three non-accessible pedestrian push buttons, located within Marion Avenue Plaza.

- The clear floor space adjacent to each of the pedestrian push buttons on the north corner of the Marion Avenue and Taylor Street intersection is approximately 3.5%.
- The clear floor space adjacent to the pedestrian push button on the west corner of the Marion Avenue and US 41 Northbound intersection is approximately 3%.

ADAAG 302.1 states that, “Floor or ground surfaces shall be stable, firm, and slip resistant.”

ADAAG 305.2 states that, “Floor and ground surfaces of a clear floor or ground space shall comply with 302. Slopes not steeper than 2% shall be permitted.”

ADAAG 305.3/PROWAG R404 states that “The clear floor or ground space shall be 30 inches minimum by 48 inches minimum.”

- Resurface the pavement adjacent to the two pedestrian push buttons on the north corner of Marion Avenue and Taylor Street so that the maximum slope of the adjacent clear floor space is 2%.
- Resurface the pavement adjacent to the pedestrian push buttons on the west corner of Marion Avenue and US 41 Northbound so that the maximum slope of the adjacent clear floor space is 2%.
