CITY OF PUNTA GORDA ADA TRANSITION PLAN FINAL REPORT Nature Park

October 4, 2017

Prepared For:
City of Punta Gorda
326 West Marion Avenue
Punta Gorda, Florida, 33950

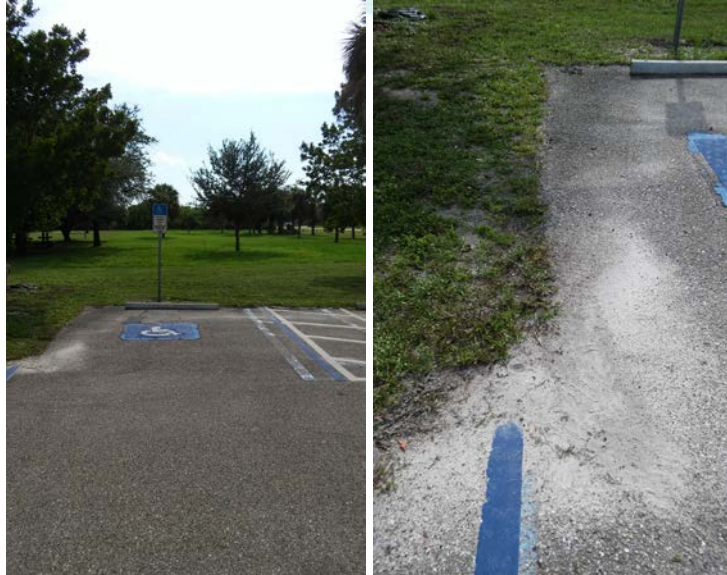
Figure 4-1 – Existing Accessible Parking Space in the East Lot

1. **FAC 502.2** states that “Each (accessible) parking space must be at least 12 feet wide.” Due to the overgrown grass, the accessible parking space in the eastern parking lot does not meet the minimum requirements.

Remove and maintain the overgrown grass adjacent to the accessible parking space in the eastern parking lot so that the accessible parking space is a minimum of 12' wide, per **FAC 502.2**.

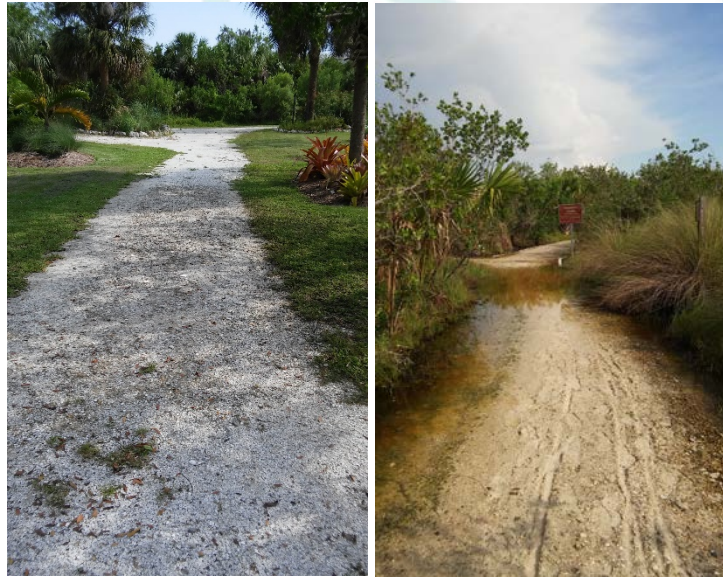
Figure 4-2 – Non-Accessible Routes within Nature Park

Nature Park's trails are made up of crushed shell, rock, and sand; are not firm, stable, or slip resistant per **ADAAG 302.1**; and are therefore not accessible as shown in the photos below. There are a variety of amenities that are only accessible via this trail, as further described in the following section.

Due to the age and presence of amenities within this park, it is recommended that a portion of Nature Park be paved to create an accessible route so all users may access it and use its amenities.

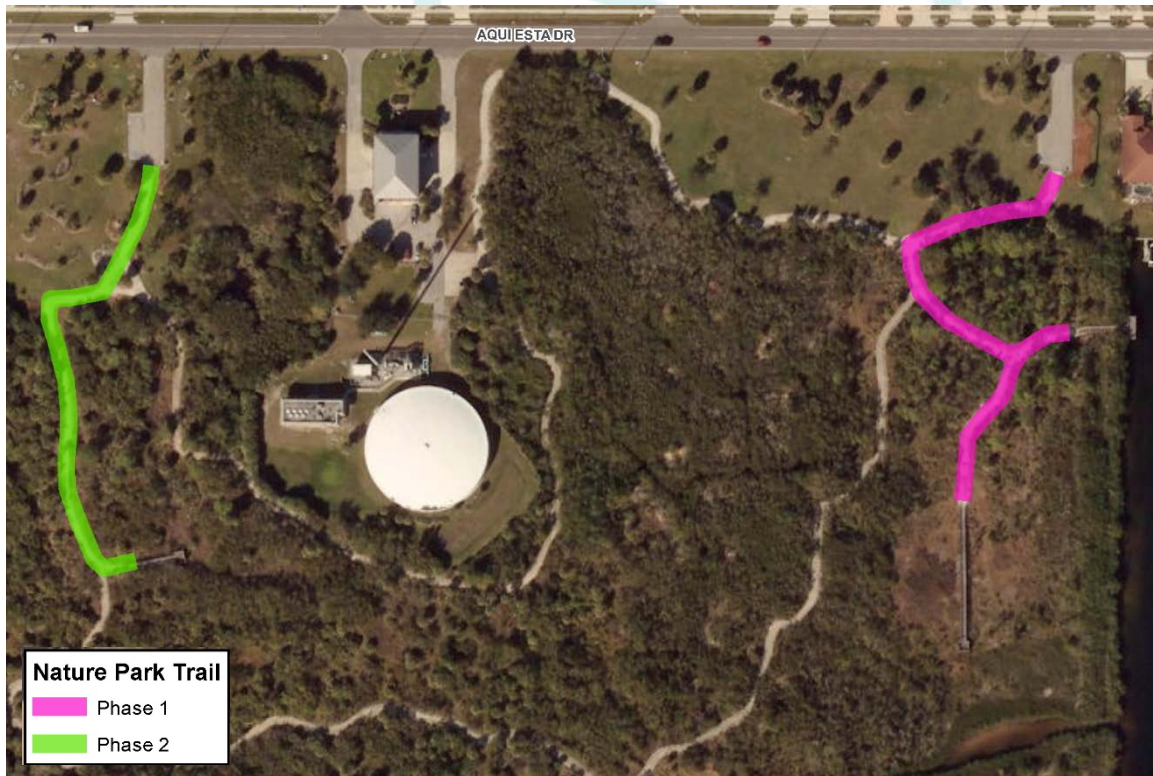
Figure 4-3 – Non-Accessible Routes within Nature Park

As further described in the following sections, it is recommended that at a minimum, an accessible route be created between the accessible parking spaces and the nearby fishing pier and boardwalks/observation decks. As shown in the map below, creating an accessible route between these locations can be accomplished via a two-phase paving program.

For this proposed phasing program, Phase 1 is approximately 650 feet and Phase 2 is approximately 575 feet in length. Be aware that if the route is less than 60 inches wide, level passing spaces complying with **ADAAG 403.5.3**, with a minimum dimension of 60"x60" or T-shaped spaces complying with **ADAAG 304.3.2**, must be provided every 200 feet.

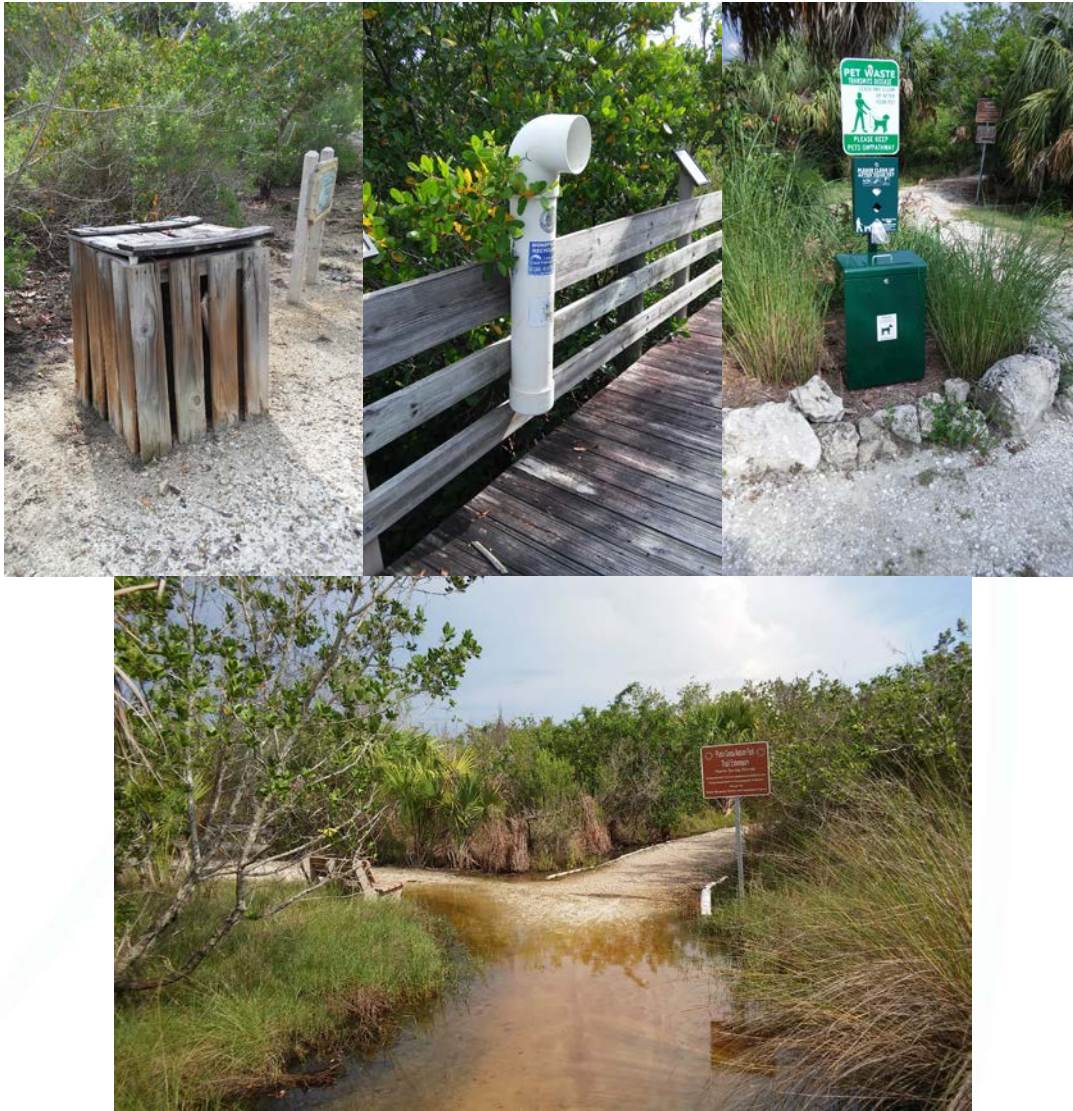
Figure 4-4 – Non-Accessible Amenities

There are a variety of amenities located throughout Nature Park. However, only one picnic table is currently accessible. With this one exception, the barriers to accessibility are primarily due to the non-accessible material the trail is made from thereby making the amenities not accessible.

ADAAG 302.1 states that, “Floor and ground surfaces shall be stable, firm, and slip resistant.”

ADAAG 305.2 generally states that “a 30”x48” firm, stable, slip resistant, and level clear floor space shall be provided.”

ADAAG 308.2 states that, “The high forward reach shall be 48” maximum and 15” minimum.”

When paving the accessible trail, make sure the adjacent amenities are also accessible. This may entail relocating the amenities to be adjacent to the trail or paving an additional section of trail to reach the amenities. In addition, it was found that the fish-hook return pipe is located above 48” high and shall need to be lowered to be ADA accessible.

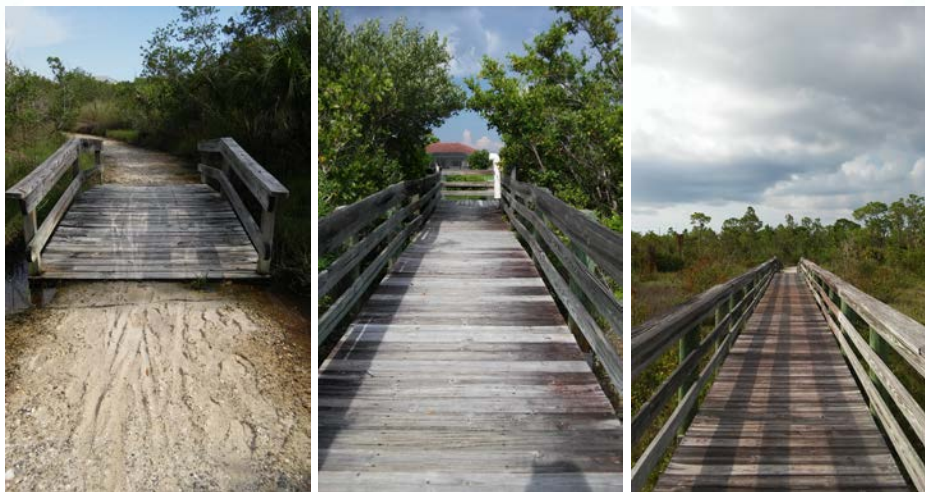
There are non-compliant slopes/lack of handrails on the bridges, boardwalks, and fishing piers located within the park

- The bridge has a running slope of 7.5%.
- The fishing pier has a running slope of 6.6%.
- The boardwalk has a running slope of 7.7%.
- None of these locations have ADA compliant handrails or edge protection.

Figure 4-5 – Sediment accumulation along path

If a paved accessible route is created in Nature Park, it is recommended that it be connected to a boardwalk or fishing pier. If so, these features shall also need to be modified to make them ADA compliant, such as adding ADA compliant handrails and edge protection where the slope is steeper than 5%.
