# Punta Gorda

## CITY OF PUNTA GORDA ADA TRANSITION PLAN FINAL REPORT Public Works Complex

October 4, 2017

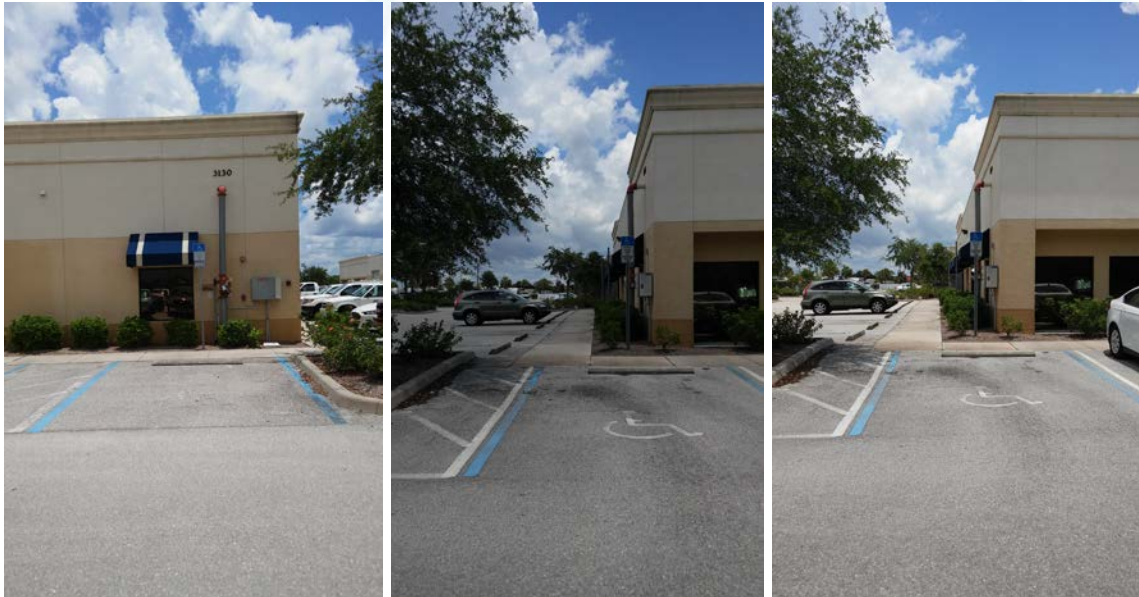
Figure 4-1 - Parking Area

A total of 6 accessible parking space are provided, 4 adjacent to the Public Utilities building and 2 by the Public Works building among the 261 total parking spaces. Some deficiencies exist in terms of requirements for accessible parking.

**ADAAG 208.3** states that, accessible parking spaces that serve a particular building shall be located on the shortest accessible route from the parking to an accessible entrance.

**ADAAG 208.2.4** states that, “For every six or fraction of six (accessible) parking spaces required at least one shall be a van parking.”

**ADAAG 502.4** states that, “Parking spaces and access aisles shall not have slopes steeper than 2%.”

**FAC 502.6.1** states that, “Each (accessible) parking space must be striped in a manner that is consistent with the standards of the controlling jurisdiction for other spaces and prominently outlined with blue paint, and must be repainted when necessary, to be clearly distinguishable as a parking space designated for persons who have disabilities.”

- All of the accessible parking spaces should be relocated to be closer to the entrance of the two facilities.
- The accessible parking space on the side of the public works building has a running slope of 4%. Accessible parking spaces must not have a slope greater

- than 2%. The slope must either be regraded or the accessible parking space relocated to a level area.
- A sign must be mounted that identifies one of the accessible parking space as being “van accessible”.
  - It is recommended to restripe the faded markings designating the accessible parking and aisles.

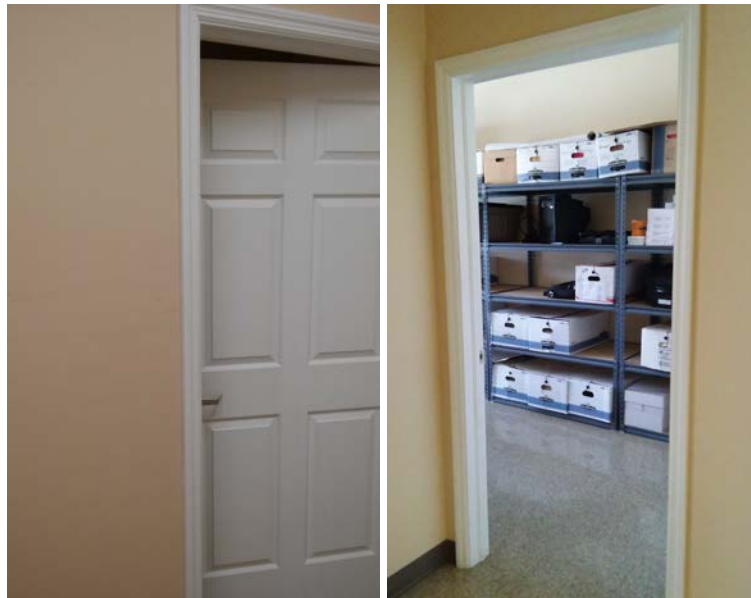
Not all doors in the interior and exterior of the facility have ADA compliant signage. The ADA also requires that wherever exit signage directs emergency egress from a facility, a raised lettering and Braille (tactile) sign, compliant with ADA standards, must also be provided to assist individuals with vision impairments in finding exits.

**ADAAG 703.1, 703.2, and 703.5** state that, permanent rooms shall have signage with visual characters, raised characters, and braille.

**ADAAG 703.4.1** states that, tactile characters on signs shall be located 48 inches minimum and 60 inches maximum above the finished floor.

**ADAAG 703.4.2** states that, at doors, the sign shall be located alongside the door at the latch side.

Figure 4-2 – Example of a doorway without ADA compliant signage.

At all exit doors, provide a tactile exit sign with raised characters and braille. At all permeant rooms, make sure the room's signage has visual characters, raised characters, and Braille.

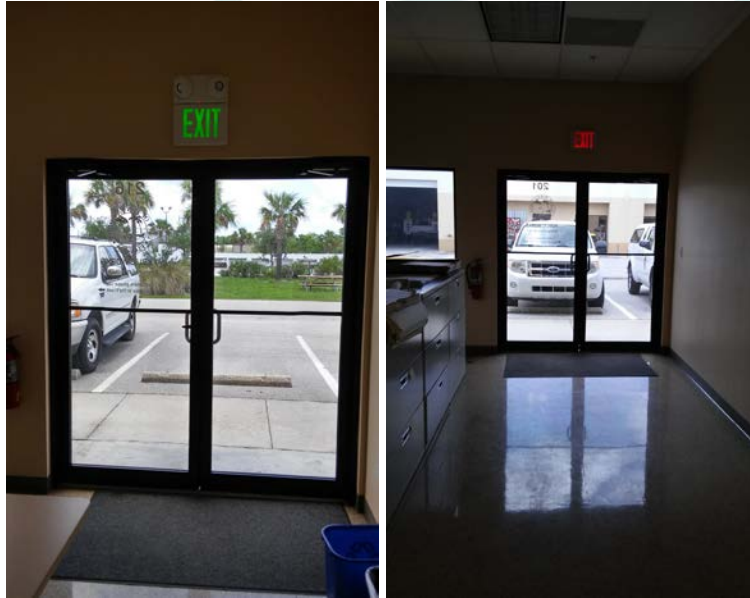
**ADAAG 216.4.1, 703.2, 703.3, 703.5** states that, exit doors are required to have tactile signs with visual characters, raised characters, and Braille.

Figure 4-3 – Examples of exit doorways without ADA compliant signage.

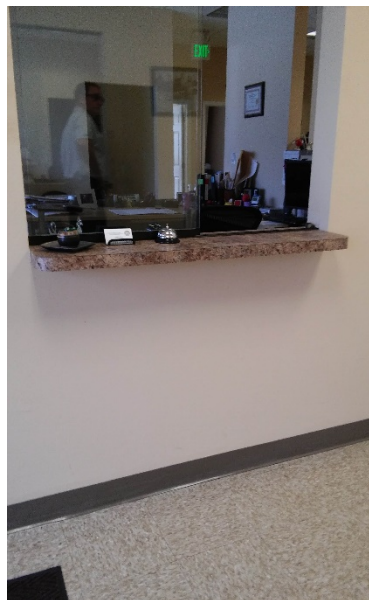
Figure 4-5 – Lobby counter

- The ramp leading to the IT room has a 33% slope.
- The counter in the lobby is 38" high.

**ADAAG 904.4** states that, "A portion of the counter space that is 30" long minimum and 36" high shall be provided."

- The ramp to the IT room has an excessive slope. The ramp should be extended to allow for a maximum of an 8.3% slope, complying with ADA section 405.
- The service counter is too high at 38". A 30" wide section of counter shall be constructed at 36" high. Be sure that the counter does not protrude more than 4" from the wall, to prevent it from being considered a protruding object.
