CITY OF PUNTA GORDA ADA TRANSITION PLAN FINAL REPORT Shreve Street

October 4, 2017

City of Punta Gorda
326 West Marion Avenue
Punta Gorda, Florida, 33950

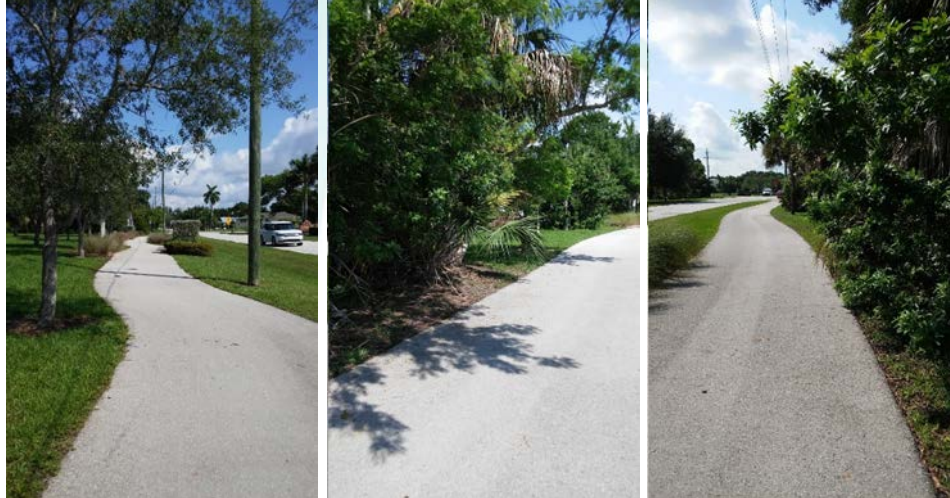
Figure 4-1: Vertical clearance. Map ID's 296, 297, and 298.

Vertical clearance is defined as the minimum unobstructed vertical passage space. Vertical clearance is often limited by obstacles such as building overhangs, tree branches, signs, and awning. As shown below in Figure 4-1, the path contain low hanging tree branches, which do not the minimum standards set forth for protruding objects.

ADAAG 307.2 states that, “objects with leading edges more than 27 inches and not more than 80 inches above the finish floor or ground shall protrude 4 inches maximum horizontally into the circulation path.

Trim and maintain the tree’s branches to meet the minimum vertical clearance. This will prevent users with visual impairment from making contact with the branches.

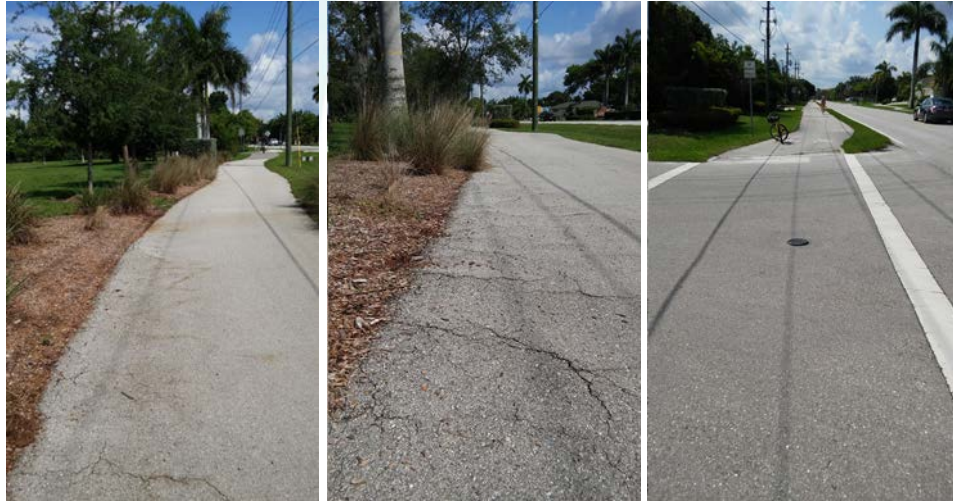
Figure 4-2: Change in level. Map ID's 295, 299, and 300.

Changes in level can cause ambulatory pedestrians to trip or catch the casters of a manual wheelchair, causing the chair to come to an abrupt stop. Changes in level are often caused by tree roots that break through the sidewalk surface. People who are blind or who have low vision might not anticipate changes in level such as a buckling brick sidewalk.

Figures 4-2 through 4-3 illustrate the deficiencies along the shared path that have been impacted by changes in level.

ADAAG 303.2 states that, "Changes in level of $\frac{1}{4}$ " high maximum shall be permitted to be vertical."

ADAAG 303.3 states that, "Changes in level of $\frac{1}{4}$ " high minimum and $\frac{1}{2}$ " high maximum shall be beveled with a slope not steeper than 1:2."

The section of pavement that has been impacted from tree roots must be resurfaced or beveled to remove the non-compliant changes in level. The location in which the utility street covers have impacted change in level should be resurfaced with asphalt or

repositioned to meet the compliant level in changes. Debris that has accumulated from the weather should be cleared to provide a slip resistant path.

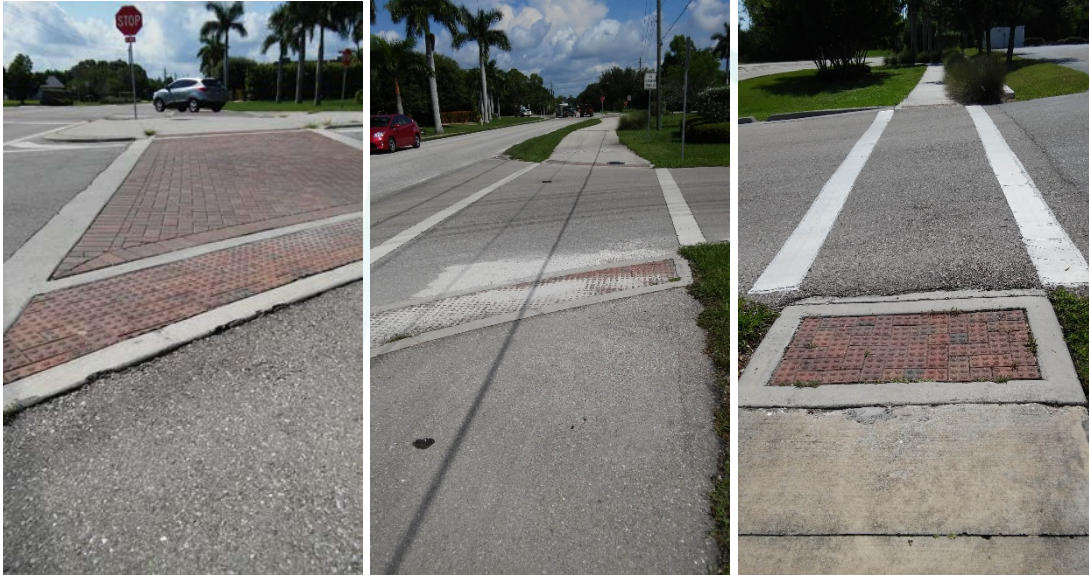
Figure 4-4: Curb ramps with tripping hazards and debris. Map ID's 69, 77, and 90.

ADAAG 406.2 states that, “Counter slopes of adjoining gutters and road surfaces immediately adjacent to the curb ramp shall not be steeper than 1:20. The adjacent surfaces at transitions at *curb ramps* to *walks*, gutters, and streets shall be at the same level.”

Remove debris that has settled onto the accessible path from the inclement weather. Changes in level at the curb ramps should be beveled or leveled out using asphalt or concrete to create a level surface. Shown in Figure 4-4 are photos taken from Shreve Street which provide examples of curb ramps which have detectable warnings that have changes in level or where debris has settled causing the surface to be non-slip resistant, potentially from an issue with improper drainage.

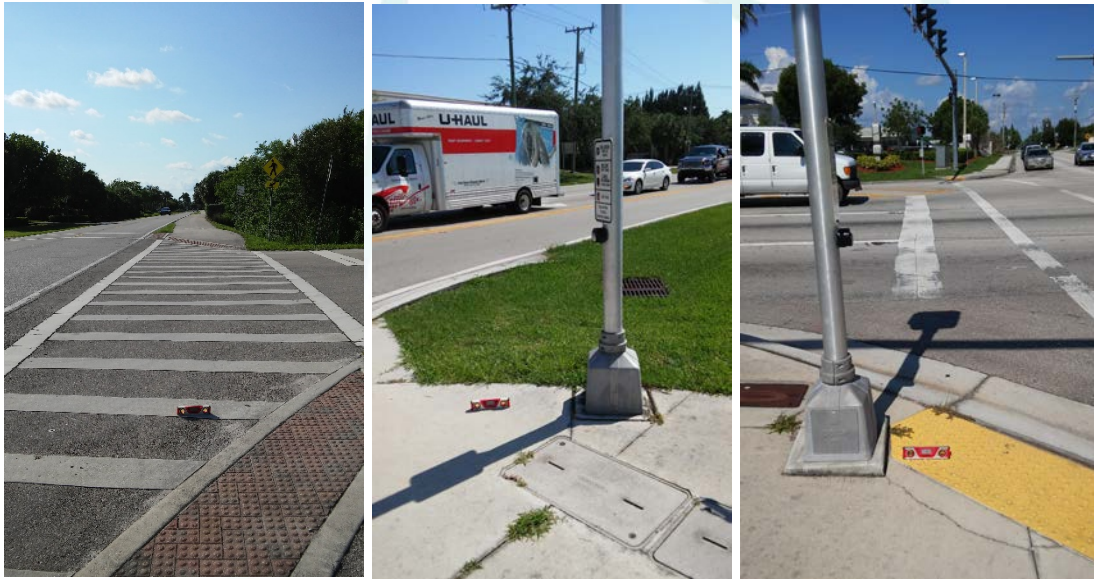
Figure 4-5: Non accessible crosswalk and pedestrian push buttons. Map ID's 793, 791, and 792.

The crosswalk, at the rear entrance to the Palm Auto Mall, item number 793 on the map, has a cross slope of 6%. This is greater than the maximum allowable cross slope of 2%.

In addition, the slope adjacent to the two pedestrian push buttons, on the northwest corner of Pompano Terrace and Tamiami Trail, is between 4% and 7%. The clear floor space at these locations must be level to allow users in wheelchairs the ability to safely push the pedestrian crossing buttons without having the possibility of inadvertently rolling into oncoming traffic.

ADAAG 403.3 states that, "The cross slope of walking surfaces shall not be steeper than 2%."

ADAAG 305.2 states that at clear floor spaces, "slopes not steeper than 2% shall be permitted."

ADAAG 305.3 states that, "the clear floor space shall be 30 inches minimum by 48 inches minimum."

Resurface the crosswalk to have a cross slope no steeper than 2%.

Either resurface the clear floor space adjacent to both of the pedestrian push buttons or relocate the pedestrian push buttons to a location that has a maximum slope of 2% in any direction for a 30 inch by 48 inch area.

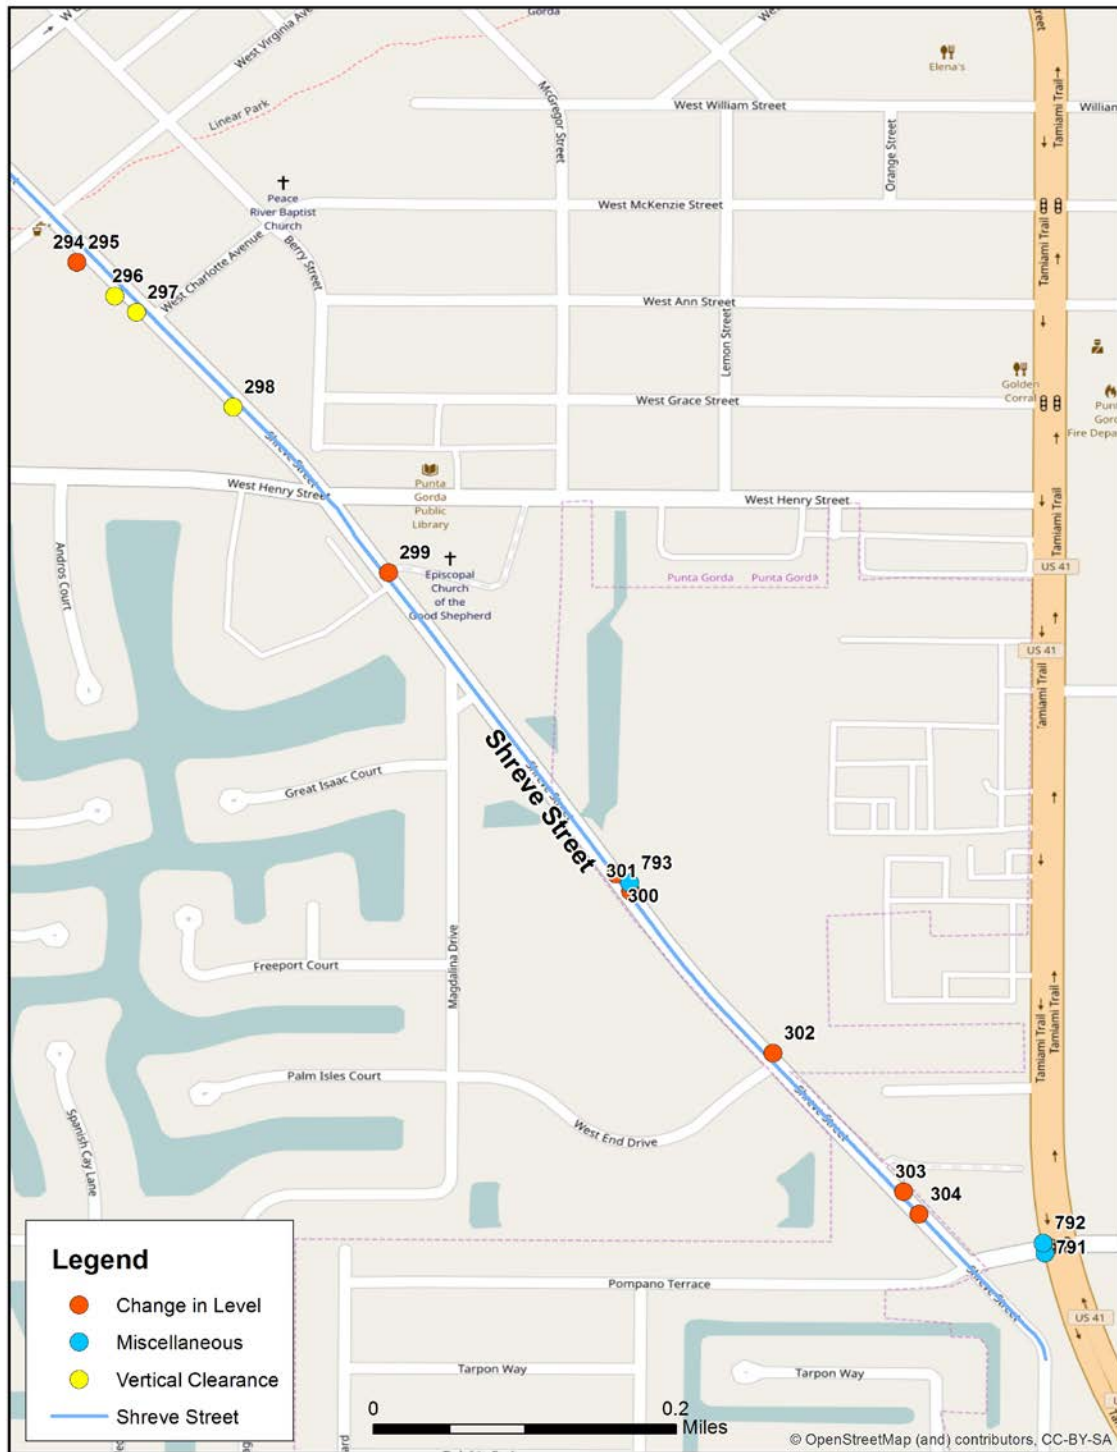
Figure 4-6: Map showing barriers to accessibility.
