# **CITY OF PUNTA GORDA ADA TRANSITION PLAN FINAL REPORT Harborwalk Core**

October 4, 2017

**Prepared For:**  
City of Punta Gorda  
326 West Marion Avenue  
Punta Gorda, Florida, 33950

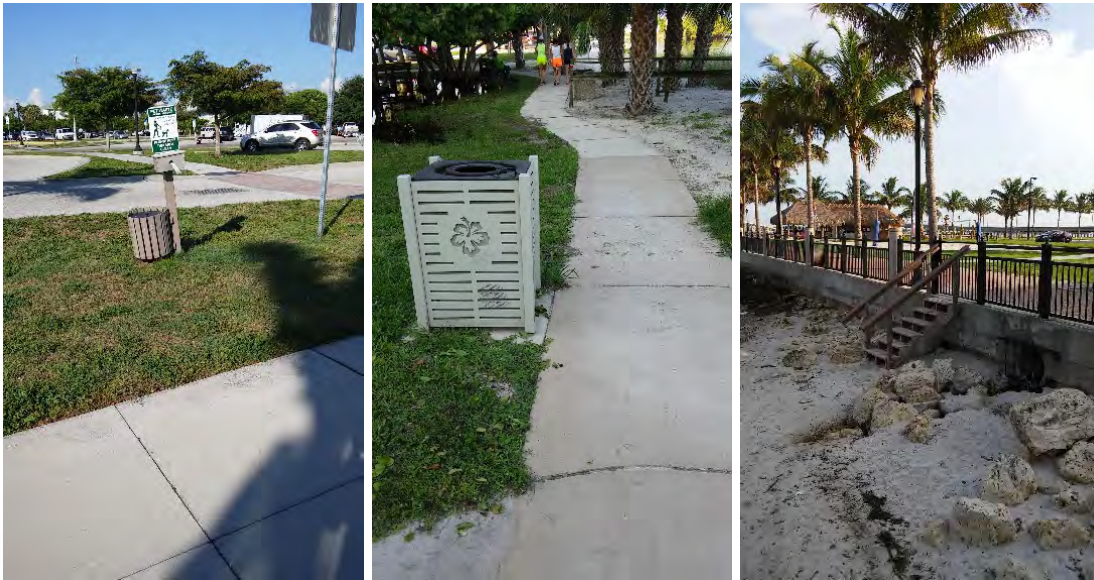
Figure 4-1: Various Non-Accessible Amenities

- Various amenities, such as the dog station shown below, are located away from the paved trail, on a non-accessible surface.
- The garbage can, shown below, is located adjacent to a paved surface with a 5% slope.
- There is no accessible way of reaching the small beach.

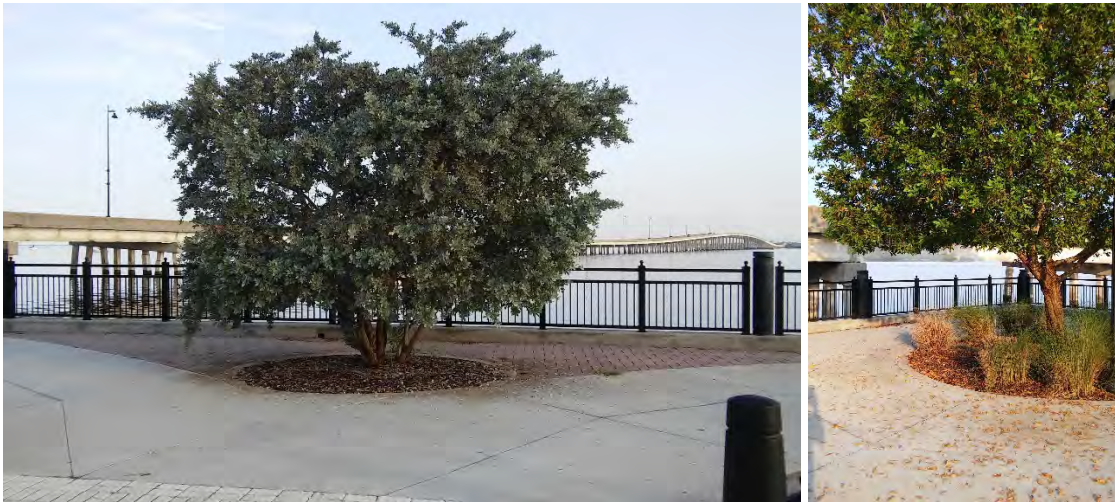
Figure 4-2 – Low hanging tree branches

Vertical clearance is defined as the minimum unobstructed vertical passage space. Vertical clearance is often limited by obstacles such as building overhangs, tree branches, signs, and awnings. Shown below in Figure 4-2, two sections of the Harborwalk Core trail contains low hanging tree branches, with protrude and obstruct the pathway. A map of these locations is provided in Appendix A.

Trim and maintain the tree branches so they do not protrude more than 4” onto the path for a height of at least 80 inches. This will prevent visitors with visual impairments from not being able to detect and then make contact with the hazardous object.

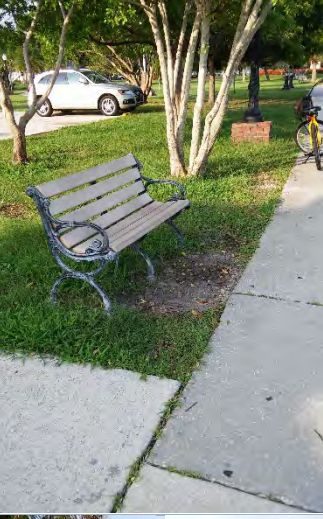
<b>A2</b>	<p>The bench is not accessible due to it being located away from the pavement.</p> <p>Move the bench forward to be adjacent to pavement.</p>

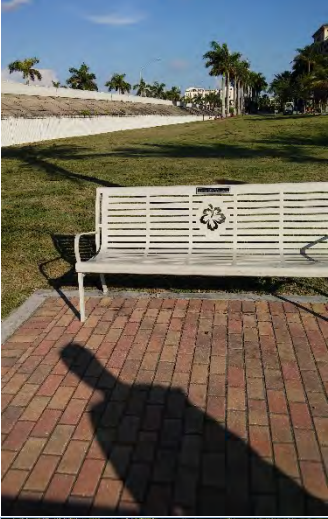
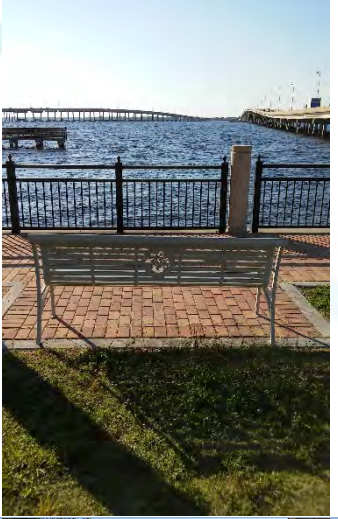
Map Item	Description & Recommendation	Photo	
<b>A4</b>	<p>There is no clear floor space on adjacent to the side of bench.</p> <p>Move bench to the right or left edge of brick to provide clear floor space for a wheelchair user.</p>

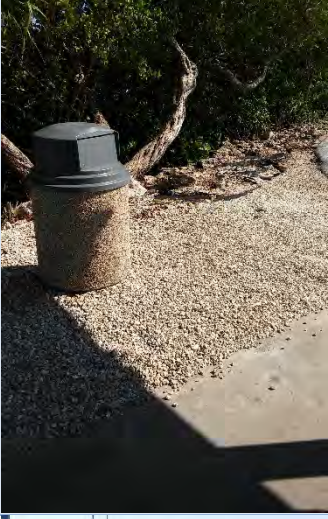
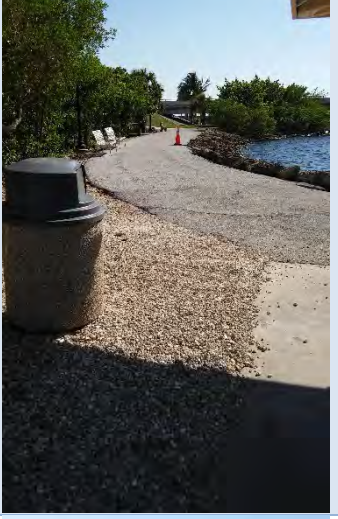
<b>A5</b>	<p>The garbage can is not located within reach range from the paved trail.</p> <p>Move the garbage can to be within reach range of pavement (10" maximum from the pavement)</p>

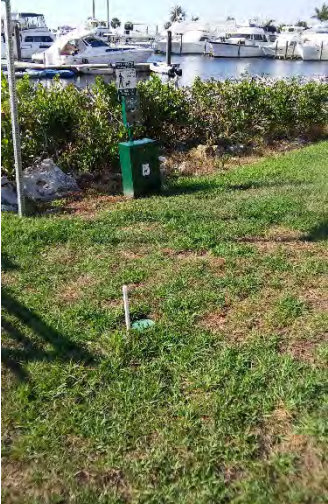
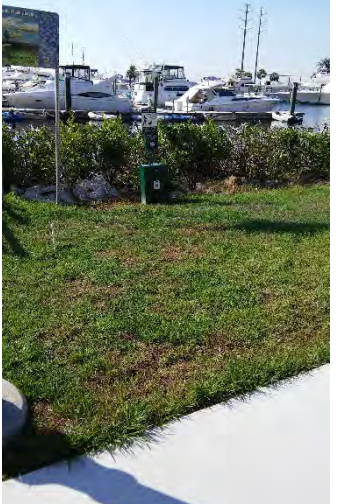
<b>A6</b>	<p>The dog station is not located within reach range from the paved trail.</p> <p>Either move the dog station to be within reach range of pavement (10" maximum horizontal from the pavement with a 48" maximum vertical height) or pave an accessible route to the dog station.</p>

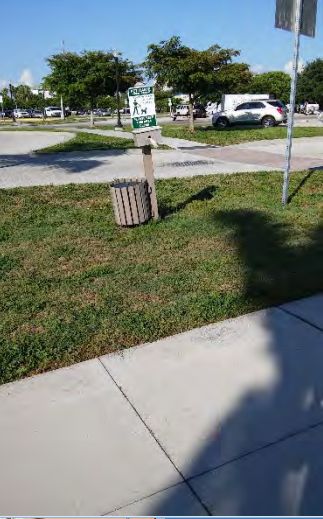
Map Item	Description & Recommendation	Photo	
<b>A7</b>	<p>The dog station is not located within reach range from the paved trail.</p> <p>Either move the dog station to be within reach range of pavement (10" maximum horizontal from the pavement with a 48" maximum vertical height) or pave an accessible route to the dog station.</p>

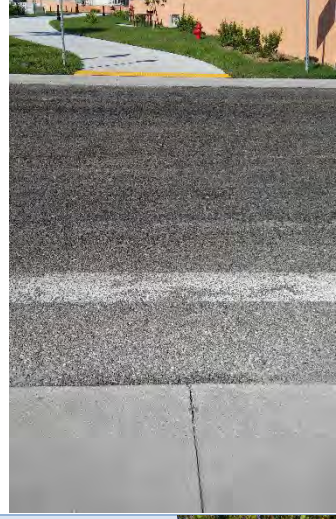
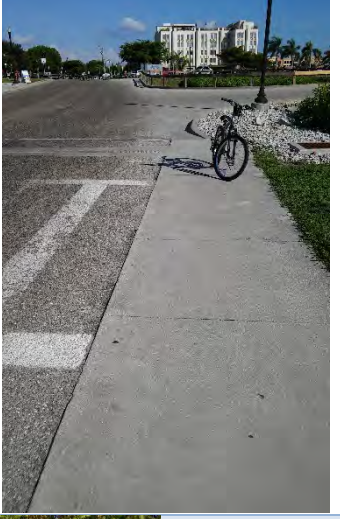
<b>CR1</b>	<p>There are no detectable warnings at this crosswalk, near the boat launch. In addition, the crosswalk is fading.</p> <p>Add detectable warnings to these two curb ramps and restripe the crosswalk. Note, this improvement was included in the Laishley Marina report and is not included in the costing section of this report.</p>

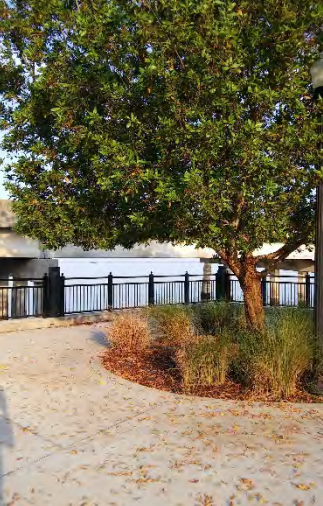
<b>P1</b>	<p>The tree branches are protruding object and have the potential to injure a visually impaired person using the multiuse trail.</p> <p>Trim the tree branches so they don't project out into the trail at a height of less than 80".</p>

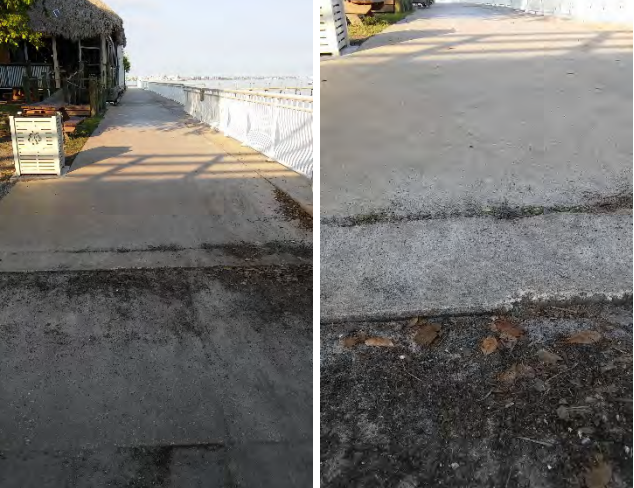
<b>T2</b>	<p>There is a raised cement lip that is a tripping hazard.</p> <p>Bevel cement lip to remove the tripping hazard.</p>

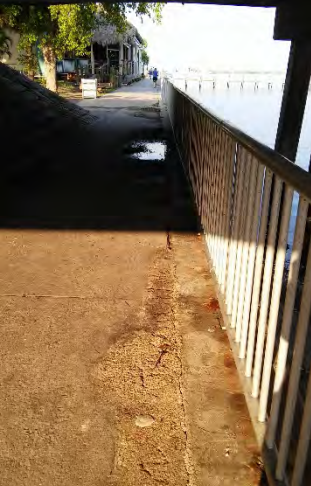
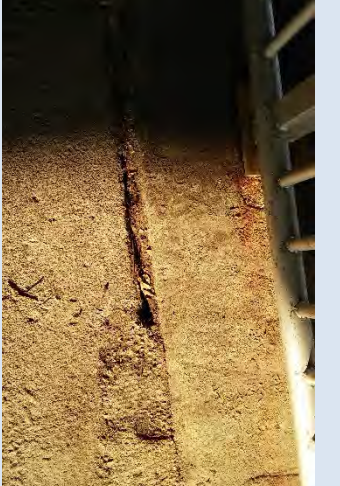
Map Item	Description & Recommendation	Photo	
<b>T3</b>	<p>There is a large puddle of standing water that can cause the surface to be slippery. In addition, a hole is located near the railing that can be a tripping hazard.</p> <p>Repave the path to eliminate the accumulation of standing water and hole in the pavement.</p>

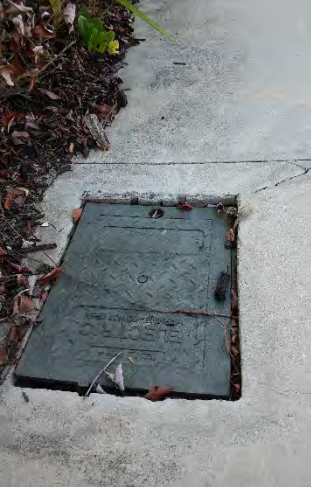
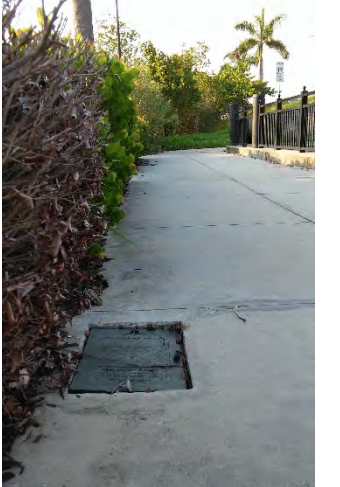
<b>T4</b>	<p>The utility cover is recessed and is a tripping hazard</p> <p>Either add additional pavement or raise the cover so that it is flush with the adjoining trail.</p>

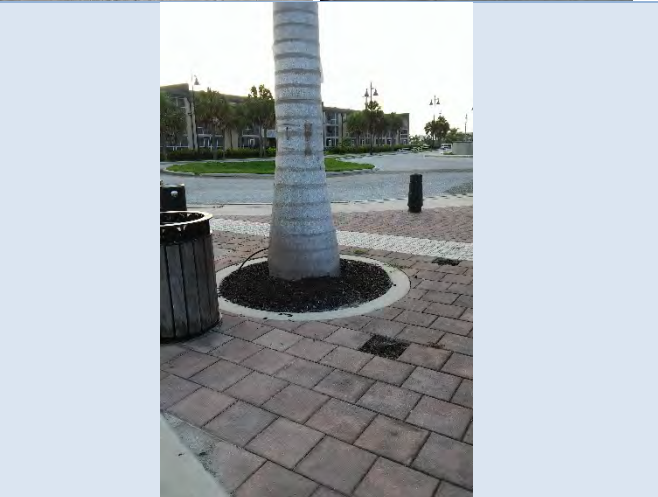
<b>T5</b>	<p>Four brick pavers are missing causing a tripping hazard.</p> <p>Replace the brick pavers to eliminate the tripping hazard.</p>

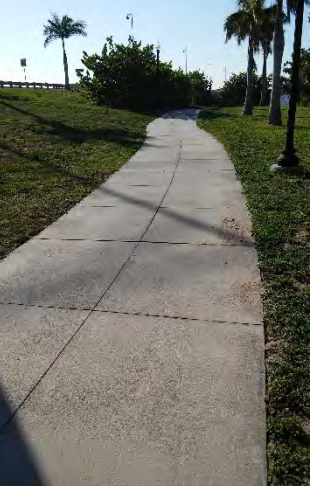
Map Item	Description & Recommendation	Photo	
<b>T12</b>	<p>This section of sidewalk has an accumulation of sand on it, possibly due to drainage issues.</p> <p>Maintain this section of trail so that the sand buildup does not prevent the area from being stable and slip resistant.</p>

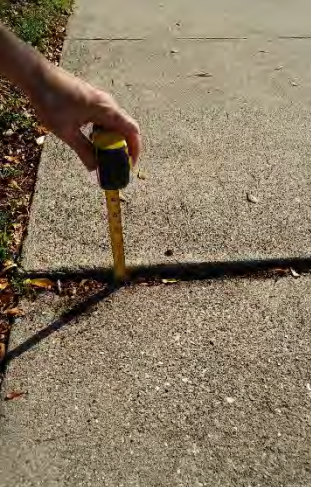
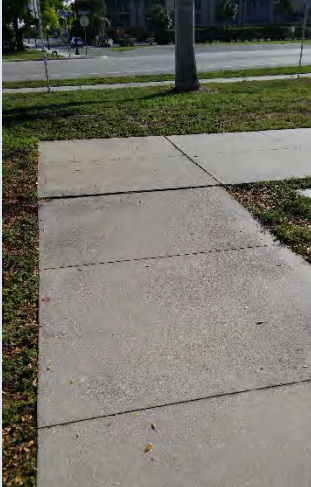
<b>T13</b>	<p>There is a raised section of sidewalk that has a 3\4" tripping hazard.</p> <p>Bevel this section of sidewalk to eliminate the tripping hazard.</p>

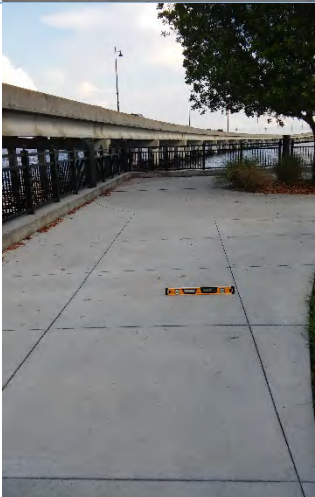
<b>C3</b>	<p>The cross slope is approximately 3.5%.</p> <p>Repave/resurface the trail so that the cross slope is no greater than 2%.</p>

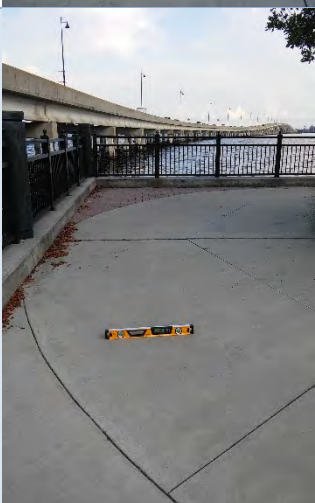
<b>C4</b>	<p>The cross slope is approximately 3%.</p> <p>Repave/resurface the trail so that the cross slope is no greater than 2%.</p>

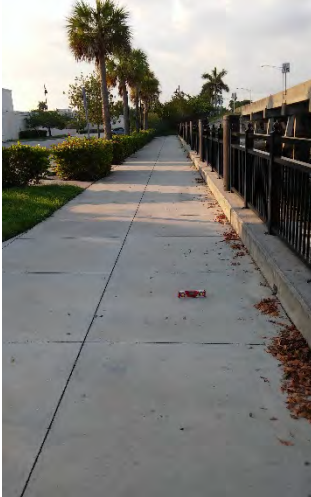
Map Item	Description & Recommendation	Photo
<b>C5</b>	<p>The cross slope is approximately 4.3%.</p> <p>Repave/resurface the trail so that the cross slope is no greater than 2%.</p>

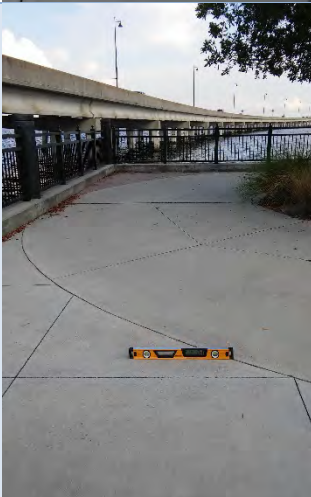
<b>C6</b>	<p>The cross slope is approximately 4.7%.</p> <p>Repave/resurface the trail so that the cross slope is no greater than 2%.</p>

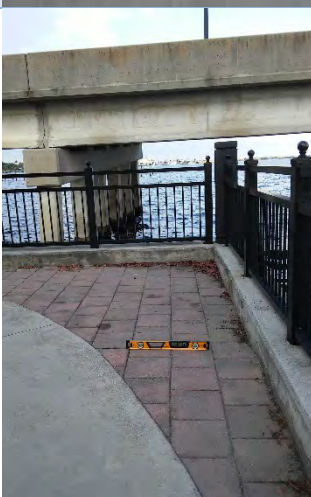
<b>C7</b>	<p>The cross slope is approximately 4.2%.</p> <p>Repave/resurface the trail so that the cross slope is no greater than 2%.</p>

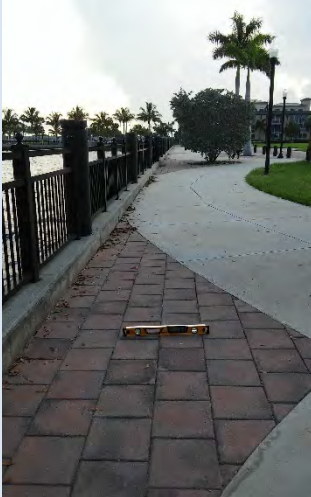
Map Item	Description & Recommendation	Photo
<b>C8</b>	<p>The cross slope is approximately 2.6%.</p> <p>Repave/resurface the trail so that the cross slope is no greater than 2%.</p>

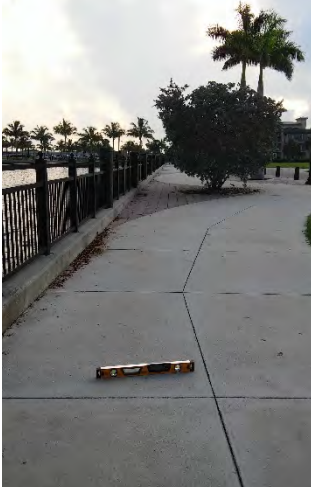
<b>C9</b>	<p>The cross slope is approximately 3%.</p> <p>Repave/resurface the trail so that the cross slope is no greater than 2%.</p>

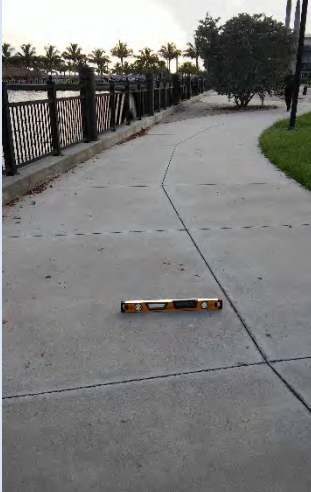
<b>C10</b>	<p>The cross slope is approximately 2.6%.</p> <p>Repave/resurface the trail so that the cross slope is no greater than 2%.</p>

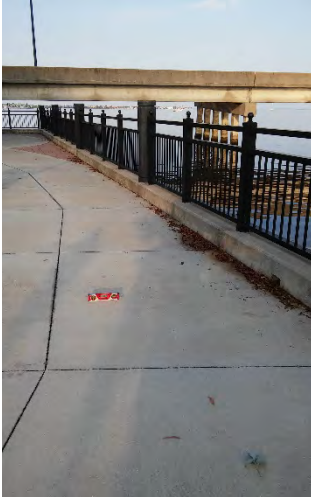
Map Item	Description & Recommendation	Photo
<b>C11</b>	<p>The cross slope is approximately 3%.</p> <p>Repave/resurface the trail so that the cross slope is no greater than 2%.</p>

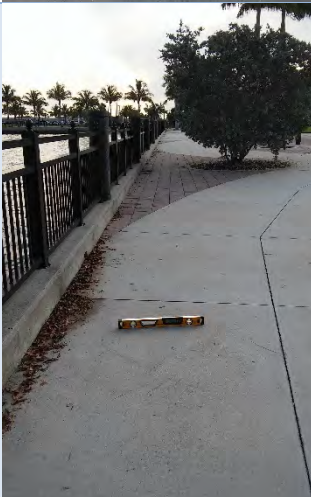
<b>C12</b>	<p>The cross slope is approximately 3.5%.</p> <p>Repave/resurface the trail so that the cross slope is no greater than 2%.</p>

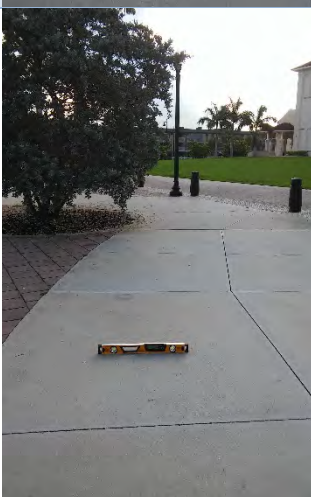
<b>C13</b>	<p>The cross slope is approximately 2.3%.</p> <p>Repave/resurface the trail so that the cross slope is no greater than 2%.</p>

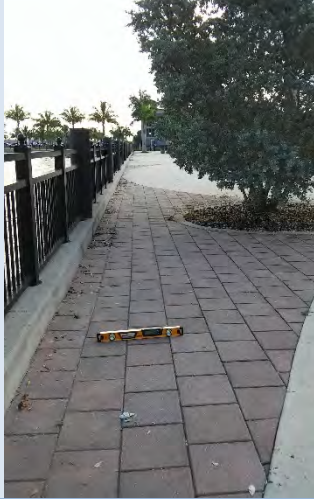
Map Item	Description & Recommendation	Photo
<b>C14</b>	<p>The cross slope is approximately 3.1%.</p> <p>Repave/resurface the trail so that the cross slope is no greater than 2%.</p>

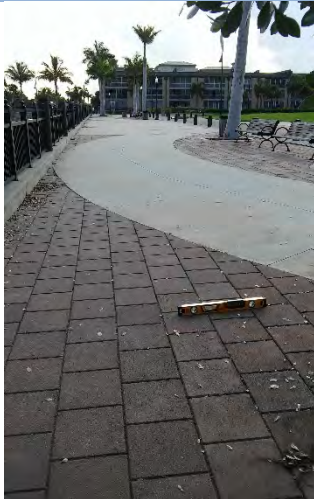
<b>C15</b>	<p>The cross slope is approximately 2.3%.</p> <p>Repave/resurface the trail so that the cross slope is no greater than 2%.</p>

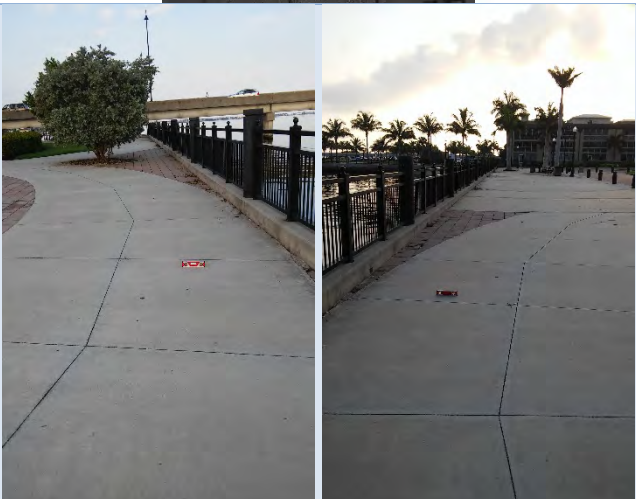
<b>C16</b>	<p>The cross slope is approximately 3.5%.</p> <p>Repave/resurface the trail so that the cross slope is no greater than 2%.</p>

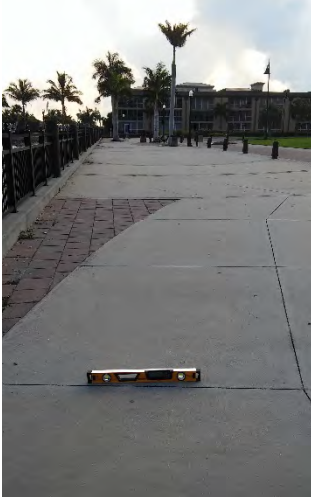
Map Item	Description & Recommendation	Photo
<b>C17</b>	<p>The cross slope is approximately 3.7%.</p> <p>Repave/resurface the trail so that the cross slope is no greater than 2%.</p>

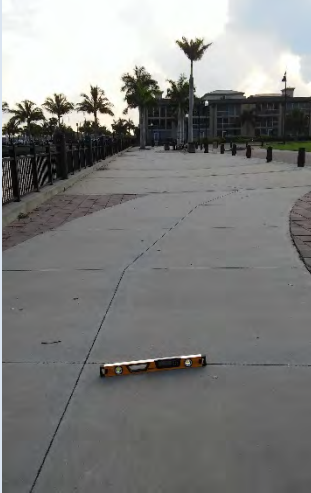
<b>C18</b>	<p>The cross slope is approximately 3.5%.</p> <p>Repave/resurface the trail so that the cross slope is no greater than 2%.</p>

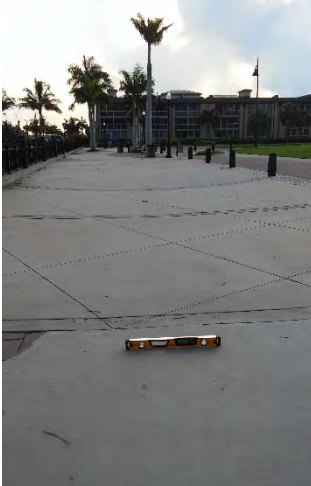
<b>C19</b>	<p>The cross slope is approximately 2.3%.</p> <p>Repave/resurface the trail so that the cross slope is no greater than 2%.</p>

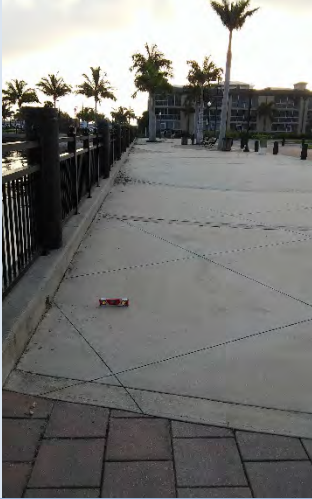
Map Item	Description & Recommendation	Photo
<b>C20</b>	<p>The cross slope is approximately 3%.</p> <p>Repave/resurface the trail so that the cross slope is no greater than 2%.</p>

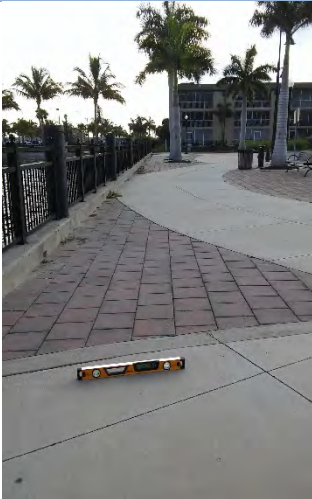
<b>C21</b>	<p>The cross slope is approximately 3.3%.</p> <p>Repave/resurface the trail so that the cross slope is no greater than 2%.</p>

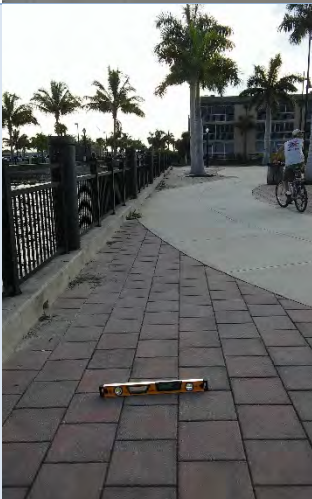
<b>C22</b>	<p>The cross slope is approximately 3.1%.</p> <p>Repave/resurface the trail so that the cross slope is no greater than 2%.</p>

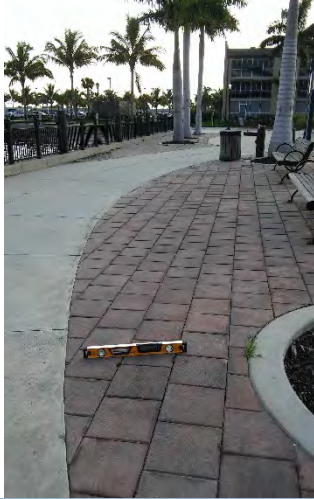
Map Item	Description & Recommendation	Photo
<b>C23</b>	<p>ID - 659 –</p> <p>The cross slope is approximately 4%.</p> <p>Repave/resurface the trail so that the cross slope is no greater than 2%.</p>

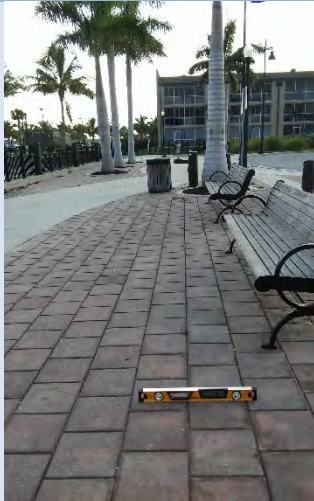
<b>C24</b>	<p>The cross slope is approximately 2.3%.</p> <p>Repave/resurface the trail so that the cross slope is no greater than 2%.</p>

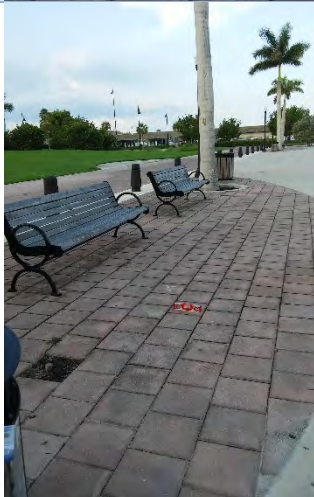
<b>C25</b>	<p>The cross slope is approximately 2.8%.</p> <p>Repave/resurface the trail so that the cross slope is no greater than 2%.</p>

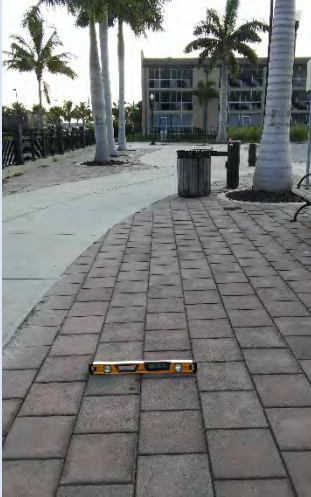
Map Item	Description & Recommendation	Photo
<b>C26</b>	<p>The cross slope is approximately 3.3%.</p> <p>Repave/resurface the trail so that the cross slope is no greater than 2%.</p>

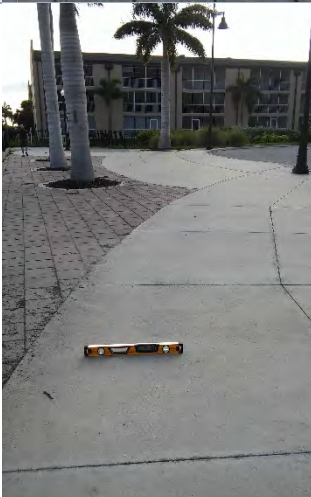
<b>C27</b>	<p>The cross slope is approximately 3.5%.</p> <p>Repave/resurface the trail so that the cross slope is no greater than 2%.</p>

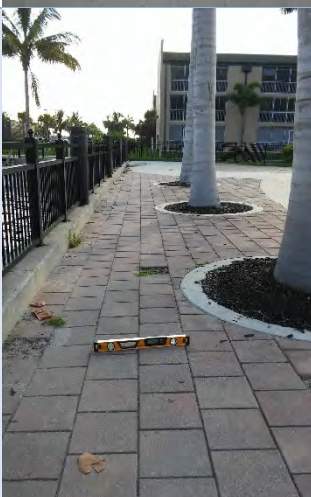
<b>C28</b>	<p>The cross slope is approximately 3.1%.</p> <p>Repave/resurface the trail so that the cross slope is no greater than 2%.</p>

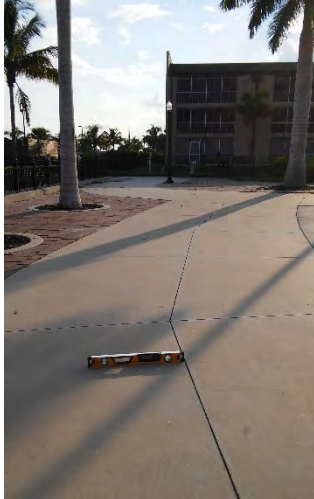
Map Item	Description & Recommendation	Photo
<b>C29</b>	<p>The cross slope is approximately 2.3%.</p> <p>Repave/resurface the trail so that the cross slope is no greater than 2%.</p>

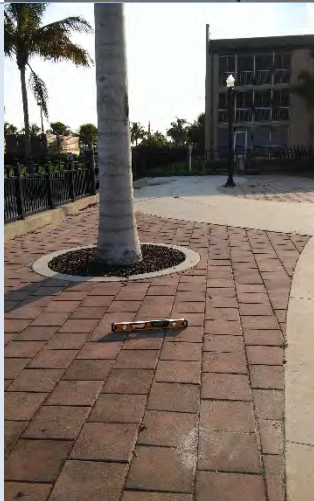
<b>C30</b>	<p>The cross slope is approximately 2.8%.</p> <p>Repave/resurface the trail so that the cross slope is no greater than 2%.</p>

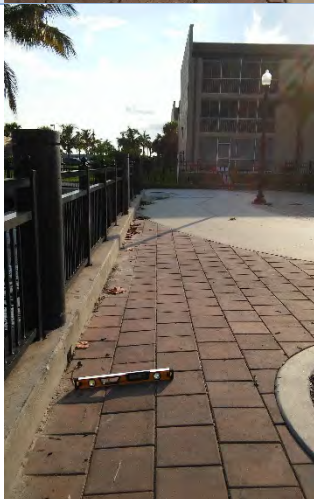
<b>C31</b>	<p>The cross slope is approximately 9.3%.</p> <p>Repave/resurface the trail so that the cross slope is no greater than 2%.</p>

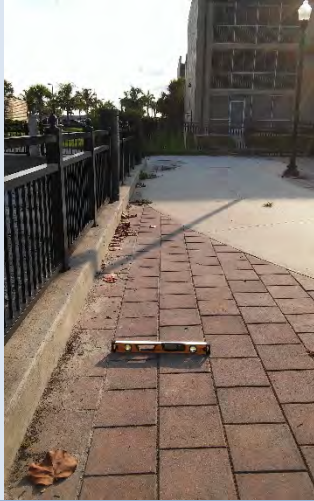
Map Item	Description & Recommendation	Photo
C32	<p>The cross slope is approximately 5.2%.</p> <p>Repave/resurface the trail so that the cross slope is no greater than 2%.</p>

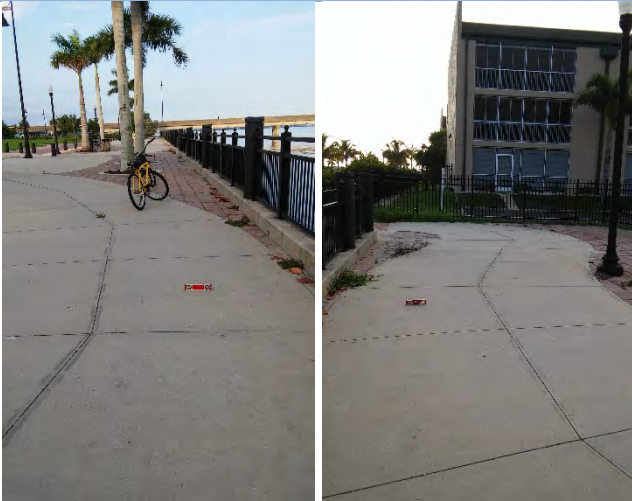
C33	<p>The cross slope is approximately 3%.</p> <p>Repave/resurface the trail so that the cross slope is no greater than 2%.</p>

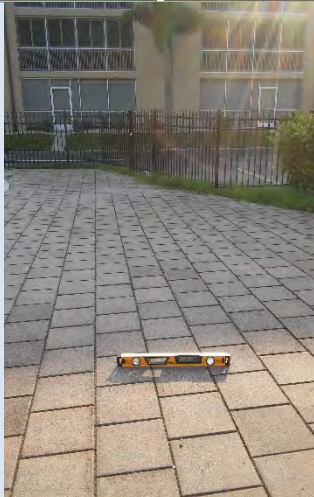
C34	<p>The cross slope is approximately 2.6%.</p> <p>Repave/resurface the trail so that the cross slope is no greater than 2%.</p>

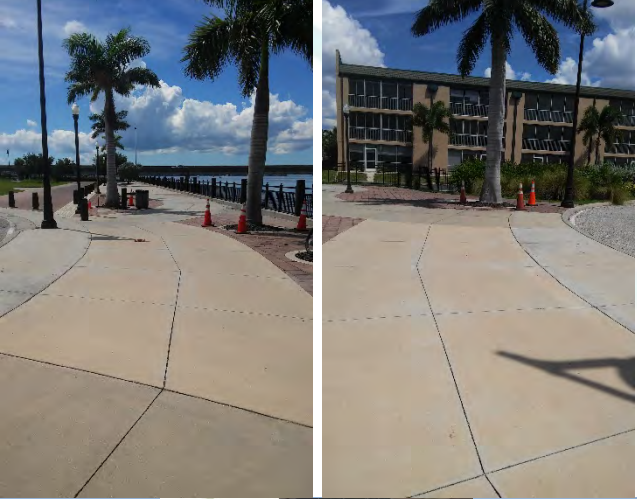
Map Item	Description & Recommendation	Photo
<b>C35</b>	<p>The cross slope is approximately 3% within a 6ft wide by 18ft long area.</p> <p>Repave/resurface the trail so that the cross slope is no greater than 2%.</p>

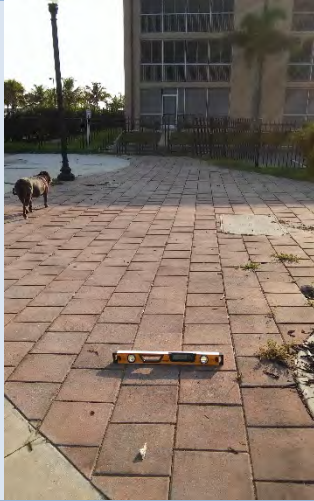
<b>C36</b>	<p>The cross slope is approximately 5.6%.</p> <p>Repave/resurface the trail so that the cross slope is no greater than 2%.</p>

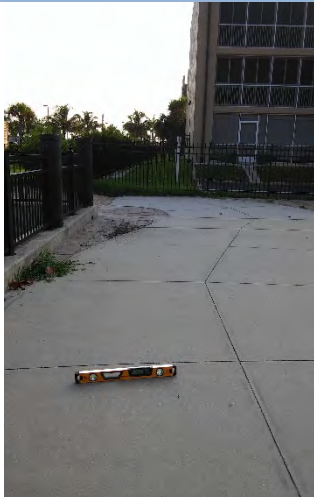
<b>C37</b>	<p>The cross slope is approximately 3.8%.</p> <p>Repave/resurface the trail so that the cross slope is no greater than 2%.</p>

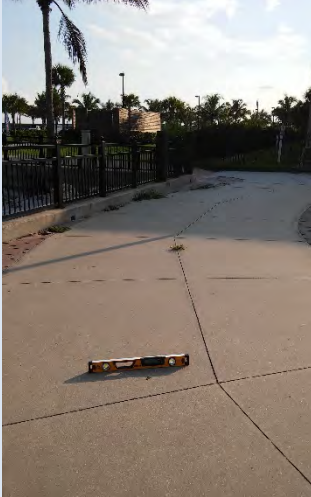
Map Item	Description & Recommendation	Photo
<b>C38</b>	<p>The cross slope is approximately 3.3%.</p> <p>Repave/resurface the trail so that the cross slope is no greater than 2%.</p>

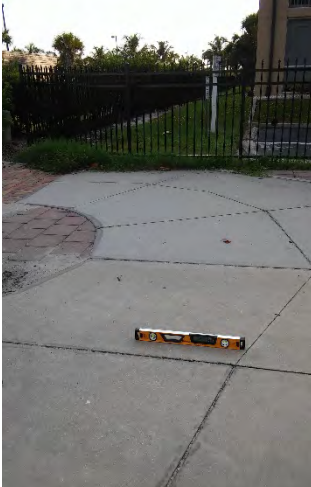
<b>C39</b>	<p>The cross slope is approximately 2.4%.</p> <p>Repave/resurface the trail so that the cross slope is no greater than 2%.</p>

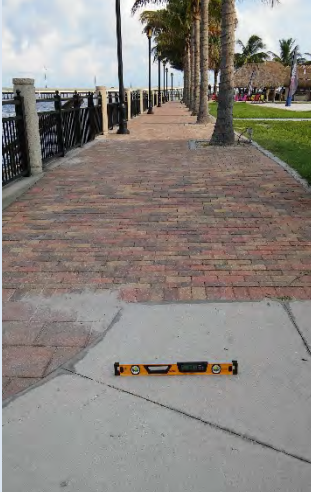
<b>C40</b>	<p>The cross slope is approximately 4.4%.</p> <p>Repave/resurface the trail so that the cross slope is no greater than 2%.</p>

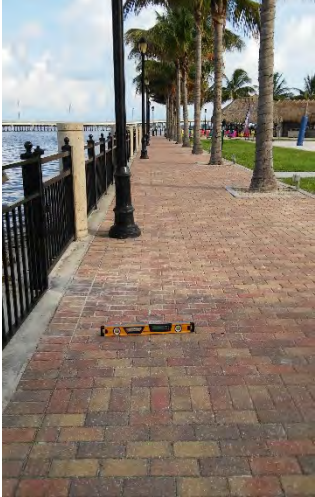
Map Item	Description & Recommendation	Photo
<b>C41</b>	<p>The cross slope is approximately 3%.</p> <p>Repave/resurface the trail so that the cross slope is no greater than 2%.</p>

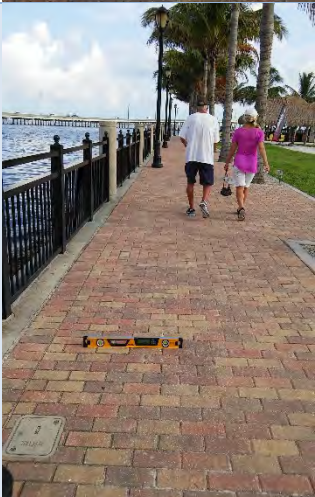
<b>C42</b>	<p>The cross slope is approximately 3.3%.</p> <p>Repave/resurface the trail so that the cross slope is no greater than 2%.</p>

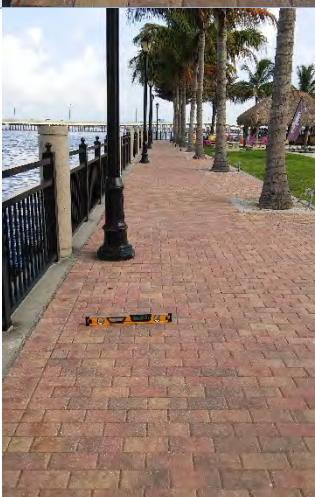
<b>C43</b>	<p>The cross slope is approximately 3%.</p> <p>Repave/resurface the trail so that the cross slope is no greater than 2%.</p>

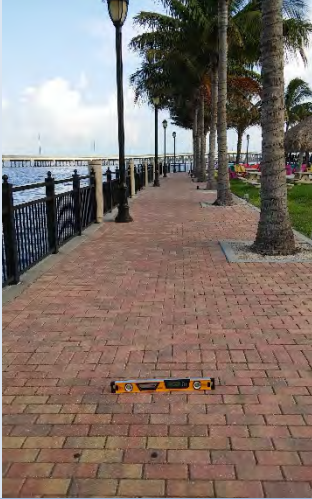
Map Item	Description & Recommendation	Photo
<b>C44</b>	<p>The cross slope is approximately 2.8%.</p> <p>Repave/resurface the trail so that the cross slope is no greater than 2%.</p>

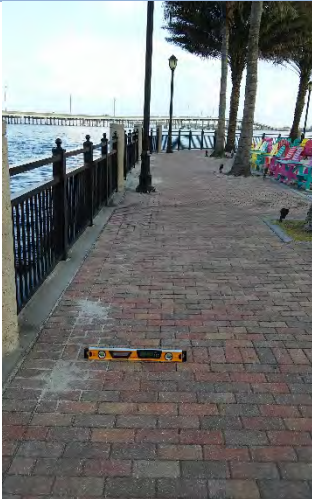
<b>C45</b>	<p>The cross slope is approximately 3.1%.</p> <p>Repave/resurface the trail so that the cross slope is no greater than 2%.</p>

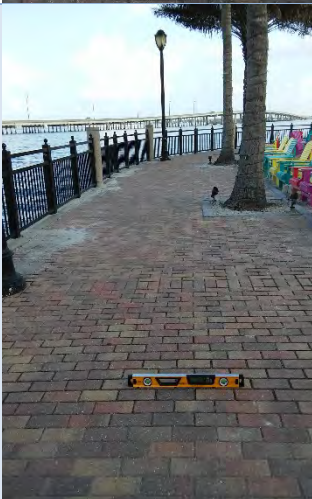
<b>C46</b>	<p>The cross slope is approximately 3%.</p> <p>Repave/resurface the trail so that the cross slope is no greater than 2%.</p>

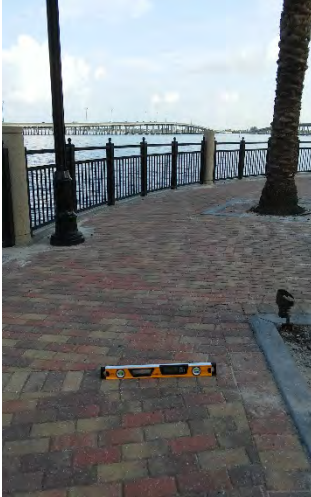
Map Item	Description & Recommendation	Photo
<b>C47</b>	<p>The cross slope is approximately 7%.</p> <p>Repave/resurface the trail so that the cross slope is no greater than 2%.</p>

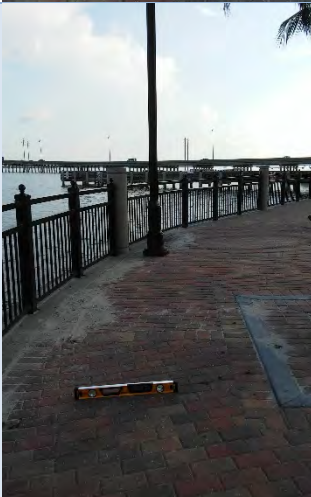
<b>C48</b>	<p>The cross slope is approximately 4.9%.</p> <p>Repave/resurface the trail so that the cross slope is no greater than 2%.</p>

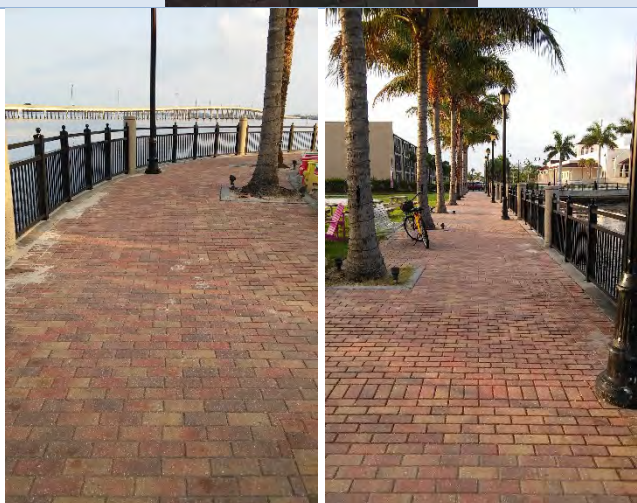
<b>C49</b>	<p>The cross slope is approximately 3.4% in the middle of the trail.</p> <p>Repave/resurface the trail so that the cross slope is no greater than 2%.</p>

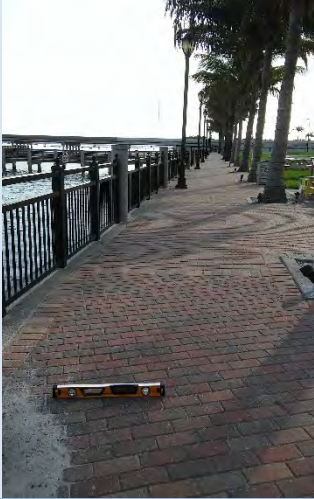
Map Item	Description & Recommendation	Photo
<b>C50</b>	<p>The cross slope is approximately 4.4%.</p> <p>Repave/resurface the trail so that the cross slope is no greater than 2%.</p>

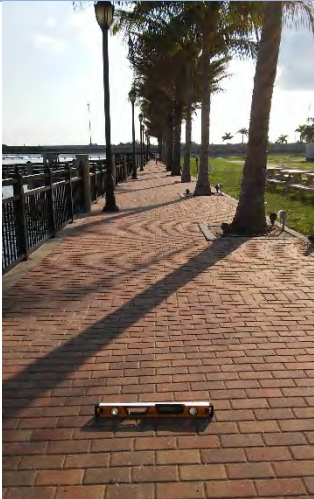
<b>C51</b>	<p>The cross slope is approximately 2.8%.</p> <p>Repave/resurface the trail so that the cross slope is no greater than 2%.</p>

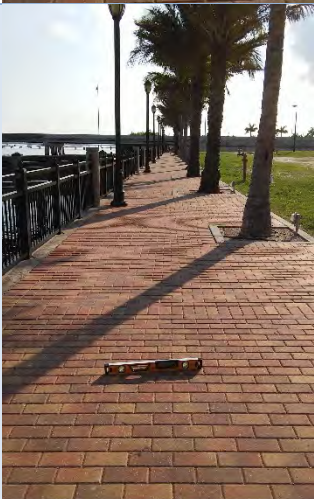
<b>C52</b>	<p>The cross slope is approximately 3.3%.</p> <p>Repave/resurface the trail so that the cross slope is no greater than 2%.</p>

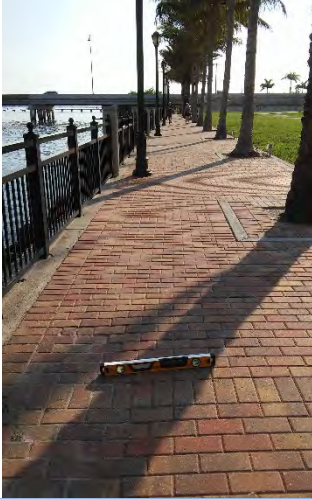
Map Item	Description & Recommendation	Photo
<b>C53</b>	<p>The cross slope is approximately 6.6%.</p> <p>Repave/resurface the trail so that the cross slope is no greater than 2%.</p>

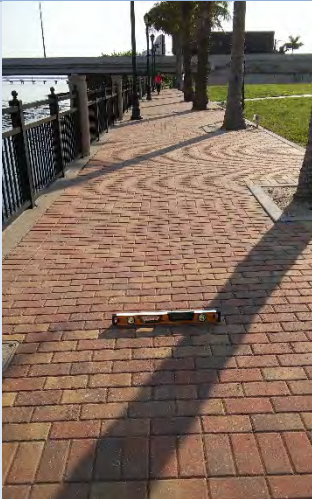
<b>C54</b>	<p>The cross slope is approximately 3.3%.</p> <p>Repave/resurface the trail so that the cross slope is no greater than 2%.</p>

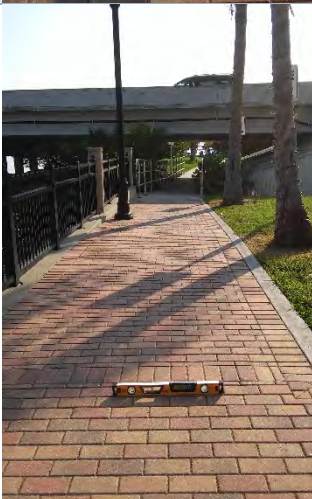
<b>C55</b>	<p>The cross slope is approximately 2.6%.</p> <p>Repave/resurface the trail so that the cross slope is no greater than 2%.</p>

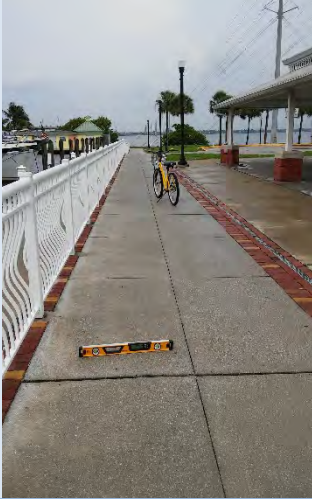
Map Item	Description & Recommendation	Photo
<b>C56</b>	<p>The cross slope is approximately 3%.</p> <p>Repave/resurface the trail so that the cross slope is no greater than 2%.</p>

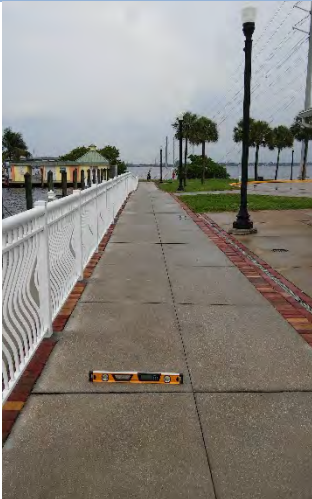
<b>C57</b>	<p>The cross slope is approximately 2.6%.</p> <p>Repave/resurface the trail so that the cross slope is no greater than 2%.</p>

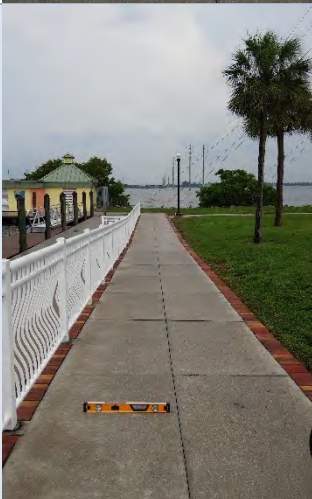
<b>C58</b>	<p>The cross slope is approximately 2.3%.</p> <p>Repave/resurface the trail so that the cross slope is no greater than 2%.</p>

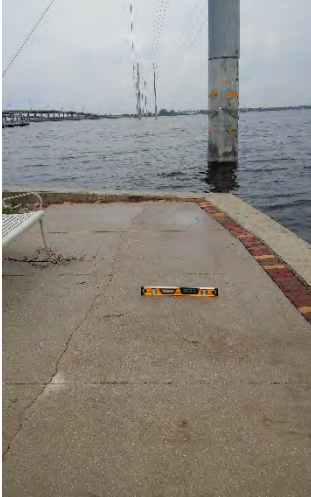
Map Item	Description & Recommendation	Photo
<b>C59</b>	<p>The cross slope is approximately 2.8%.</p> <p>Repave/resurface the trail so that the cross slope is no greater than 2%.</p>

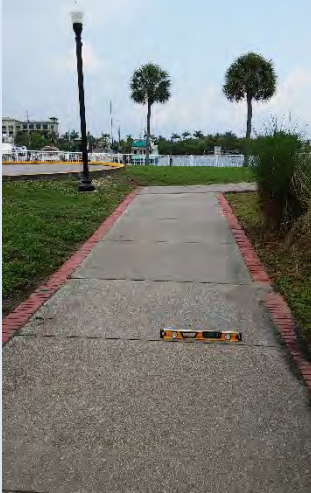
<b>C60</b>	<p>The cross slope is approximately 4%.</p> <p>Repave/resurface the trail so that the cross slope is no greater than 2%.</p>

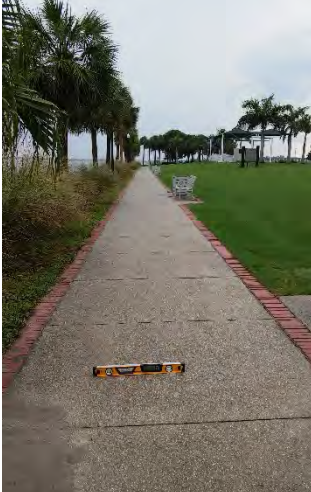
<b>C61</b>	<p>The cross slope is approximately 4%.</p> <p>Repave/resurface the trail so that the cross slope is no greater than 2%.</p>

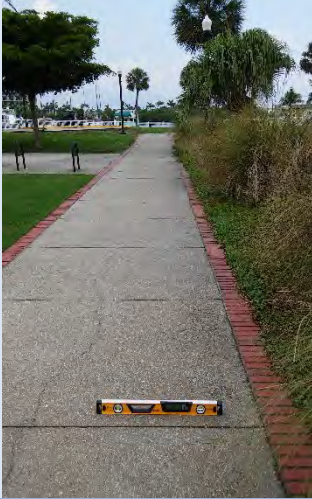
Map Item	Description & Recommendation	Photo
<b>C62</b>	<p>The cross slope is approximately 3.5%.</p> <p>Repave/resurface the trail so that the cross slope is no greater than 2%.</p>

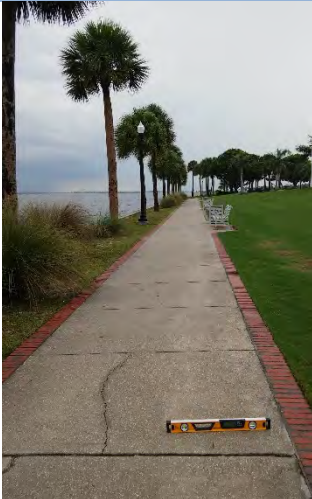
<b>C63</b>	<p>The cross slope is approximately 2.8%.</p> <p>Repave/resurface the trail so that the cross slope is no greater than 2%.</p>

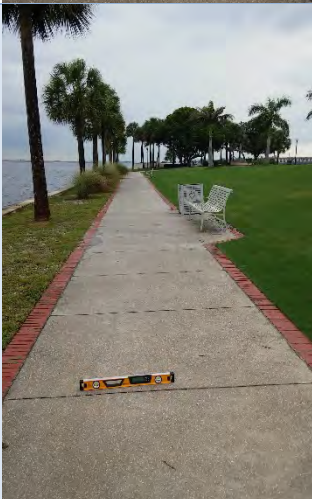
<b>C64</b>	<p>The cross slope is approximately 3.5%.</p> <p>Repave/resurface the trail so that the cross slope is no greater than 2%.</p>

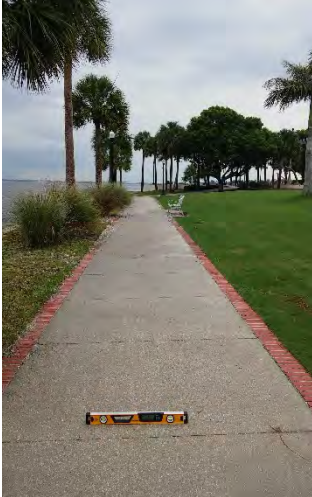
Map Item	Description & Recommendation	Photo
<b>C65</b>	<p>The cross slope is approximately 3.3%.</p> <p>Repave/resurface the trail so that the cross slope is no greater than 2%.</p>

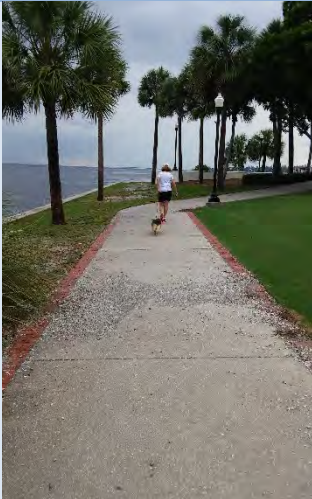
<b>C66</b>	<p>The cross slope is approximately 3.5%. There is a lot of sand within the trail.</p> <p>Repave/resurface the trail so that the cross slope is no greater than 2%. In addition, maintain this section of trail to make sure that the buildup of sand does not prevent this section of trail from being firm, stable, and slip resistant.</p>

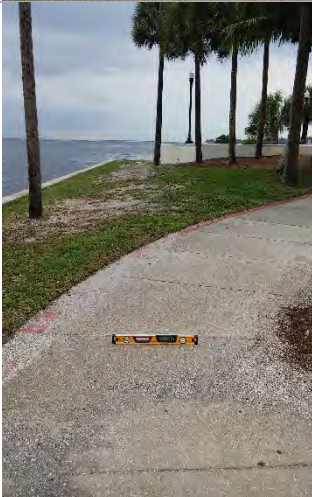
<b>C67</b>	<p>The cross slope is approximately 3.3%.</p> <p>Repave/resurface the trail so that the cross slope is no greater than 2%.</p>

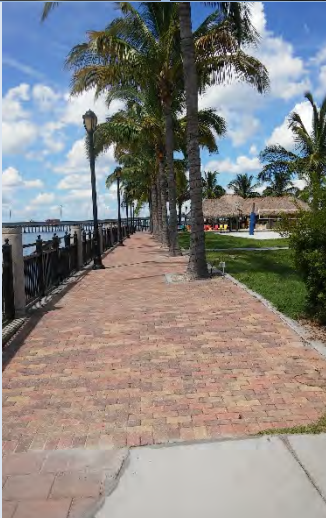
R3	<p>This section of trail has a 6% running slope.</p> <p>Regrade &amp; reset the brick pavers so the running slope is no greater than 5%.</p>

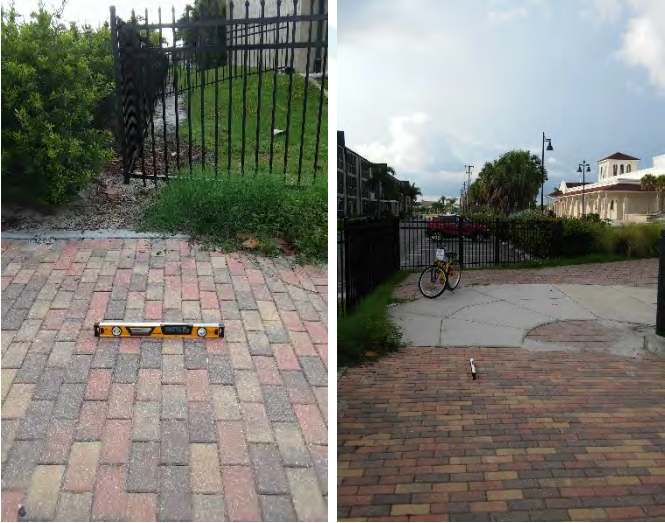
Map Item	Description & Recommendation	Photo
R4	<p>This section of trail has a 5.6% running slope.</p> <p>Regrade &amp; reset the brick pavers so the running slope is no greater than 5%.</p>

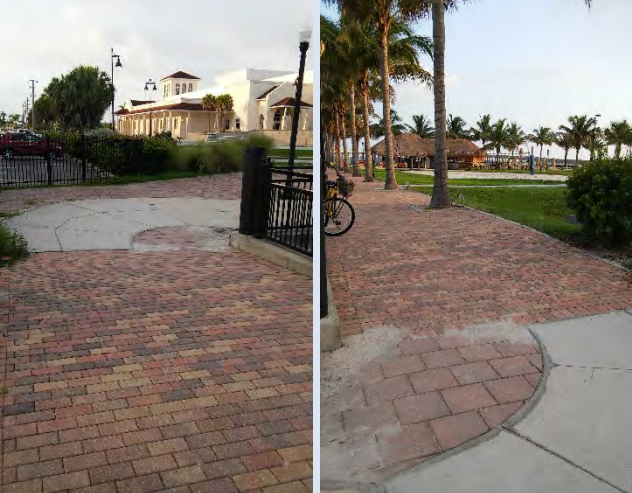
R5	<p>The brick ramp has a running slope between 5% and 10% for approximately 12 feet.</p> <p>Regrade &amp; reset the brick pavers so the running slope is no greater than 5%. Or, resurface the ramp to have a slope no greater than 8.33% and add handrails and landings.</p>

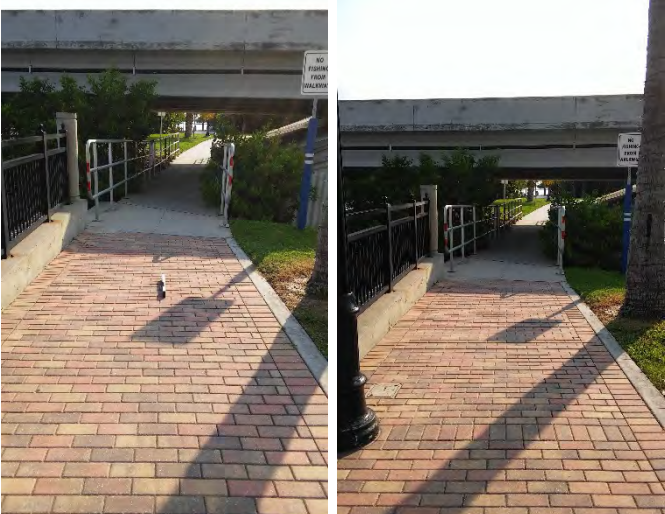
R6	<p>A small section of trail has a 6% running slope.</p> <p>Regrade &amp; reset the brick pavers so the running slope is no greater than 5%.</p>

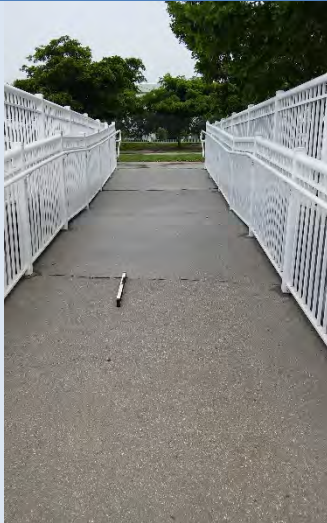
Map Item	Description & Recommendation	Photo
R7	<p>The ramp has a max running slope of 8.6%.</p> <p>Resurface the section of the ramp with a non-compliant running slope so it is no greater than 8.33%.</p>

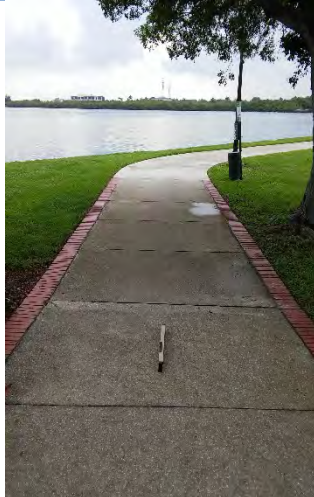
R8	<p>This section of trail has a 7.1% running slope.</p> <p>Repave &amp; regrade the trail to have a slope no greater than 5%. Or, designate this section of trail as a ramp and add handrails and landings.</p>

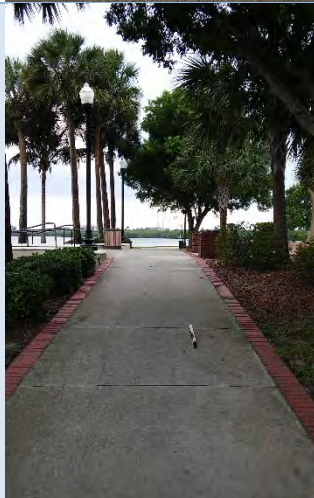
R9	<p>This section of trail has a 9.1% running slope.</p> <p>Repave &amp; regrade the trail to have a slope no greater than 5%. Or, designate this section of trail as a ramp and add handrails and landings.</p>
