CITY OF PUNTA GORDA ADA TRANSITION PLAN FINAL REPORT

Laishley Park

October 4, 2017

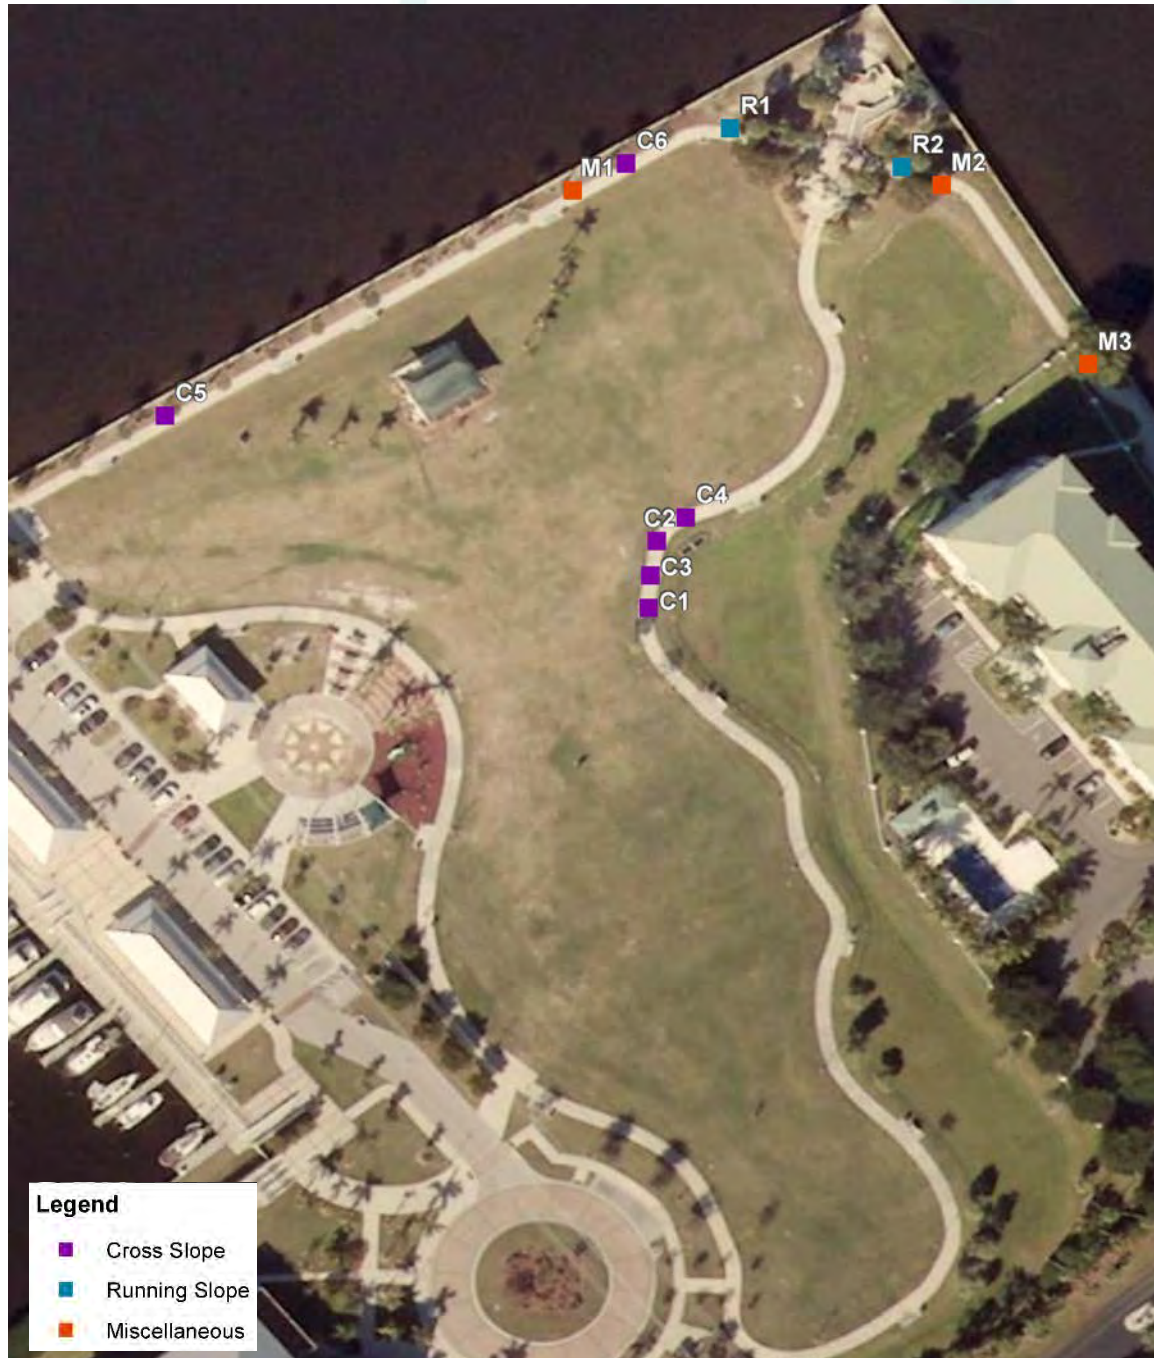
The maps and tables on the following pages illustrate the location, description, and remediation of additional barriers to accessibility found throughout Laishley Park.
