CITY OF PUNTA GORDA ADA TRANSITION PLAN FINAL REPORT US 41 MULTI-USE RECREATION TRAIL

October 4, 2017

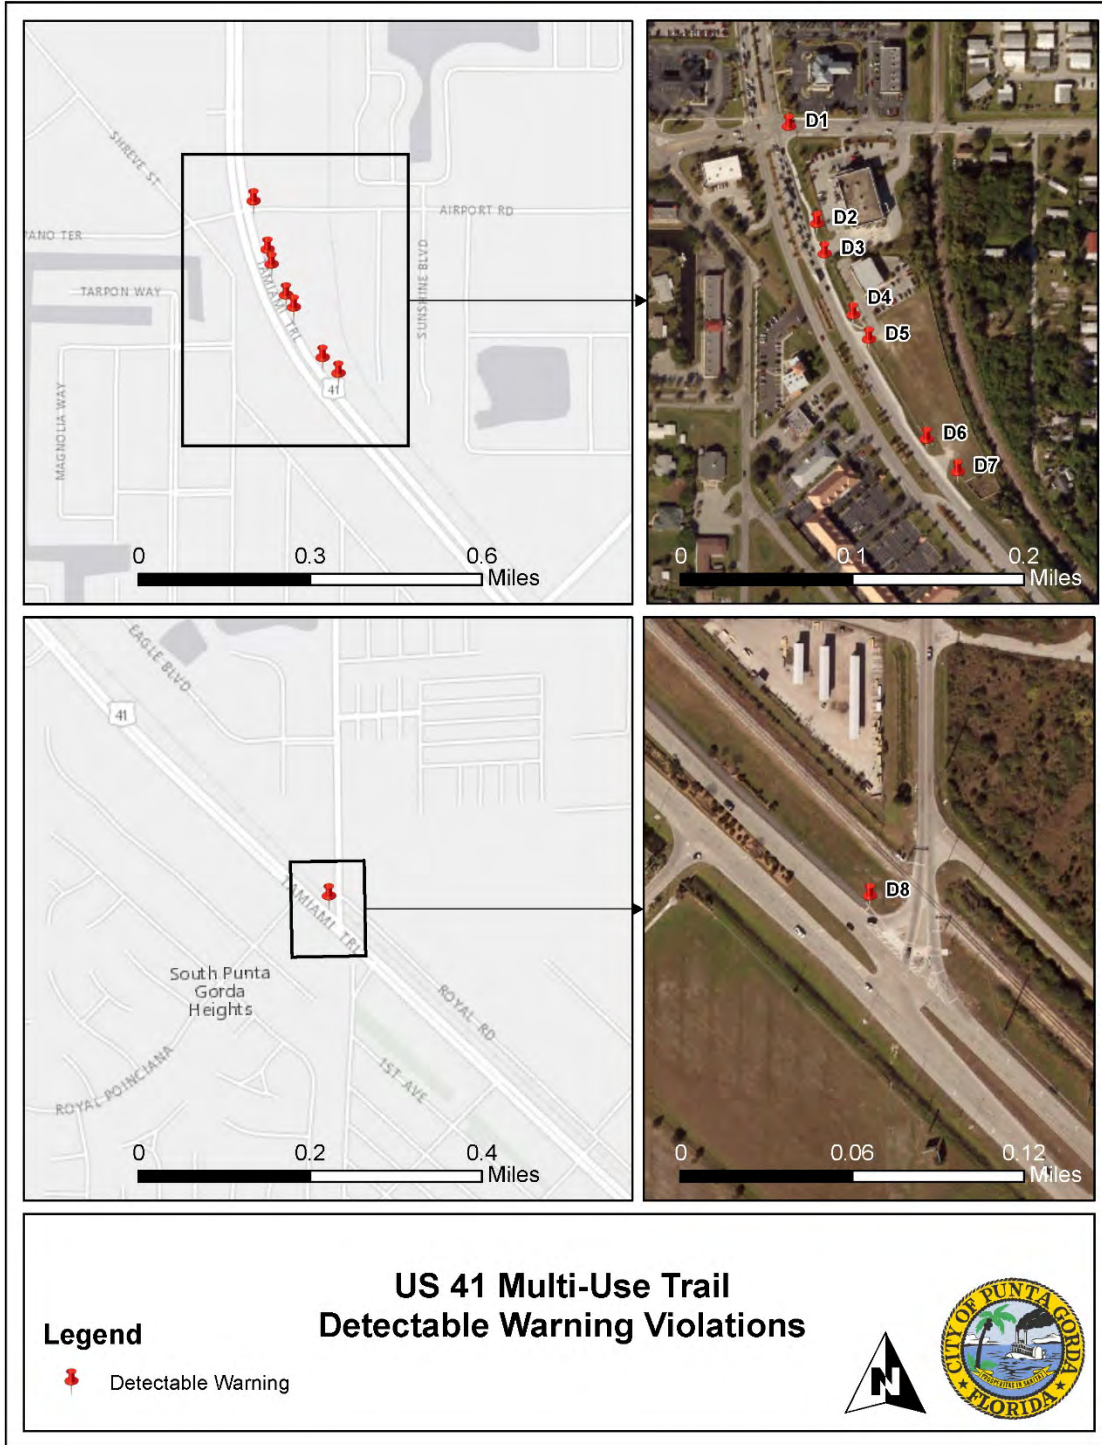
Map Item	Description & Recommendation	Photo(s)
D1	<p>The detectable warning is not securely fastened to the curb ramp and therefore may present a tripping hazard.</p> <p>Securely fasten the detectable warning.</p>
