CITY OF PUNTA GORDA ADA TRANSITION PLAN FINAL REPORT Harborwalk Core

October 4, 2017

Prepared For:
City of Punta Gorda
326 West Marion Avenue
Punta Gorda, Florida, 33950

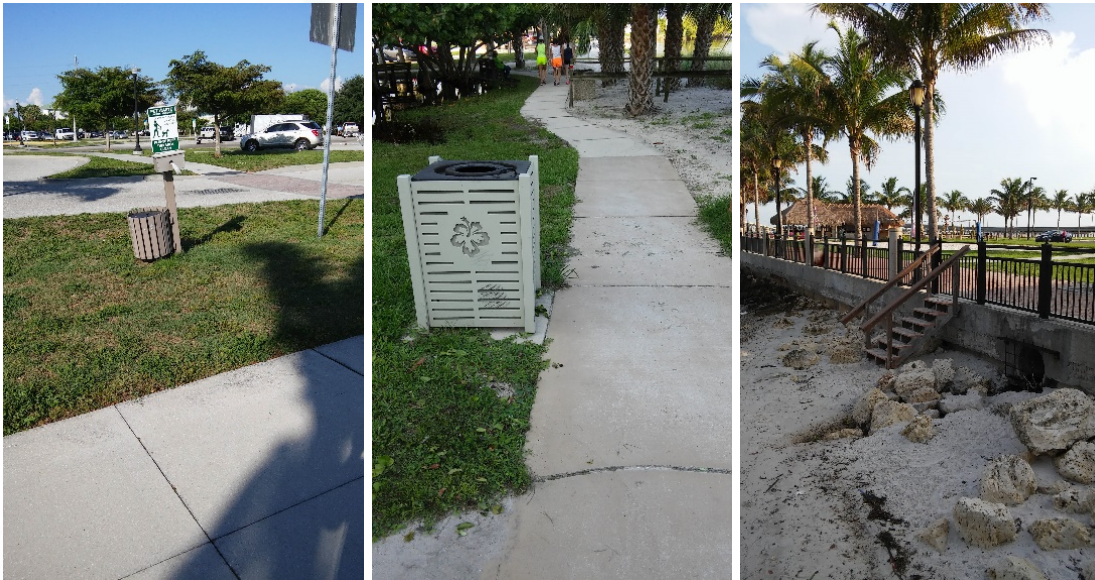
Figure 4-1: Various Non-Accessible Amenities

- Various amenities, such as the dog station shown below, are located away from the paved trail, on a non-accessible surface.
- The garbage can, shown below, is located adjacent to a paved surface with a 5% slope.
- There is no accessible way of reaching the small beach.

ADAAG 308.3 states that, “Where a clear floor space allows a parallel approach to an element, the high side reach shall be 48” maximum above the ground... An obstruction shall be permitted between the clear floor space and the element where the depth of the obstruction is 10” maximum.”

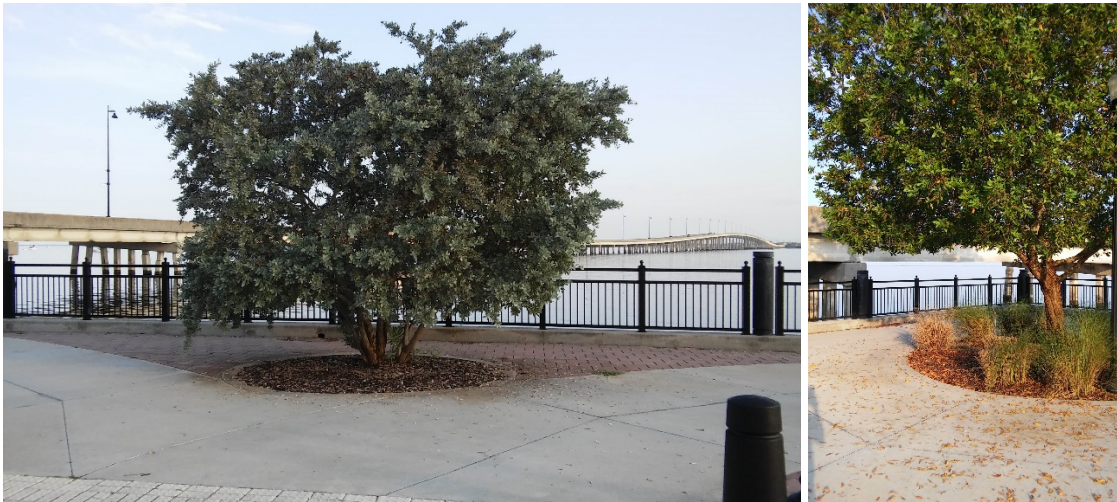
Figure 4-2 – Low hanging tree branches

Vertical clearance is defined as the minimum unobstructed vertical passage space. Vertical clearance is often limited by obstacles such as building overhangs, tree branches, signs, and awnings. Shown below in Figure 4-2, two sections of the Harborwalk Core trail contains low hanging tree branches, which protrude and obstruct the pathway. A map of these locations is provided in Appendix A.

ADAAG states that, “objects with leading edges more than 27 inches and not more than 80 inches above the finish floor or ground shall protrude 4 inches maximum horizontally into the circulation path.

Trim and maintain the tree branches so they do not protrude more than 4” onto the path for a height of at least 80 inches. This will prevent visitors with visual impairments from not being able to detect and then make contact with the hazardous object.

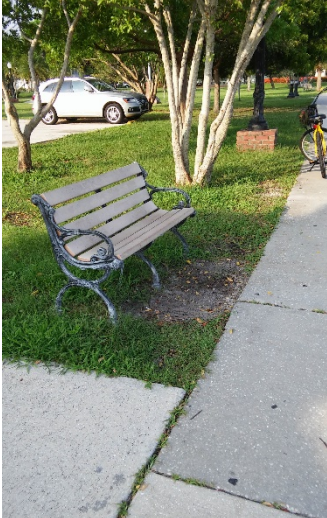
<p>A2</p>	<p>The bench is not accessible due to it being located away from the pavement.</p> <p>Move the bench forward to be adjacent to pavement.</p>

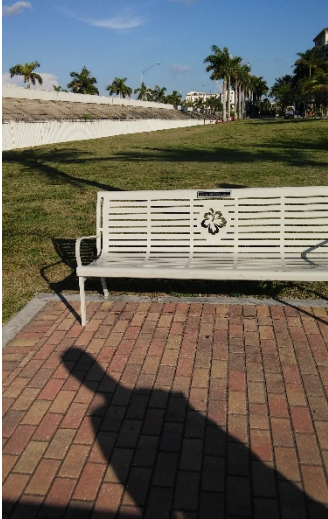
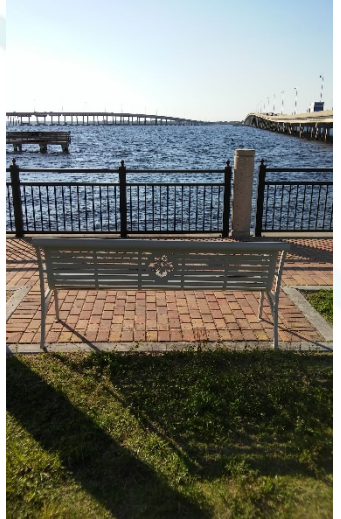
Map Item	Description & Recommendation	Photo	
<p>A4</p>	<p>There is no clear floor space on adjacent to the side of bench.</p> <p>Move bench to the right or left edge of brick to provide clear floor space for a wheelchair user.</p>

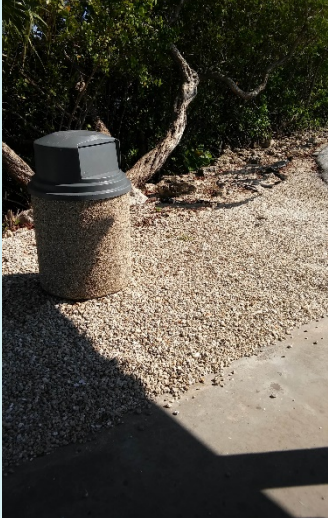
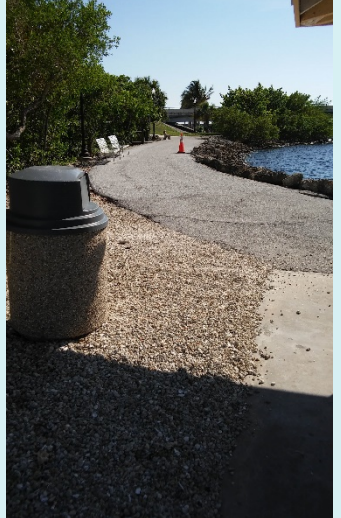
<p>A5</p>	<p>The garbage can is not located within reach range from the paved trail.</p> <p>Move the garbage can to be within reach range of pavement (10" maximum from the pavement)</p>

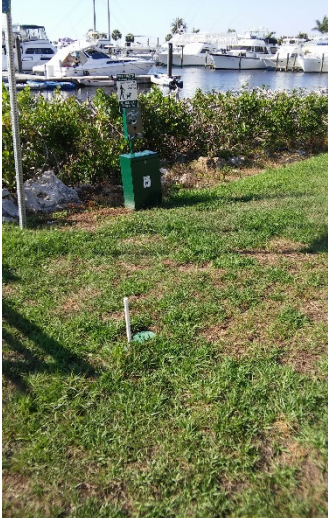
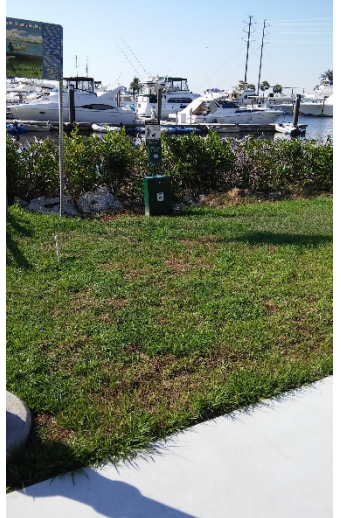
<p>A6</p>	<p>The dog station is not located within reach range from the paved trail.</p> <p>Either move the dog station to be within reach range of pavement (10" maximum horizontal from the pavement with a 48" maximum vertical height) or pave an accessible route to the dog station.</p>

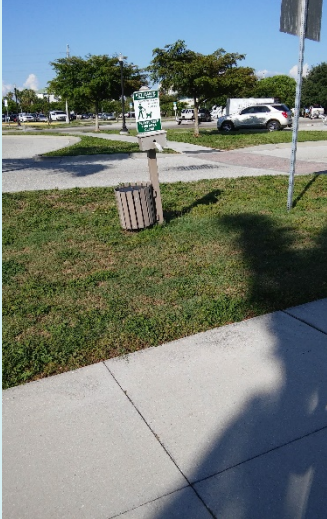
Map Item	Description & Recommendation	Photo
<p>A7</p>	<p>The dog station is not located within reach range from the paved trail.</p> <p>Either move the dog station to be within reach range of pavement (10" maximum horizontal from the pavement with a 48" maximum vertical height) or pave an accessible route to the dog station.</p>

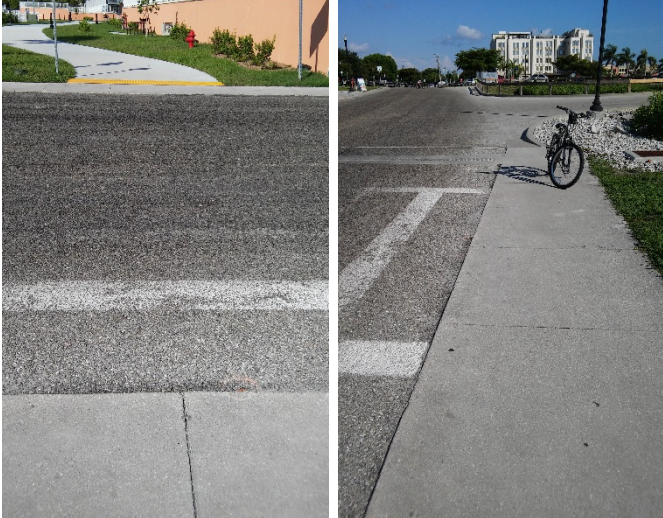
<p>CR1</p>	<p>There are no detectable warnings at this crosswalk, near the boat launch. In addition, the crosswalk is fading.</p> <p>Add detectable warnings to these two curb ramps and restripe the crosswalk. Note, this improvement was included in the Laishley Marina report and is not included in the costing section of this report.</p>

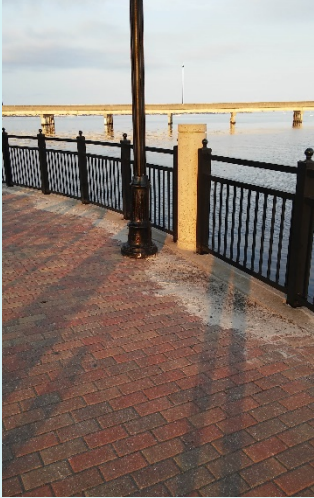
Map Item	Description & Recommendation	Photo
<p>T9</p>	<p>This section of sidewalk has an accumulation of sand on it, possibly due to drainage issues. In addition, the slope is between 5% and 8%</p> <p>Repave this section of trail to eliminate the slope issues. In addition, maintain this area so that the sand buildup does not prevent the area from being stable and slip resistant.</p>

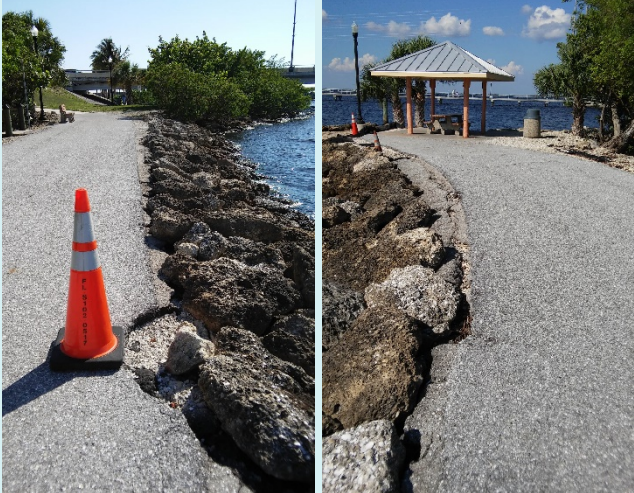
<p>T10</p>	<p>The bricks have settled and are uneven, creating a depression that can act as a tripping hazard.</p> <p>Reset the bricks in this section so that the depression is eliminated.</p>	 
<p>T11</p>	<p>There is a 10" drop off adjacent to the trail where the asphalt path has deteriorated.</p> <p>Fill in the hole to eliminate this hazard.</p>

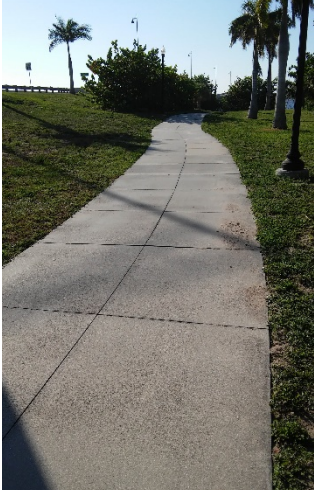
Map Item	Description & Recommendation	Photo
<p>T12</p>	<p>This section of sidewalk has an accumulation of sand on it, possibly due to drainage issues.</p> <p>Maintain this section of trail so that the sand buildup does not prevent the area from being stable and slip resistant.</p>

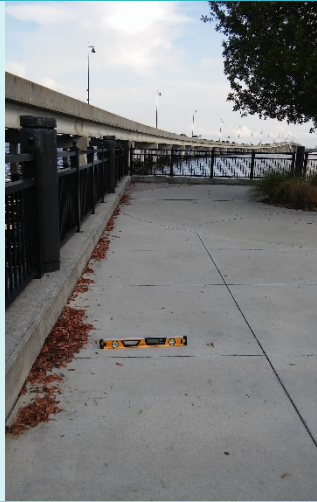
Map Item	Description & Recommendation	Photo
<p>C2</p>	<p>The cross slope is approximately 4.4%.</p> <p>Repave/resurface the trail so that the cross slope is no greater than 2%.</p>

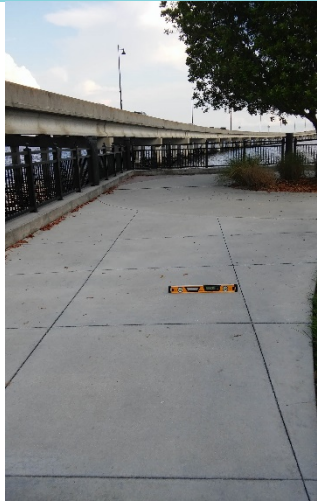
<p>C3</p>	<p>The cross slope is approximately 3.5%.</p> <p>Repave/resurface the trail so that the cross slope is no greater than 2%.</p>

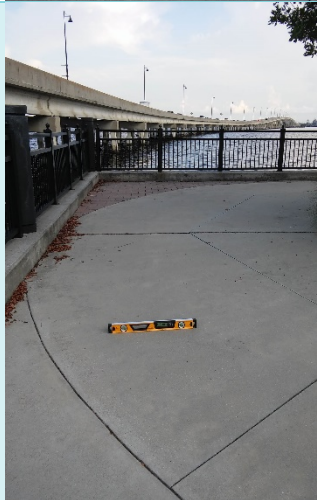
<p>C4</p>	<p>The cross slope is approximately 3%.</p> <p>Repave/resurface the trail so that the cross slope is no greater than 2%.</p>

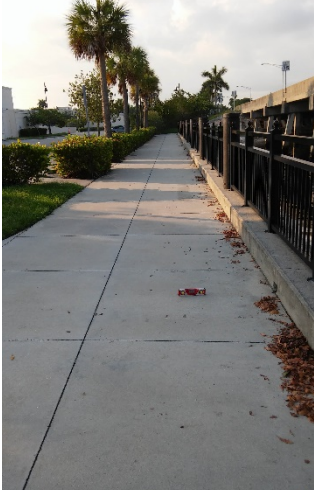
Map Item	Description & Recommendation	Photo
<p>C5</p>	<p>The cross slope is approximately 4.3%.</p> <p>Repave/resurface the trail so that the cross slope is no greater than 2%.</p>

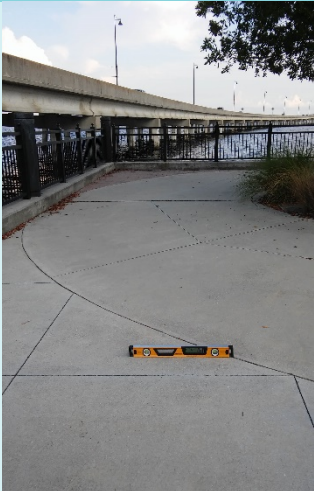
<p>C6</p>	<p>The cross slope is approximately 4.7%.</p> <p>Repave/resurface the trail so that the cross slope is no greater than 2%.</p>

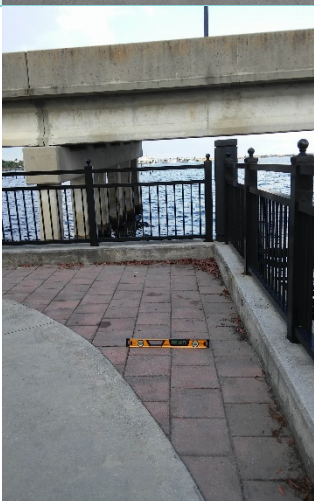
<p>C7</p>	<p>The cross slope is approximately 4.2%.</p> <p>Repave/resurface the trail so that the cross slope is no greater than 2%.</p>

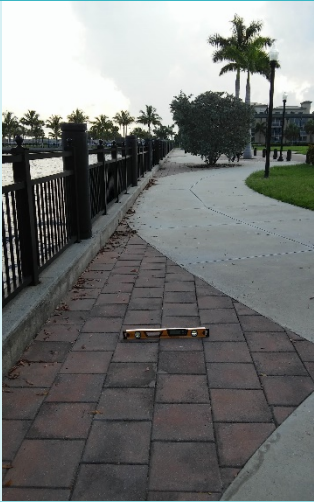
Map Item	Description & Recommendation	Photo
<p>C8</p>	<p>The cross slope is approximately 2.6%.</p> <p>Repave/resurface the trail so that the cross slope is no greater than 2%.</p>

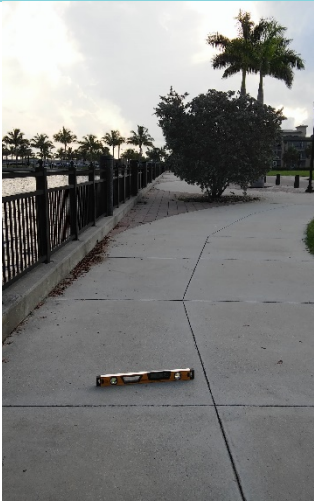
<p>C9</p>	<p>The cross slope is approximately 3%.</p> <p>Repave/resurface the trail so that the cross slope is no greater than 2%.</p>

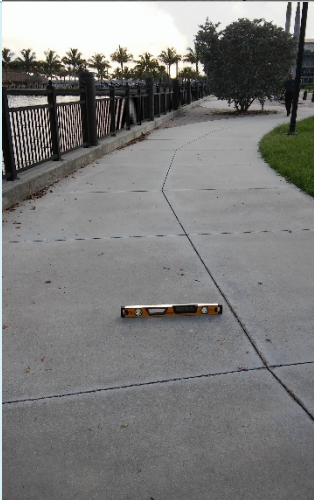
<p>C10</p>	<p>The cross slope is approximately 2.6%.</p> <p>Repave/resurface the trail so that the cross slope is no greater than 2%.</p>

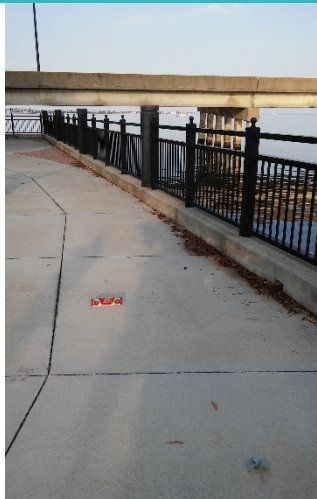
Map Item	Description & Recommendation	Photo
<p>C11</p>	<p>The cross slope is approximately 3%.</p> <p>Repave/resurface the trail so that the cross slope is no greater than 2%.</p>

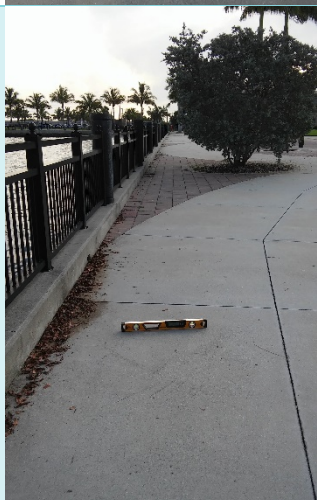
<p>C12</p>	<p>The cross slope is approximately 3.5%.</p> <p>Repave/resurface the trail so that the cross slope is no greater than 2%.</p>

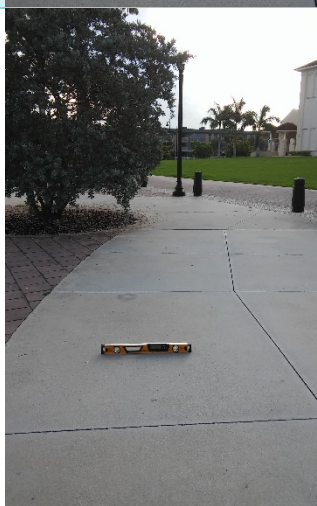
<p>C13</p>	<p>The cross slope is approximately 2.3%.</p> <p>Repave/resurface the trail so that the cross slope is no greater than 2%.</p>

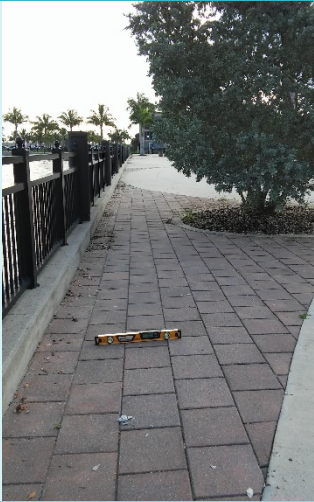
Map Item	Description & Recommendation	Photo
<p>C14</p>	<p>The cross slope is approximately 3.1%.</p> <p>Repave/resurface the trail so that the cross slope is no greater than 2%.</p>

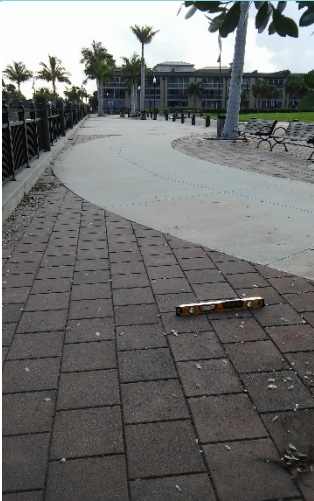
<p>C15</p>	<p>The cross slope is approximately 2.3%.</p> <p>Repave/resurface the trail so that the cross slope is no greater than 2%.</p>

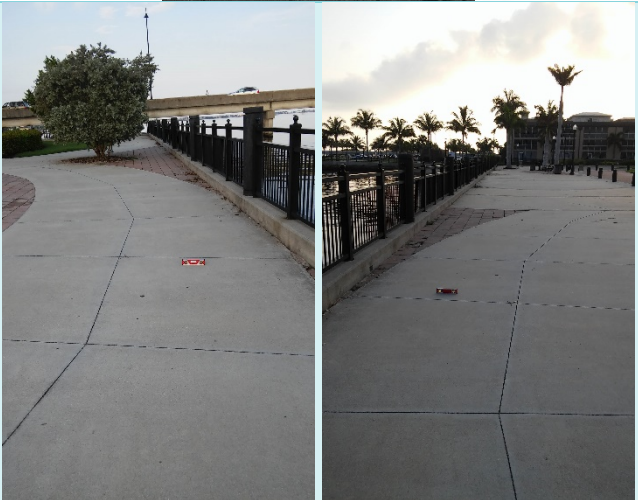
<p>C16</p>	<p>The cross slope is approximately 3.5%.</p> <p>Repave/resurface the trail so that the cross slope is no greater than 2%.</p>

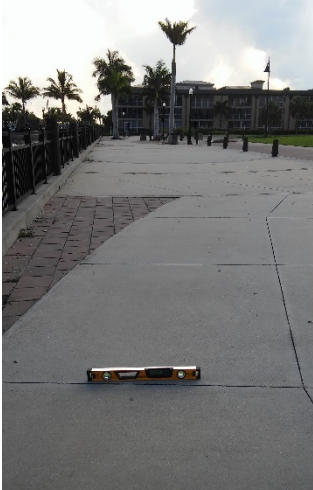
Map Item	Description & Recommendation	Photo
<p>C17</p>	<p>The cross slope is approximately 3.7%.</p> <p>Repave/resurface the trail so that the cross slope is no greater than 2%.</p>

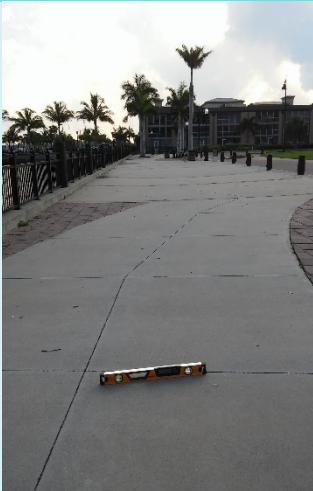
<p>C18</p>	<p>The cross slope is approximately 3.5%.</p> <p>Repave/resurface the trail so that the cross slope is no greater than 2%.</p>

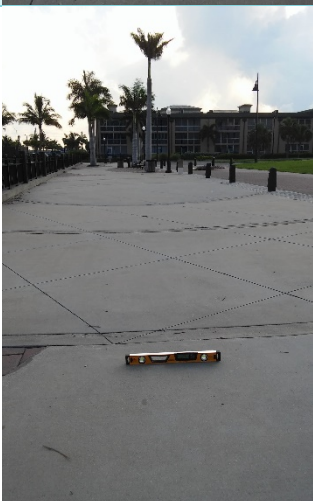
<p>C19</p>	<p>The cross slope is approximately 2.3%.</p> <p>Repave/resurface the trail so that the cross slope is no greater than 2%.</p>

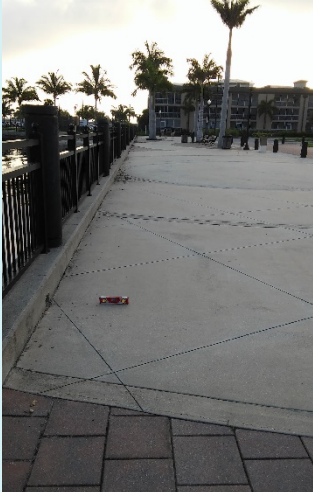
Map Item	Description & Recommendation	Photo
<p>C20</p>	<p>The cross slope is approximately 3%.</p> <p>Repave/resurface the trail so that the cross slope is no greater than 2%.</p>

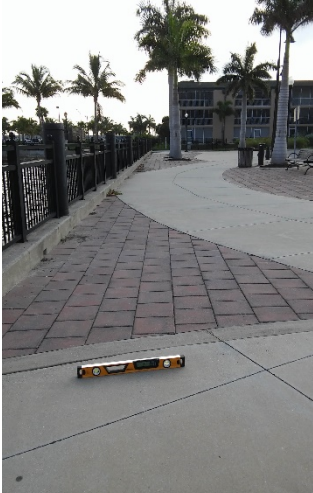
<p>C21</p>	<p>The cross slope is approximately 3.3%.</p> <p>Repave/resurface the trail so that the cross slope is no greater than 2%.</p>

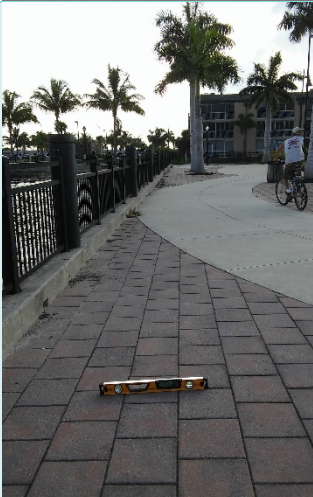
<p>C22</p>	<p>The cross slope is approximately 3.1%.</p> <p>Repave/resurface the trail so that the cross slope is no greater than 2%.</p>

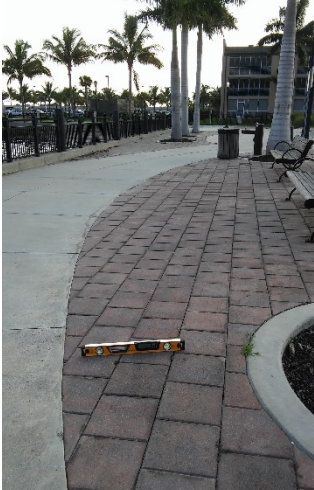
Map Item	Description & Recommendation	Photo
<p>C23</p>	<p>ID - 659 – The cross slope is approximately 4%. Repave/resurface the trail so that the cross slope is no greater than 2%.</p>

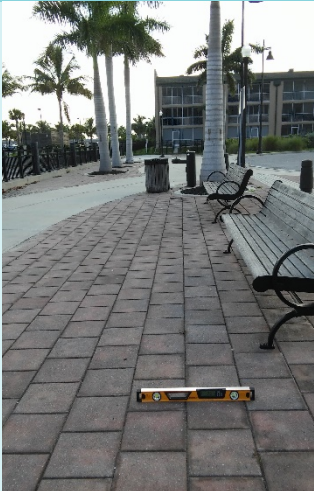
<p>C24</p>	<p>The cross slope is approximately 2.3%. Repave/resurface the trail so that the cross slope is no greater than 2%.</p>

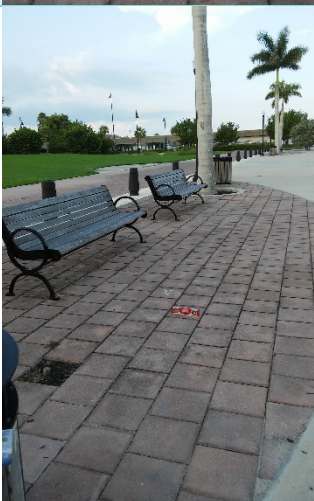
<p>C25</p>	<p>The cross slope is approximately 2.8%. Repave/resurface the trail so that the cross slope is no greater than 2%.</p>

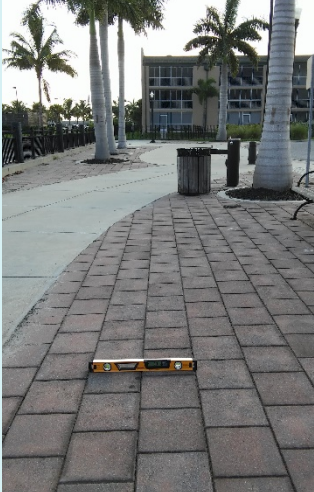
Map Item	Description & Recommendation	Photo
<p>C26</p>	<p>The cross slope is approximately 3.3%.</p> <p>Repave/resurface the trail so that the cross slope is no greater than 2%.</p>

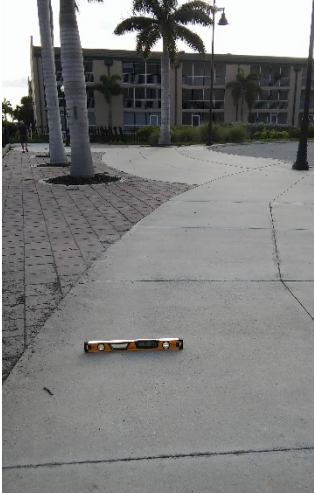
<p>C27</p>	<p>The cross slope is approximately 3.5%.</p> <p>Repave/resurface the trail so that the cross slope is no greater than 2%.</p>

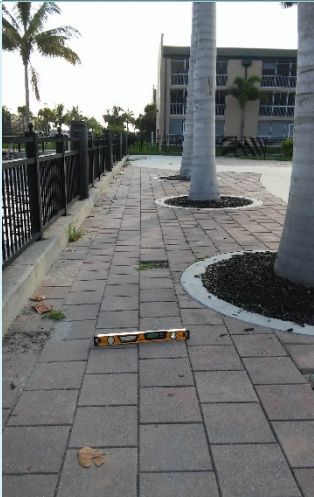
<p>C28</p>	<p>The cross slope is approximately 3.1%.</p> <p>Repave/resurface the trail so that the cross slope is no greater than 2%.</p>

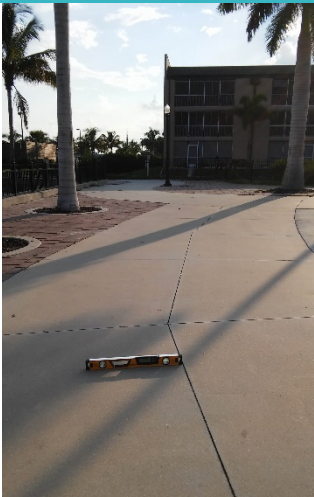
Map Item	Description & Recommendation	Photo
<p>C29</p>	<p>The cross slope is approximately 2.3%.</p> <p>Repave/resurface the trail so that the cross slope is no greater than 2%.</p>

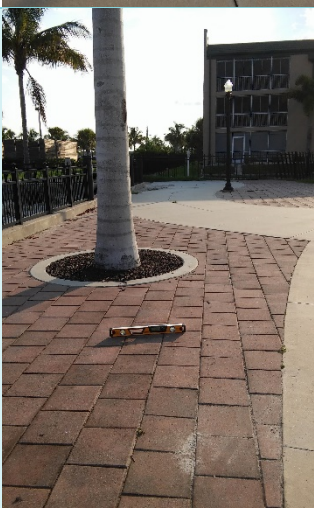
<p>C30</p>	<p>The cross slope is approximately 2.8%.</p> <p>Repave/resurface the trail so that the cross slope is no greater than 2%.</p>

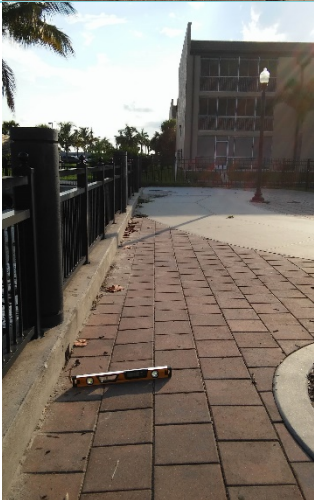
<p>C31</p>	<p>The cross slope is approximately 9.3%.</p> <p>Repave/resurface the trail so that the cross slope is no greater than 2%.</p>

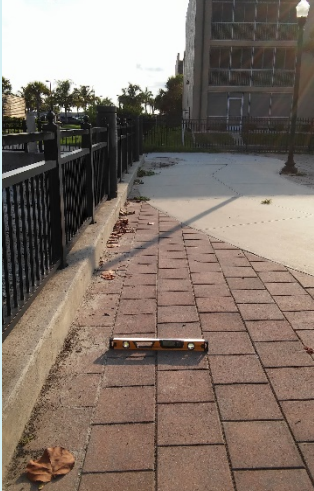
Map Item	Description & Recommendation	Photo
<p>C32</p>	<p>The cross slope is approximately 5.2%.</p> <p>Repave/resurface the trail so that the cross slope is no greater than 2%.</p>

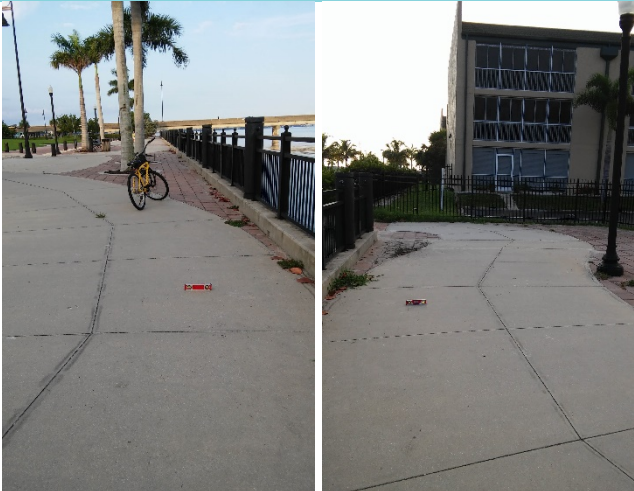
<p>C33</p>	<p>The cross slope is approximately 3%.</p> <p>Repave/resurface the trail so that the cross slope is no greater than 2%.</p>

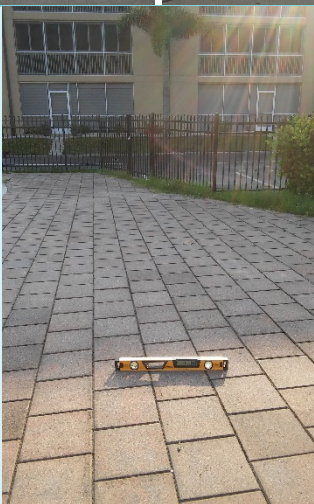
<p>C34</p>	<p>The cross slope is approximately 2.6%.</p> <p>Repave/resurface the trail so that the cross slope is no greater than 2%.</p>

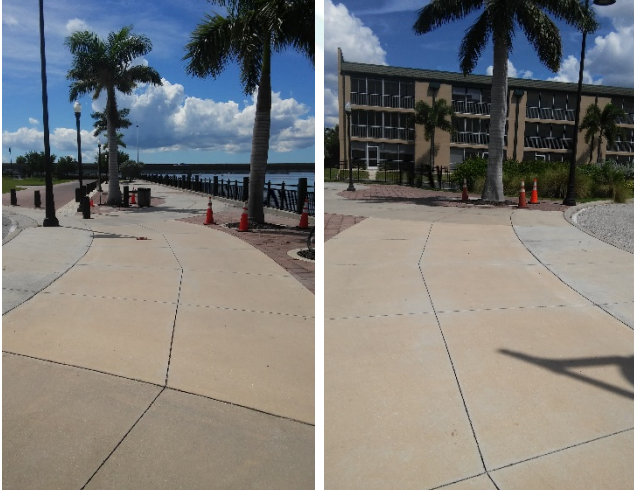
Map Item	Description & Recommendation	Photo
<p>C35</p>	<p>The cross slope is approximately 3% within a 6ft wide by 18ft long area.</p> <p>Repave/resurface the trail so that the cross slope is no greater than 2%.</p>

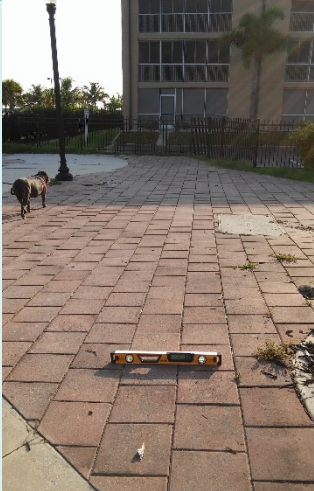
<p>C36</p>	<p>The cross slope is approximately 5.6%.</p> <p>Repave/resurface the trail so that the cross slope is no greater than 2%.</p>

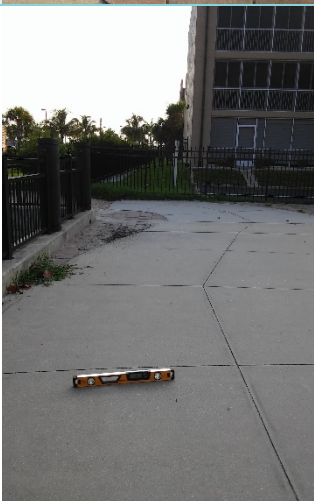
<p>C37</p>	<p>The cross slope is approximately 3.8%.</p> <p>Repave/resurface the trail so that the cross slope is no greater than 2%.</p>

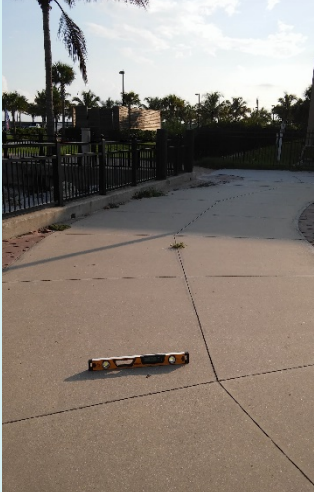
Map Item	Description & Recommendation	Photo
<p>C38</p>	<p>The cross slope is approximately 3.3%.</p> <p>Repave/resurface the trail so that the cross slope is no greater than 2%.</p>

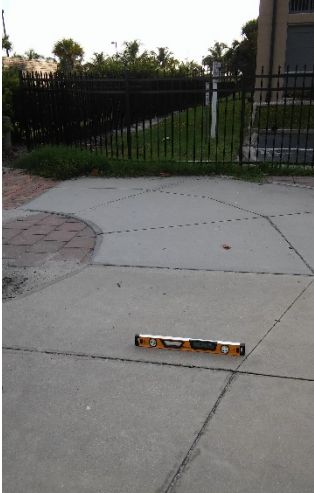
<p>C39</p>	<p>The cross slope is approximately 2.4%.</p> <p>Repave/resurface the trail so that the cross slope is no greater than 2%.</p>

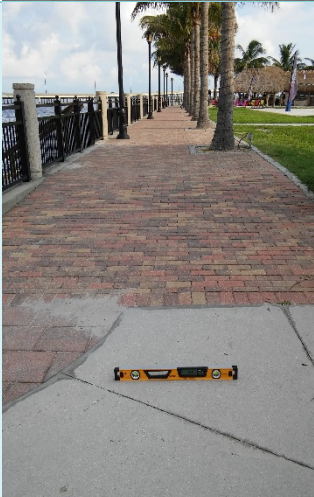
<p>C40</p>	<p>The cross slope is approximately 4.4%.</p> <p>Repave/resurface the trail so that the cross slope is no greater than 2%.</p>

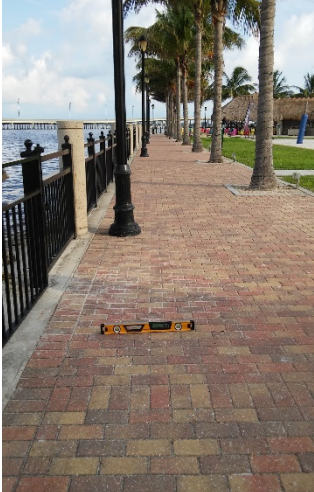
Map Item	Description & Recommendation	Photo
<p>C41</p>	<p>The cross slope is approximately 3%.</p> <p>Repave/resurface the trail so that the cross slope is no greater than 2%.</p>

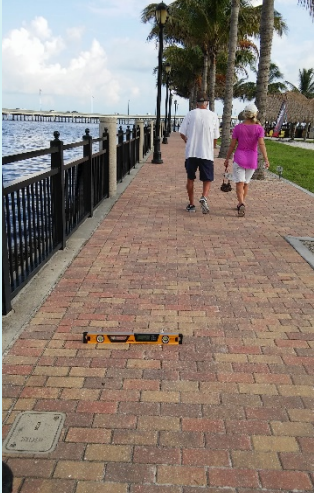
<p>C42</p>	<p>The cross slope is approximately 3.3%.</p> <p>Repave/resurface the trail so that the cross slope is no greater than 2%.</p>

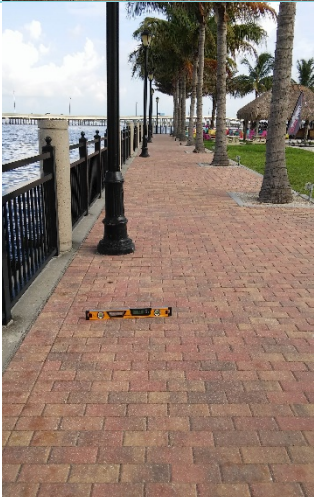
<p>C43</p>	<p>The cross slope is approximately 3%.</p> <p>Repave/resurface the trail so that the cross slope is no greater than 2%.</p>

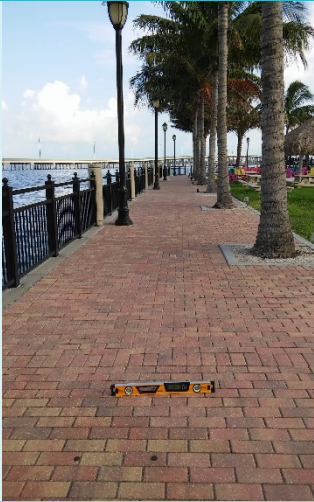
Map Item	Description & Recommendation	Photo
<p>C44</p>	<p>The cross slope is approximately 2.8%.</p> <p>Repave/resurface the trail so that the cross slope is no greater than 2%.</p>

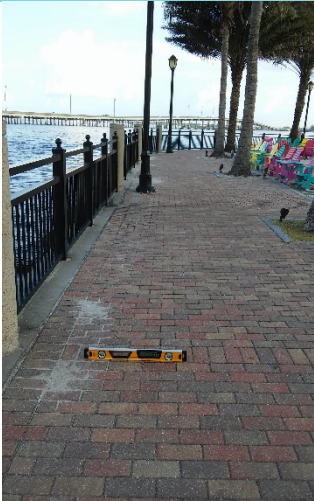
<p>C45</p>	<p>The cross slope is approximately 3.1%.</p> <p>Repave/resurface the trail so that the cross slope is no greater than 2%.</p>

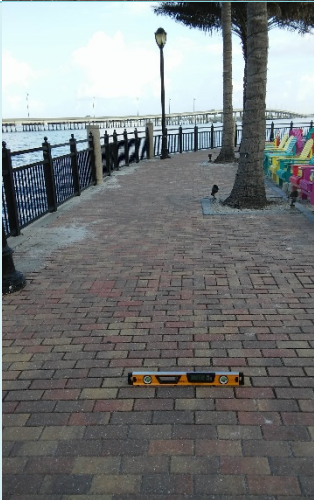
<p>C46</p>	<p>The cross slope is approximately 3%.</p> <p>Repave/resurface the trail so that the cross slope is no greater than 2%.</p>

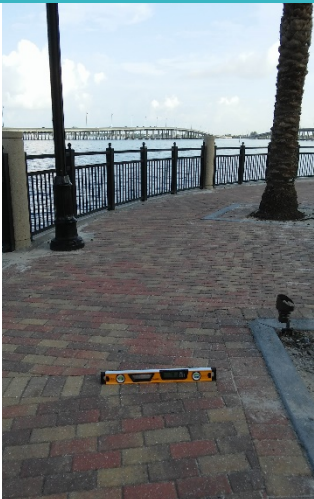
Map Item	Description & Recommendation	Photo
<p>C47</p>	<p>The cross slope is approximately 7%.</p> <p>Repave/resurface the trail so that the cross slope is no greater than 2%.</p>

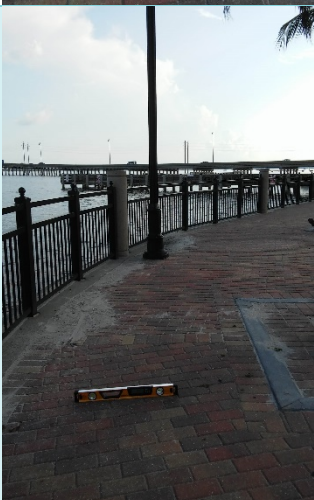
<p>C48</p>	<p>The cross slope is approximately 4.9%.</p> <p>Repave/resurface the trail so that the cross slope is no greater than 2%.</p>

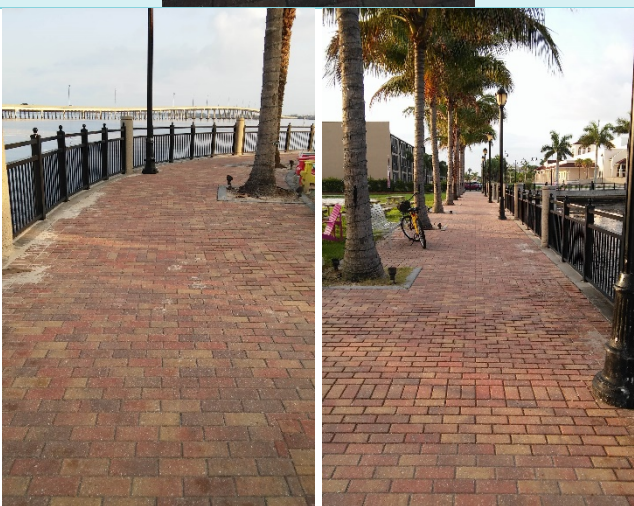
<p>C49</p>	<p>The cross slope is approximately 3.4% in the middle of the trail.</p> <p>Repave/resurface the trail so that the cross slope is no greater than 2%.</p>

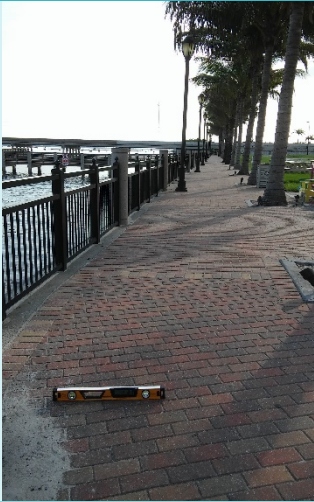
Map Item	Description & Recommendation	Photo
<p>C50</p>	<p>The cross slope is approximately 4.4%.</p> <p>Repave/resurface the trail so that the cross slope is no greater than 2%.</p>

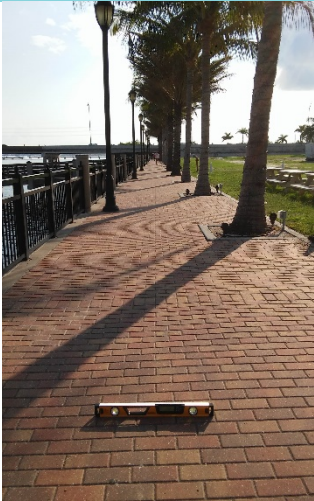
<p>C51</p>	<p>The cross slope is approximately 2.8%.</p> <p>Repave/resurface the trail so that the cross slope is no greater than 2%.</p>

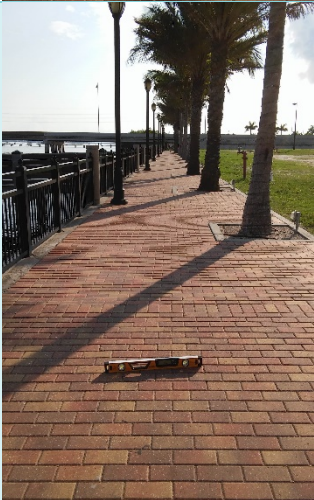
<p>C52</p>	<p>The cross slope is approximately 3.3%.</p> <p>Repave/resurface the trail so that the cross slope is no greater than 2%.</p>

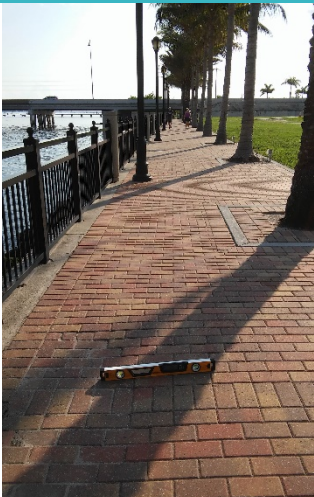
Map Item	Description & Recommendation	Photo
<p>C53</p>	<p>The cross slope is approximately 6.6%.</p> <p>Repave/resurface the trail so that the cross slope is no greater than 2%.</p>

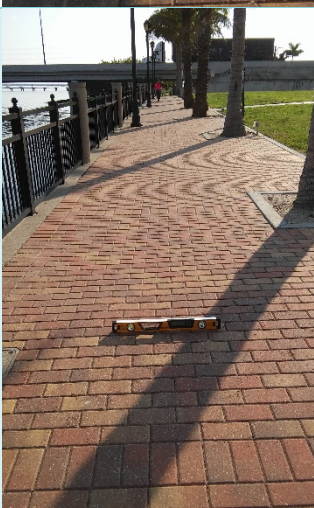
<p>C54</p>	<p>The cross slope is approximately 3.3%.</p> <p>Repave/resurface the trail so that the cross slope is no greater than 2%.</p>

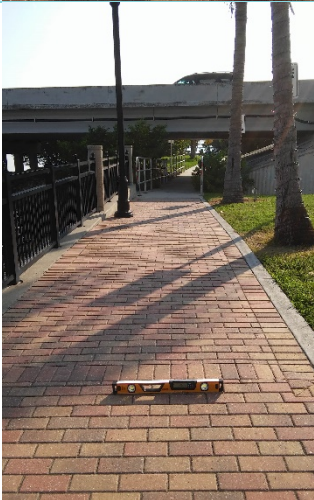
<p>C55</p>	<p>The cross slope is approximately 2.6%.</p> <p>Repave/resurface the trail so that the cross slope is no greater than 2%.</p>

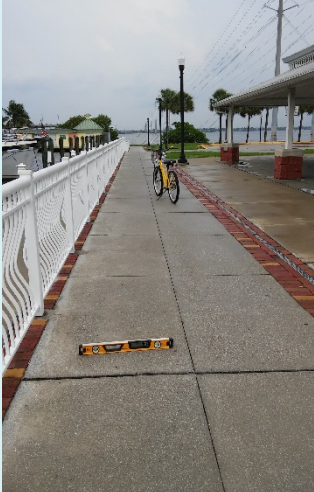
Map Item	Description & Recommendation	Photo
<p>C56</p>	<p>The cross slope is approximately 3%.</p> <p>Repave/resurface the trail so that the cross slope is no greater than 2%.</p>

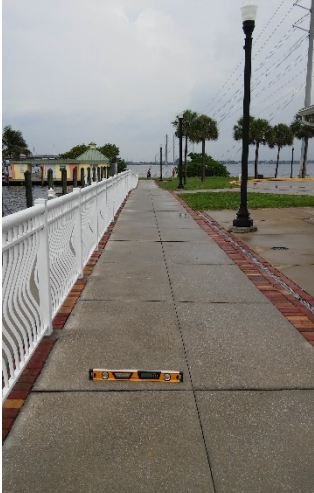
<p>C57</p>	<p>The cross slope is approximately 2.6%.</p> <p>Repave/resurface the trail so that the cross slope is no greater than 2%.</p>

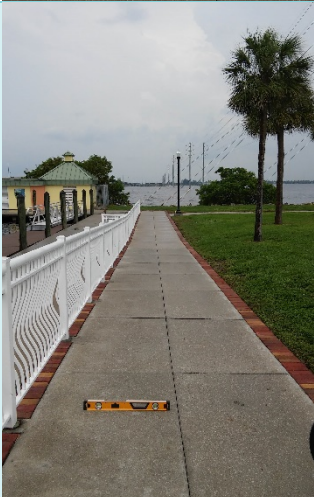
<p>C58</p>	<p>The cross slope is approximately 2.3%.</p> <p>Repave/resurface the trail so that the cross slope is no greater than 2%.</p>

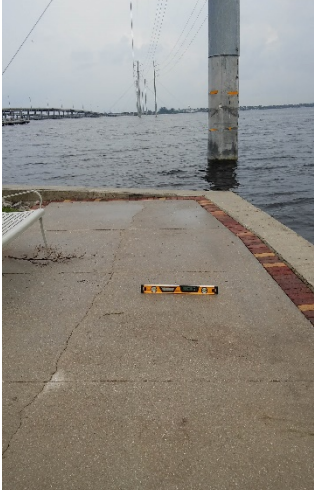
Map Item	Description & Recommendation	Photo
<p>C59</p>	<p>The cross slope is approximately 2.8%.</p> <p>Repave/resurface the trail so that the cross slope is no greater than 2%.</p>

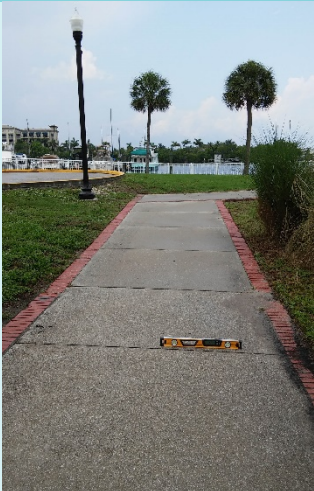
<p>C60</p>	<p>The cross slope is approximately 4%.</p> <p>Repave/resurface the trail so that the cross slope is no greater than 2%.</p>

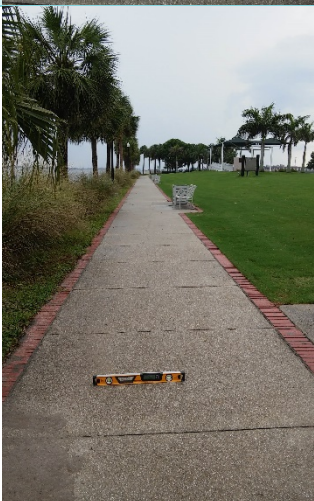
<p>C61</p>	<p>The cross slope is approximately 4%.</p> <p>Repave/resurface the trail so that the cross slope is no greater than 2%.</p>

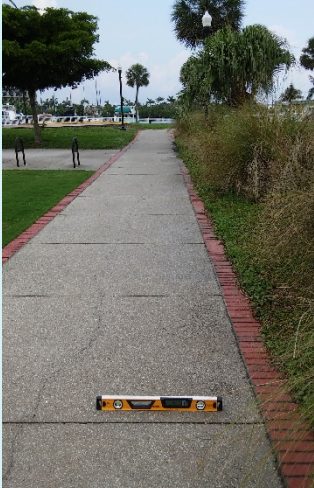
Map Item	Description & Recommendation	Photo
<p>C62</p>	<p>The cross slope is approximately 3.5%.</p> <p>Repave/resurface the trail so that the cross slope is no greater than 2%.</p>

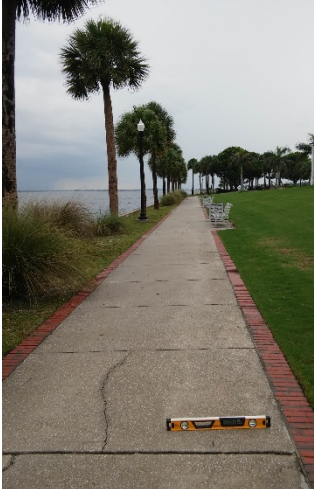
<p>C63</p>	<p>The cross slope is approximately 2.8%.</p> <p>Repave/resurface the trail so that the cross slope is no greater than 2%.</p>

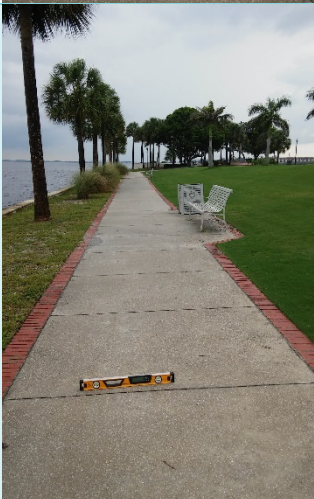
<p>C64</p>	<p>The cross slope is approximately 3.5%.</p> <p>Repave/resurface the trail so that the cross slope is no greater than 2%.</p>

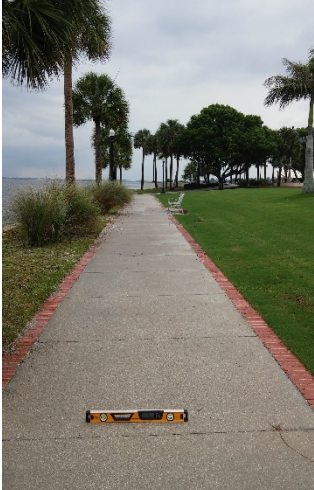
Map Item	Description & Recommendation	Photo
<p>C65</p>	<p>The cross slope is approximately 3.3%.</p> <p>Repave/resurface the trail so that the cross slope is no greater than 2%.</p>

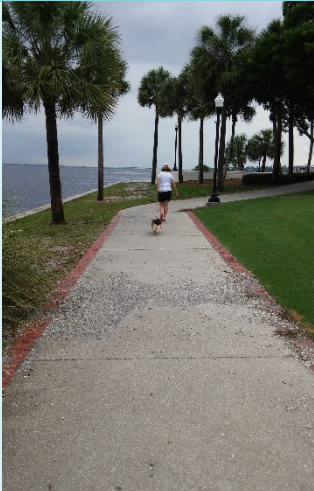
<p>C66</p>	<p>The cross slope is approximately 3.5%. There is a lot of sand within the trail.</p> <p>Repave/resurface the trail so that the cross slope is no greater than 2%. In addition, maintain this section of trail to make sure that the buildup of sand does not prevent this section of trail from being firm, stable, and slip resistant.</p>

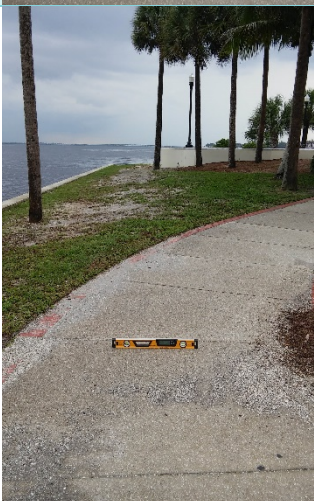
<p>C67</p>	<p>The cross slope is approximately 3.3%.</p> <p>Repave/resurface the trail so that the cross slope is no greater than 2%.</p>

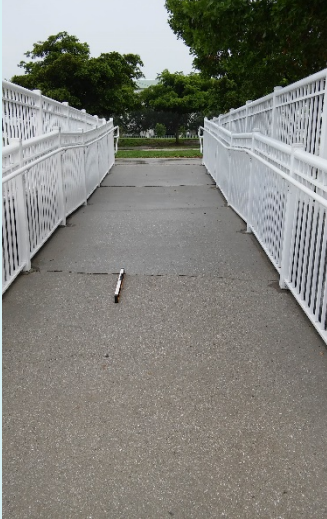
Map Item	Description & Recommendation	Photo
<p>R7</p>	<p>The ramp has a max running slope of 8.6%.</p> <p>Resurface the section of the ramp with a non-compliant running slope so it is no greater than 8.33%.</p>

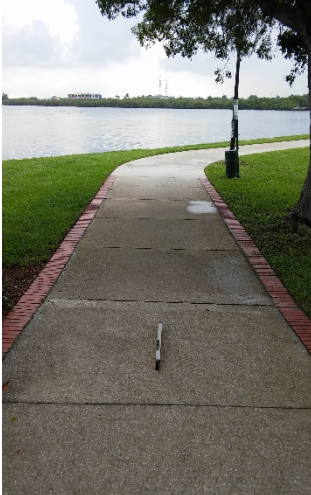
<p>R8</p>	<p>This section of trail has a 7.1% running slope.</p> <p>Repave & regrade the trail to have a slope no greater than 5%. Or, designate this section of trail as a ramp and add handrails and landings.</p>

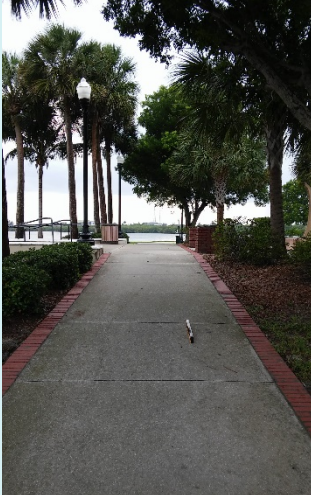
<p>R9</p>	<p>This section of trail has a 9.1% running slope.</p> <p>Repave & regrade the trail to have a slope no greater than 5%. Or, designate this section of trail as a ramp and add handrails and landings.</p>

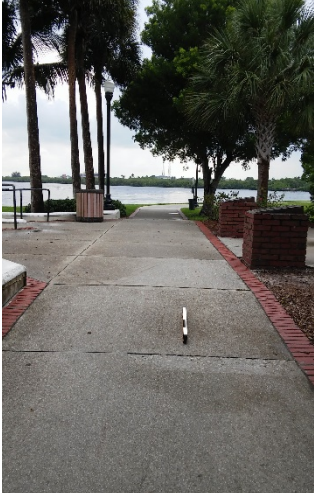
Map Item	Description & Recommendation	Photo
<p>R10</p>	<p>This section of trail has a 7% running slope.</p> <p>Repave & regrade the trail to have a slope no greater than 5%. Or, designate this section of trail as a ramp and add handrails and landings.</p>
