CITY OF PUNTA GORDA ADA TRANSITION PLAN FINAL REPORT

Laishley Park

October 4, 2017

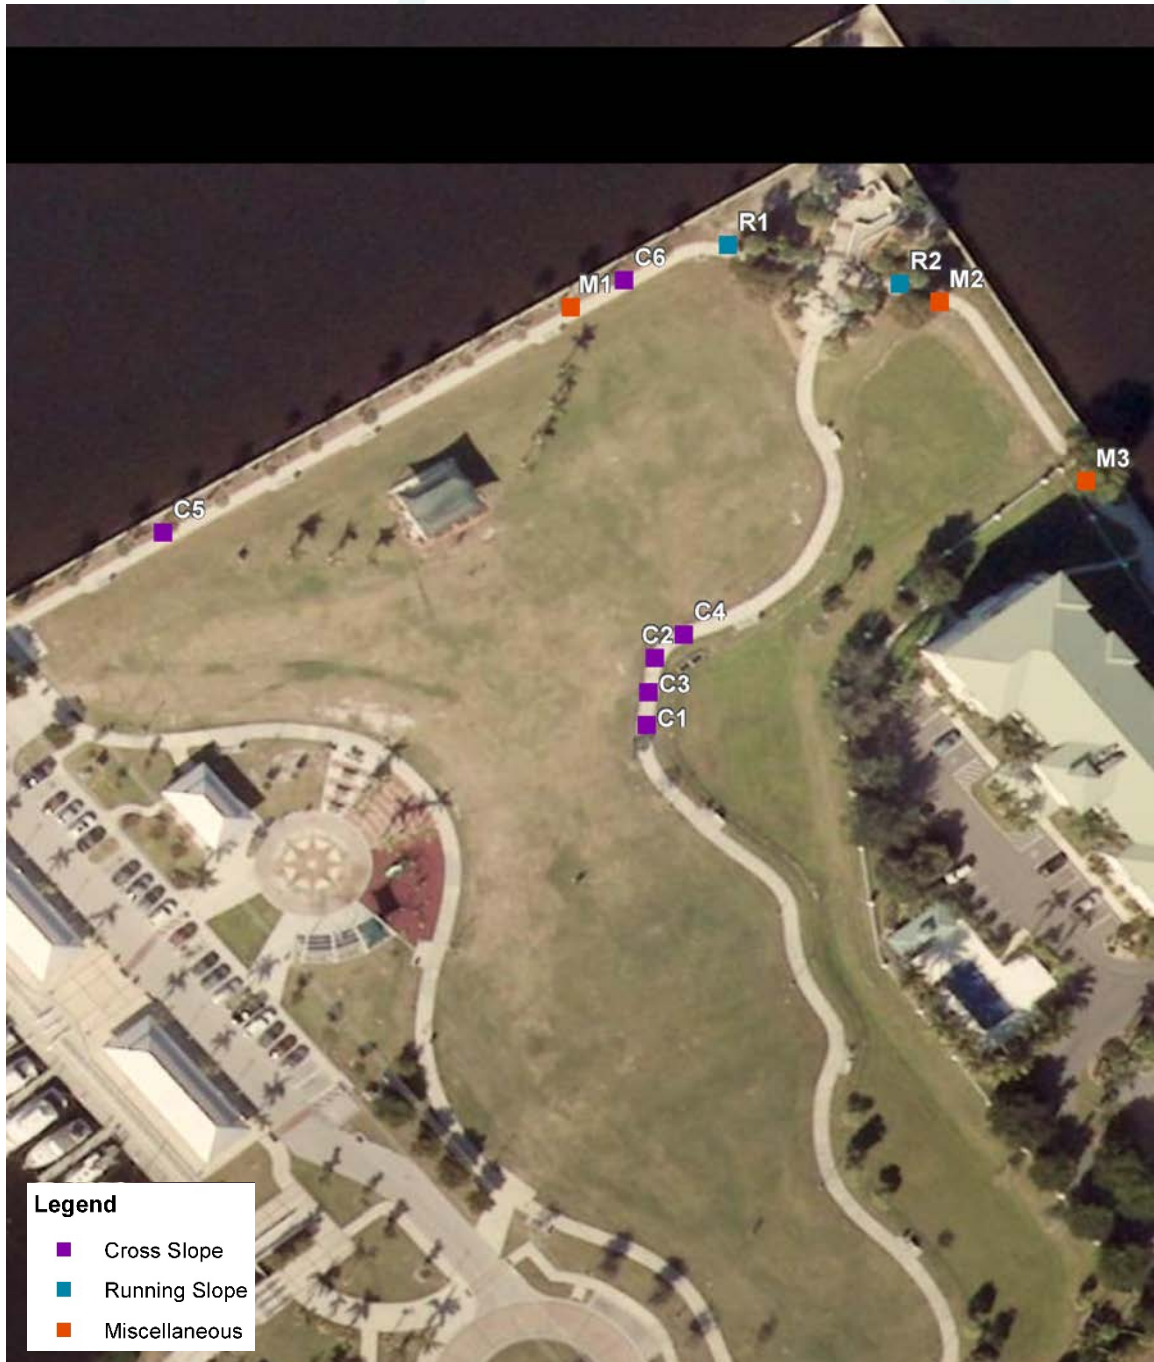
Map Item	Description & Recommendation	Photo(s)
<p>C1</p>	<p>3.3% cross slope – Resurface so the cross slope is no greater than 2%</p>
